James Madison Park Shelter

Building Condition Assessment & Study

Date: October 21, 2013

RE: **James Madison Park Shelter
Mechanical/Electrical Evaluation and Condition Report**

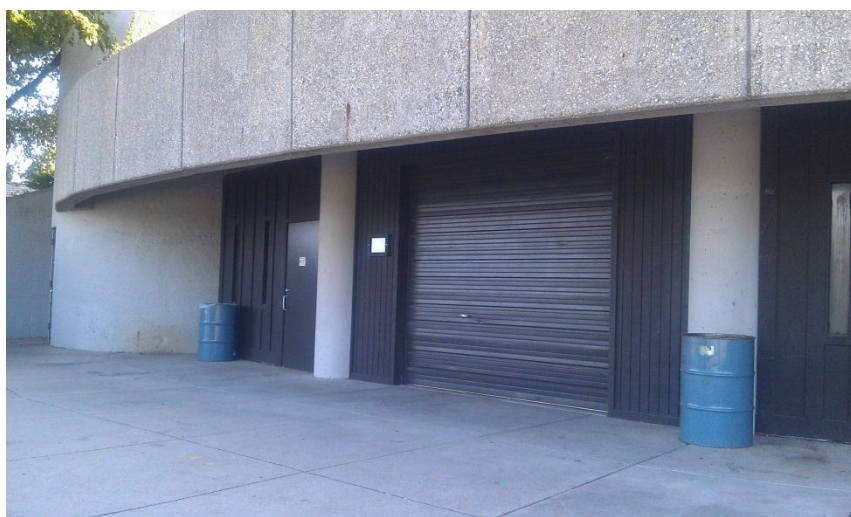
Entry: The existing brown wood entry does not welcome the community. It is dark and visually heavy. The solid wall raises concerns of visibility and security. The wood entry does not accentuate the floating curved forms of the primary structure.

Lakeside Entry to Shelter

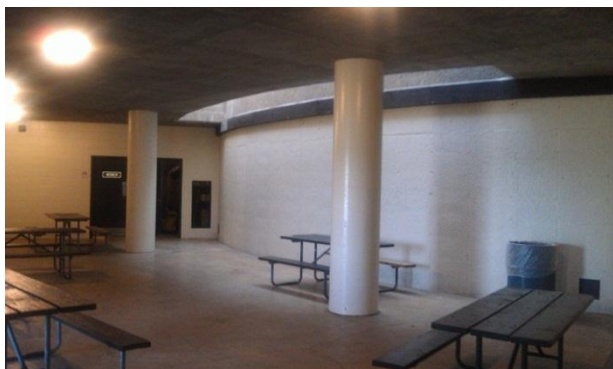
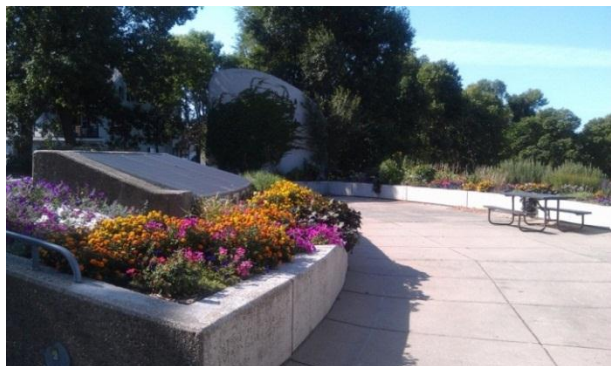
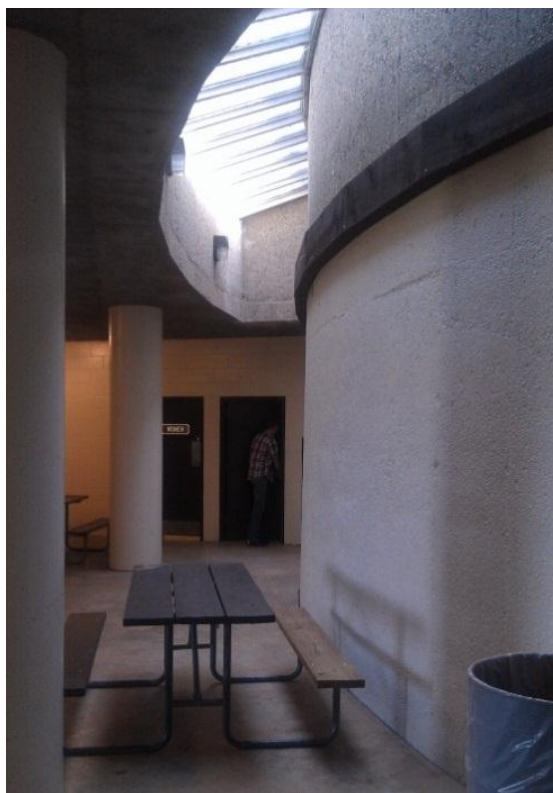
Skylight: The skylight appears to have a couple areas of cracked glass, but is in good condition. A leak at the concrete seam below the skylight was repaired 3+ years ago.

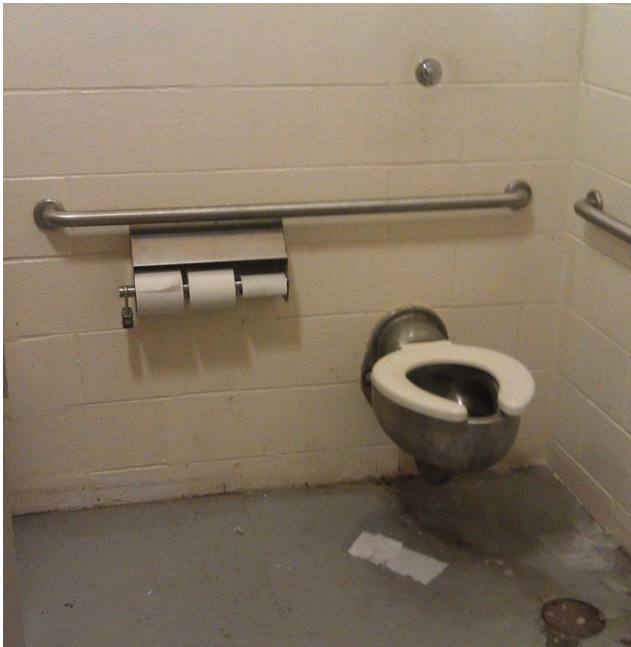
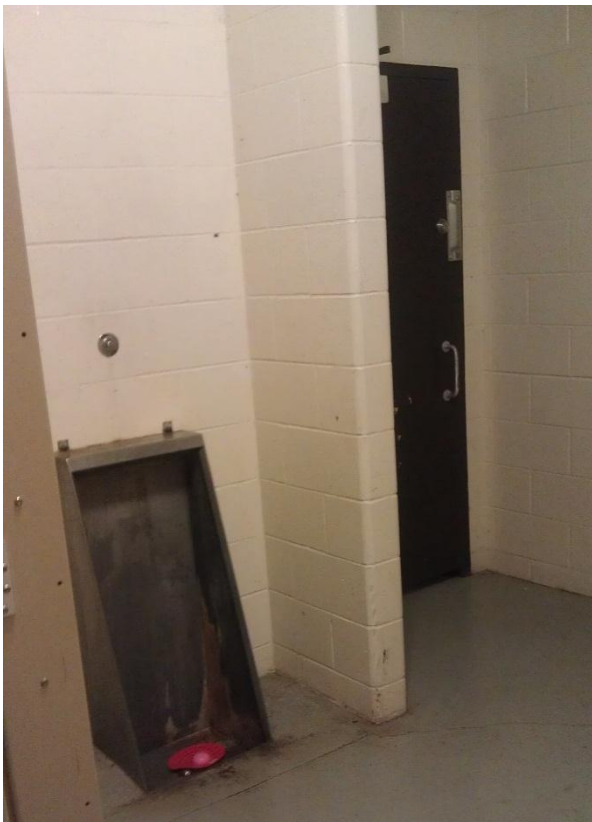
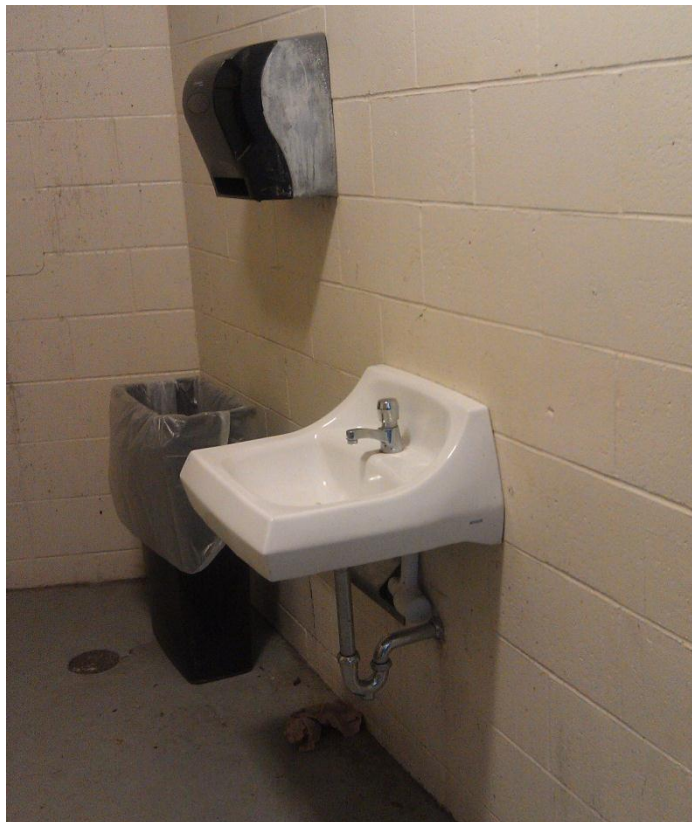
Toilet Rooms: The current toilet rooms and outdoor showers are well-used and provide only cold water. They require maintenance and need ADA Accessibility upgrades.

Existing Women's Toilet

Existing men's Urinal

Existing men's Sink

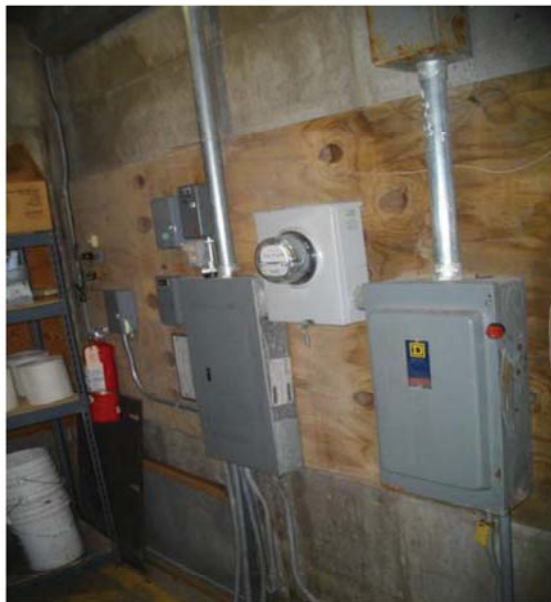
The facility is provided with 200-amp 120/240-volt/1-phase electrical service in the north mechanical room. The distribution panelboard is a Square D NQOD with 20 spaces and only 10 circuit breakers used. None of the circuit breakers appear to be labeled adequately.

Electrical Service & Meter Bank

All electrical distribution and devices (switches and receptacles) should be replaced and provided with GFI protection through out. New energy efficient light fixtures and controls will be required to meet current codes. New exist and egress lighting will also need to be addressed.

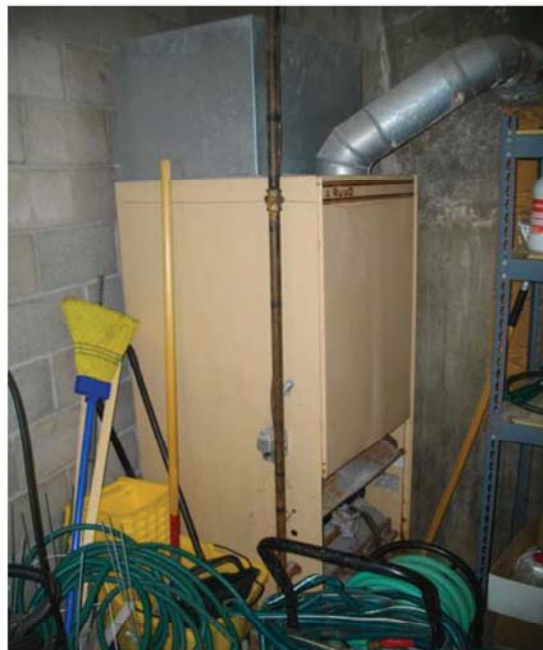
The facility was heated by gas-fired downflow furnace which appears original and non-functional at this time. The furnace unit supplied an underground transite ductwork system with supply diffusers in both sides of the activity space and a diffuser servicing the concession space. Return air is drawn through the activity space into the mechanical room by transfer grilles. The furnace is gravity vented to a concrete encased chimney above the roof patio area, which appears to be cracked.

Existing Downflow Furnace

If the facility is not planned to be heated the furnace system and underground ductwork can be abandoned. If seasonal heating is needed a preferred overhead ductwork system should be pursued.

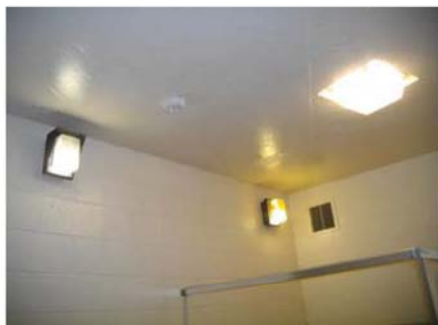
The lighting inside the building has been replaced with predominantly HID outdoor lighting and controlled by time clocks. The lighting color quality and quantity are not good. Much of the conduit system appears to be imbedded in the concrete and may not be in good condition if it was galvanized conduit.

Typical HID Light Fixtures

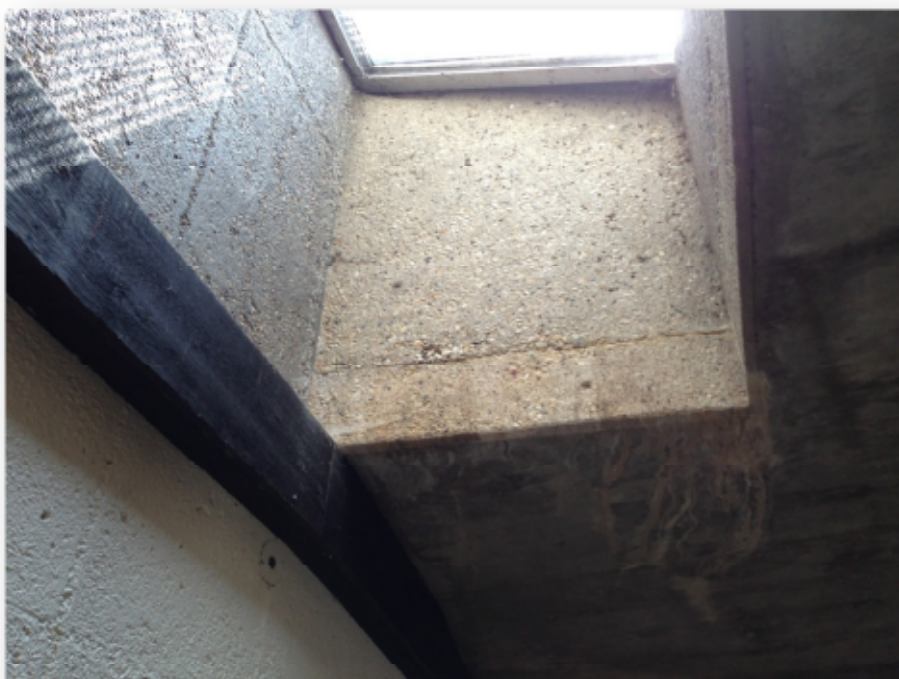
Photo 3 - Moisture Penetration

A couple notable structural concerns regarding the existing conditions were made. Concrete is spalling off the bottom of the elevated concrete wall at the front entrance of the building (Photo 4). The open air terrace has a skylight along the back of the building that appears to have an active or recent leak allowing moisture penetration (Photos 2, 3). The planter gardens located on top of the slab appear to have a soil depth of around 2’-0”. The structural drawings show these planters filled with soil to that depth and this load is

In general, the Park Shelter building is in very good condition. **(mp)²** recommends the spalling concrete be addressed to avoid possible injury from falling debris. The moisture penetration at the skylight should be addressed by repairing the leaks. **(mp)²** also would recommend a detailed analysis of the flat mat slab be performed if the proposed renovation were to increase the current slab design loads.

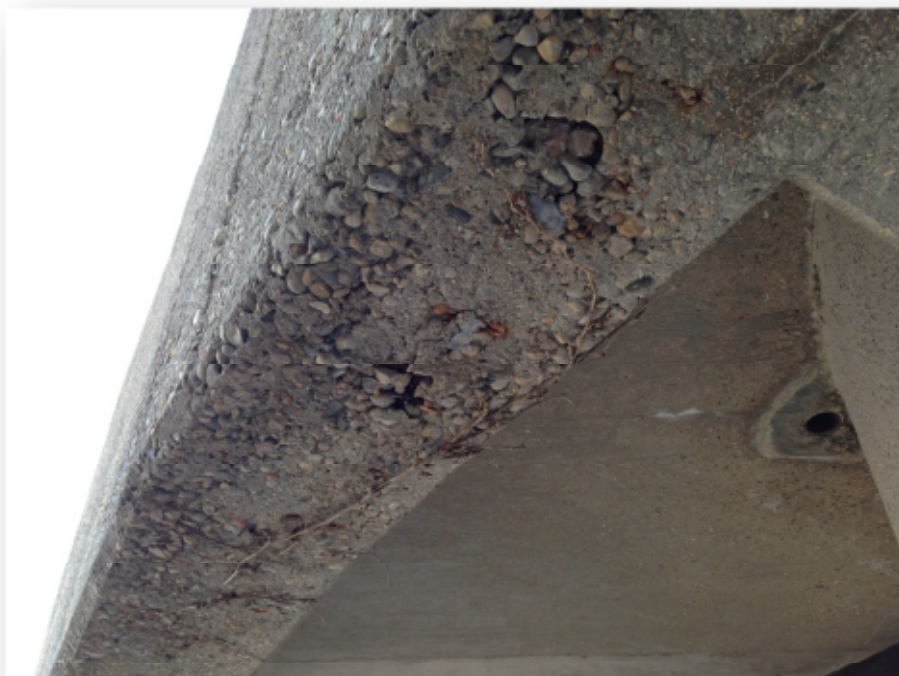
Photo 4 - Concrete Spalling

The park shelter building observed needs a few maintenance items addressed but overall, the building is in very good structural condition. The most critical repair is to address the spalling and loose concrete along the bottom of the front entrance beam since this is a potential safety issue.

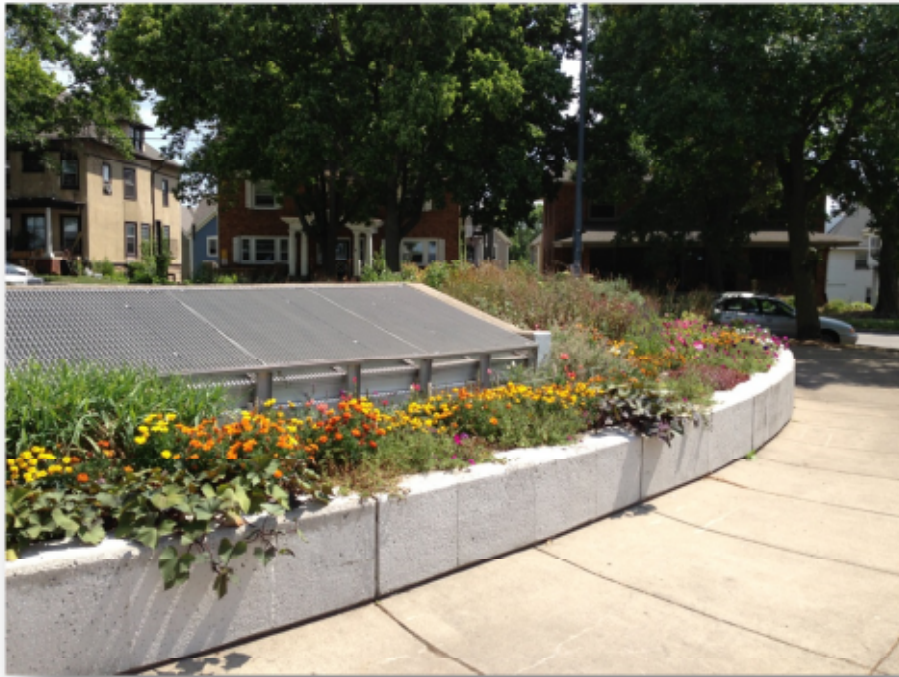
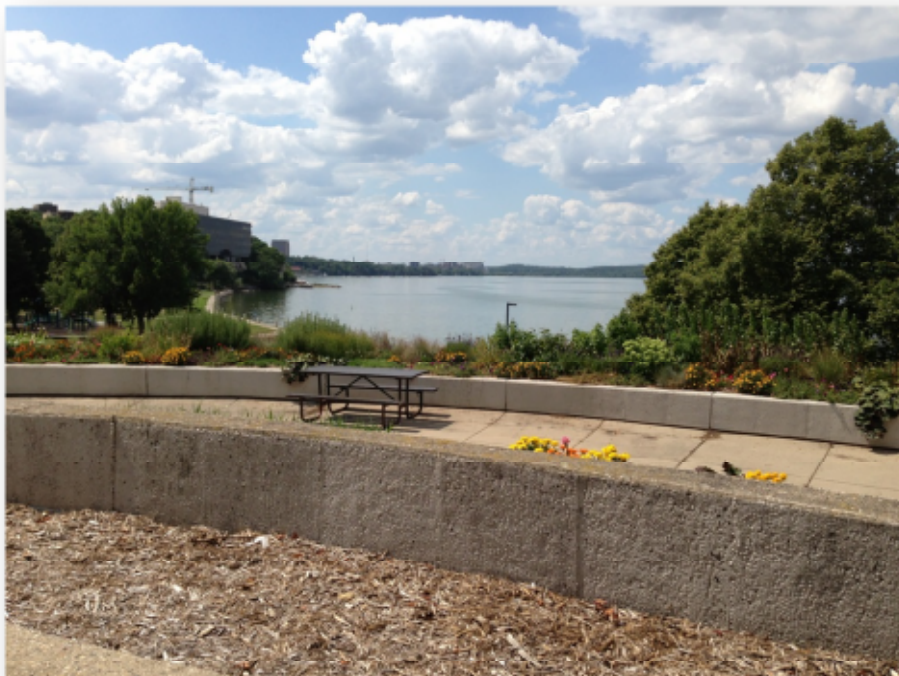
very likely considered dead load in the original structural design. (Photos 5, 6). The structural drawings indicate the design live load of the public access areas of the elevated concrete slab is 100 psf. This live load would meet the current code requirements for uses such as dance halls, ballrooms or other places of assembly.

Photo 5 - Terrace Level Garden

Photo 6 - Terrace Level Garden

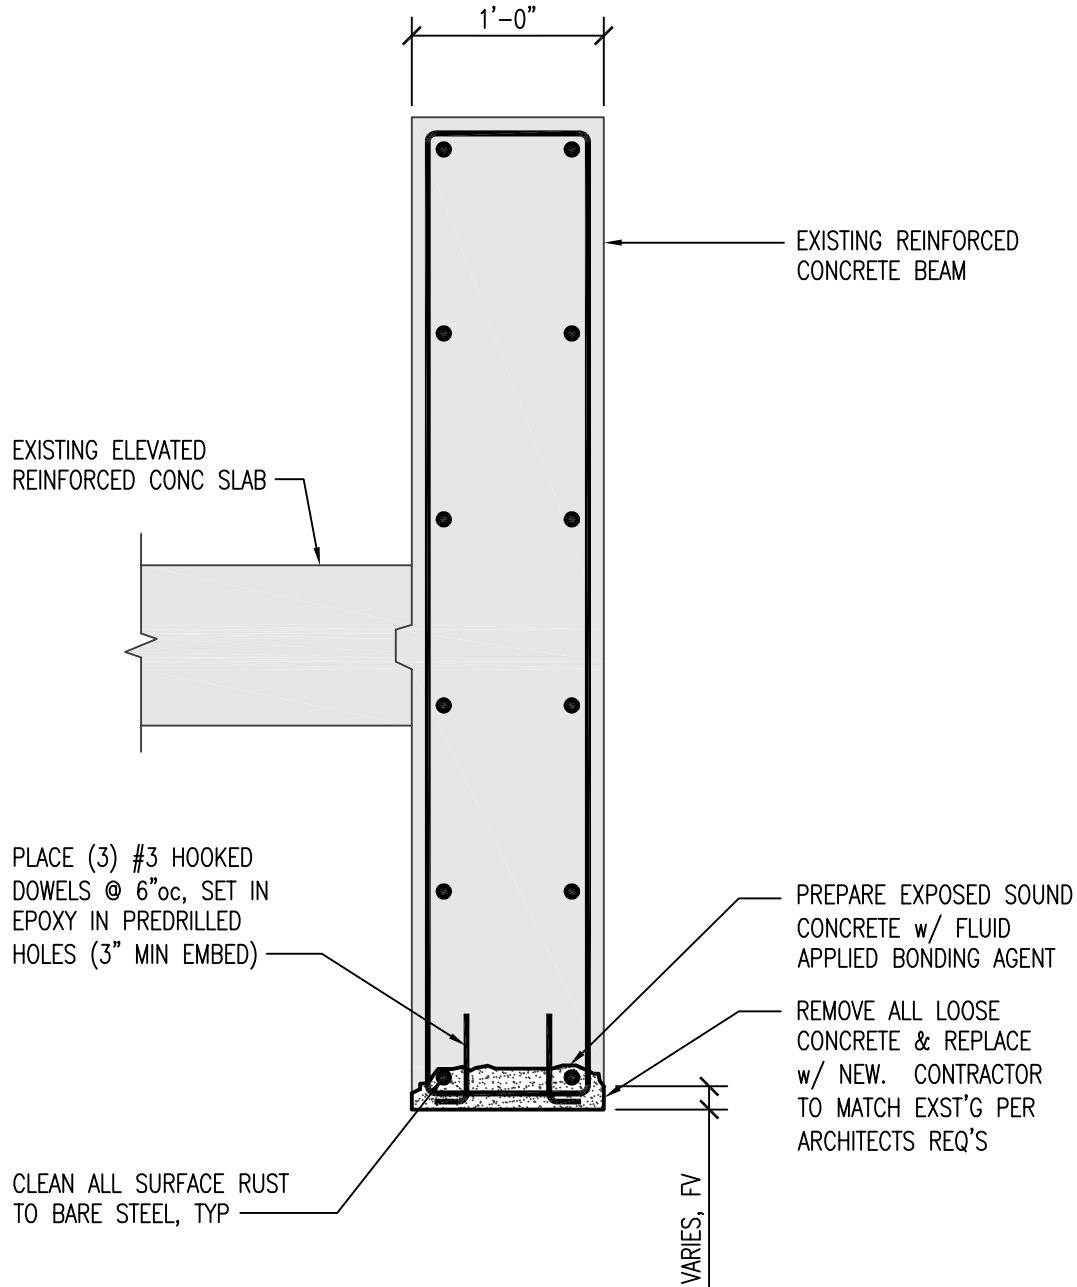
1
SK-1

CONC BEAM REPAIR DETAIL
