Advertisement for Bids – Asbestos Abatement and Building Demolition

RE: Final Report- Pre-Demolition Services
 LEGEND No. 23WI059

This report presents the results of the pre-demolition inspection of the Marshfield Medical Center located at 900 College Avenue W in Ladysmith, WI conducted by LEGEND Technical Services, Inc. (LEGEND) representative Mr. Lucas Sokol, WI Asbestos Inspector #AII-267101 and Katia Castro Lopez, WI Asbestos Inspector #AII-290508 on May 2, 3, 13 and 24; June 7, 29, 2023. LEGEND's services were requested and authorized by Gary Shilts with Rusk County.

900 Colleve Avenue W
Ladysmith, WI 54848
Ground Floor
ACM Diagram

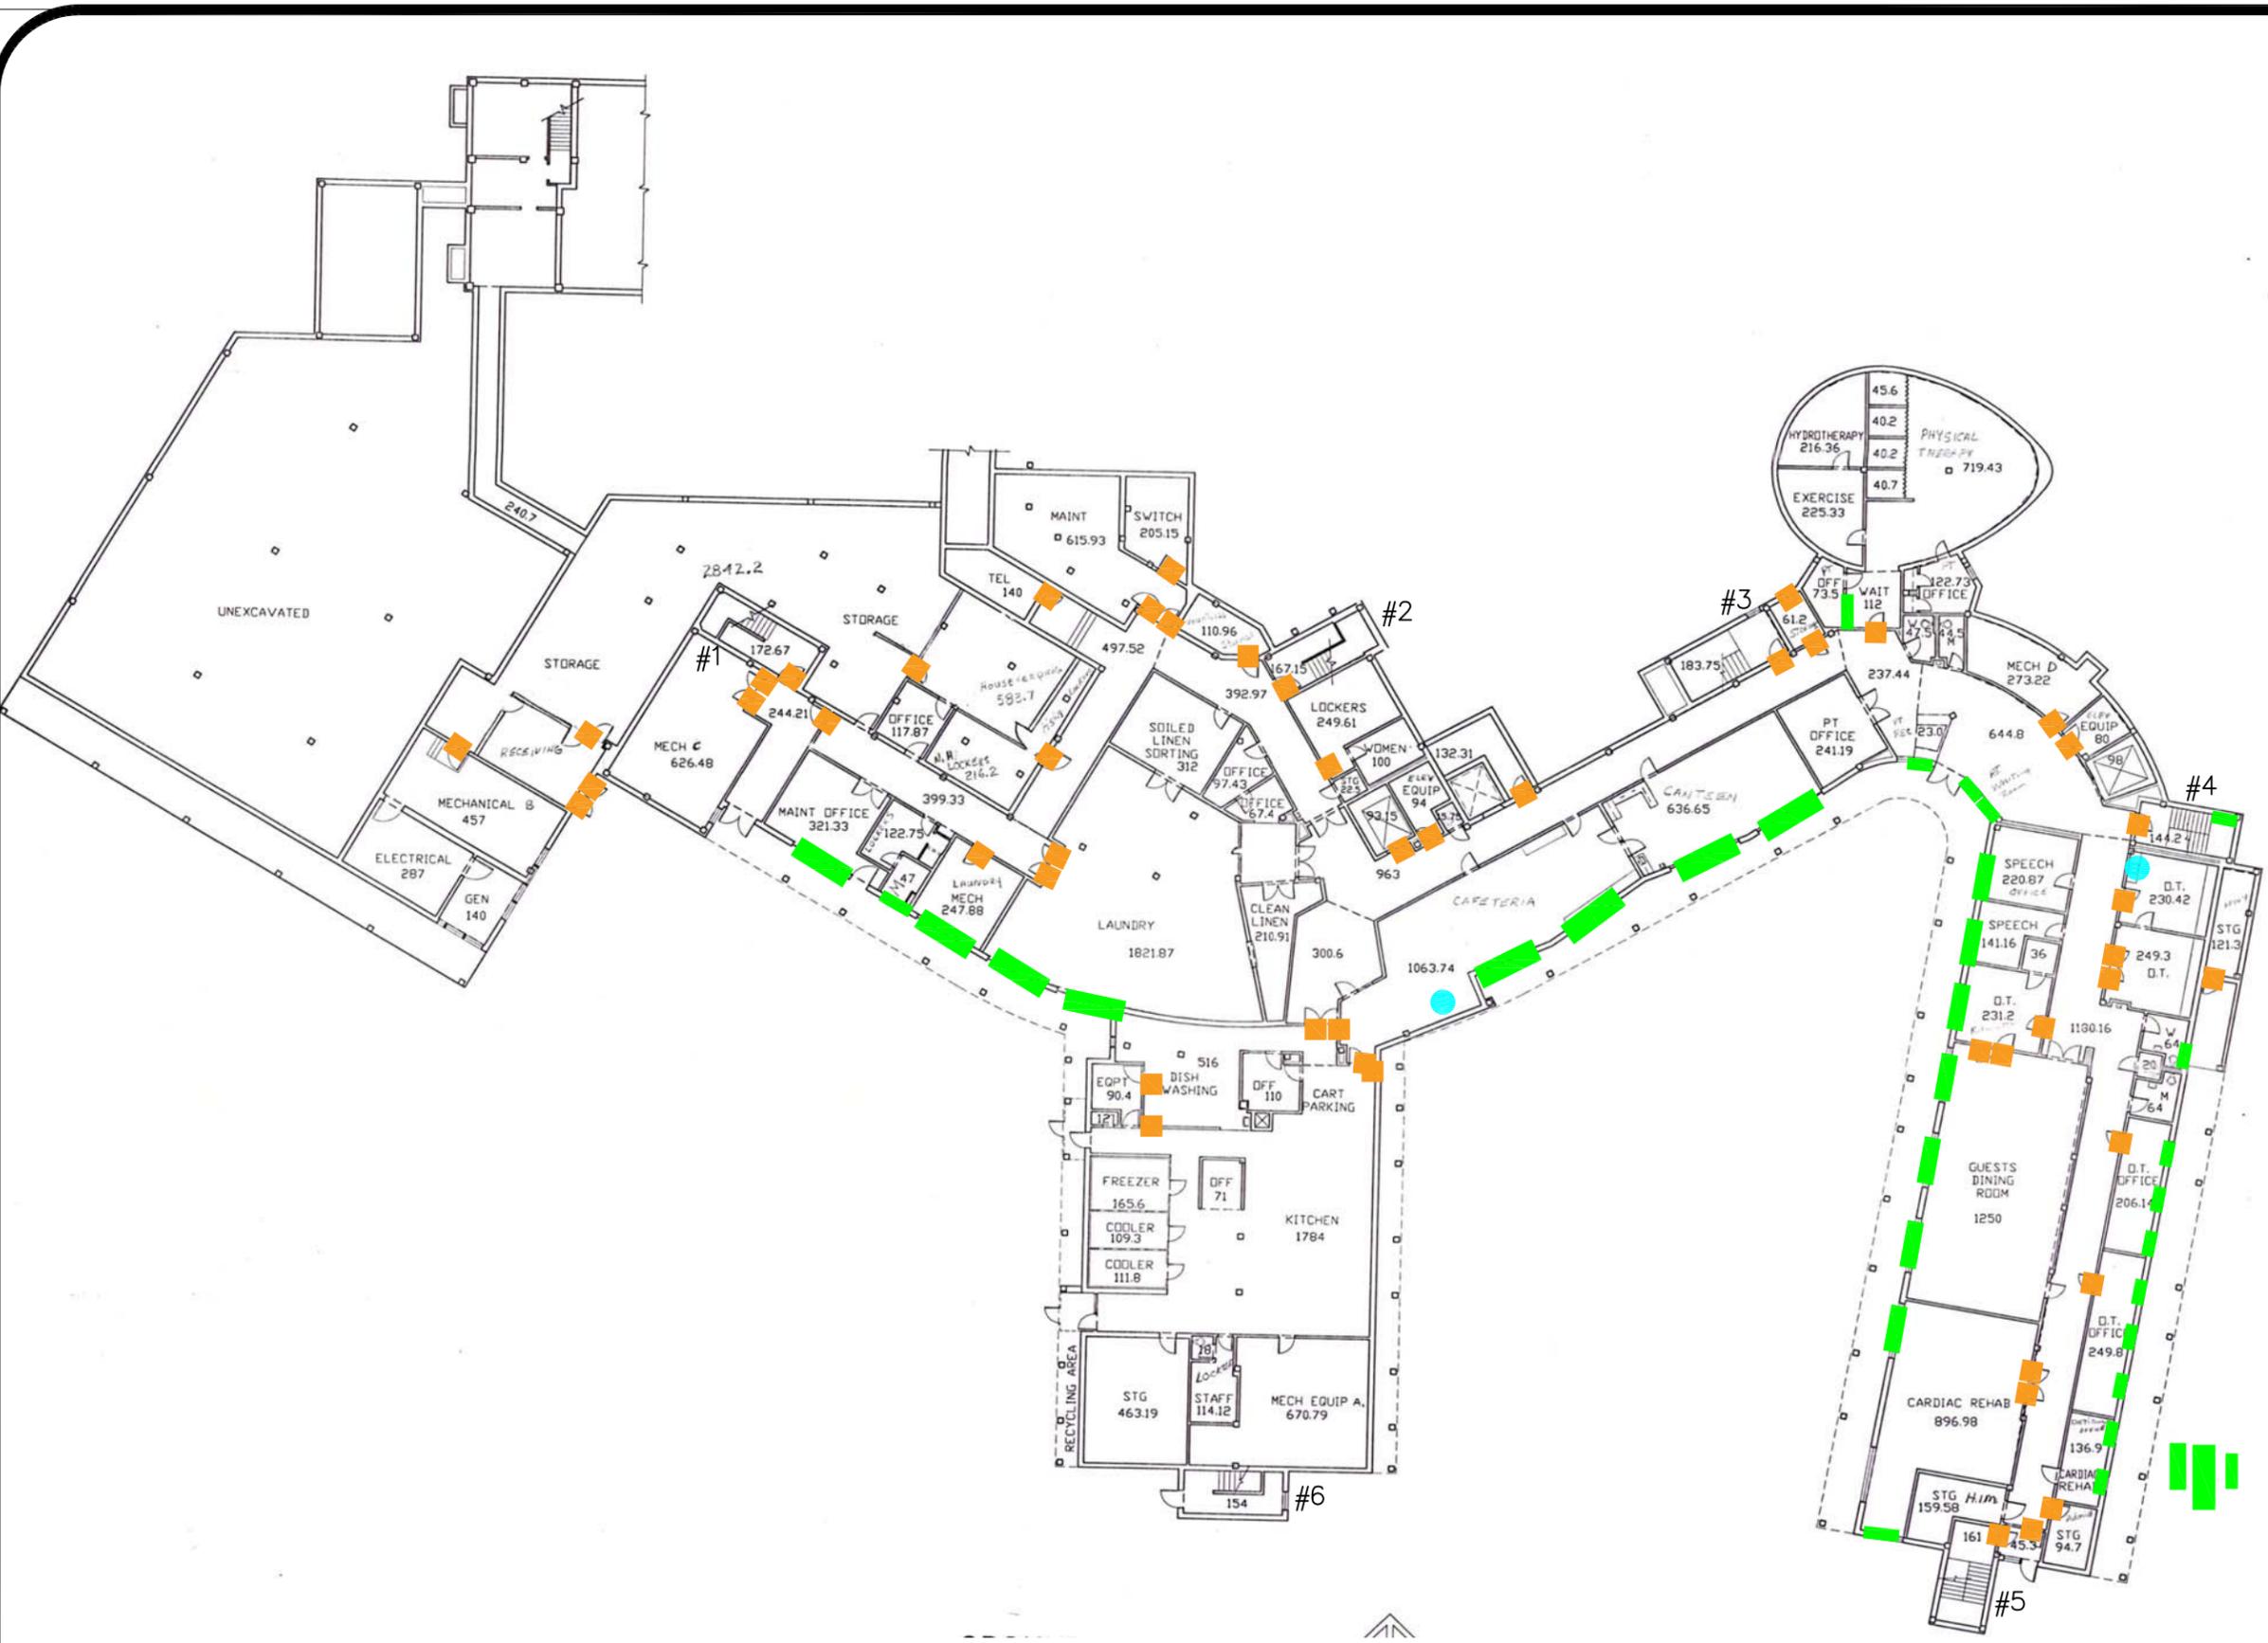
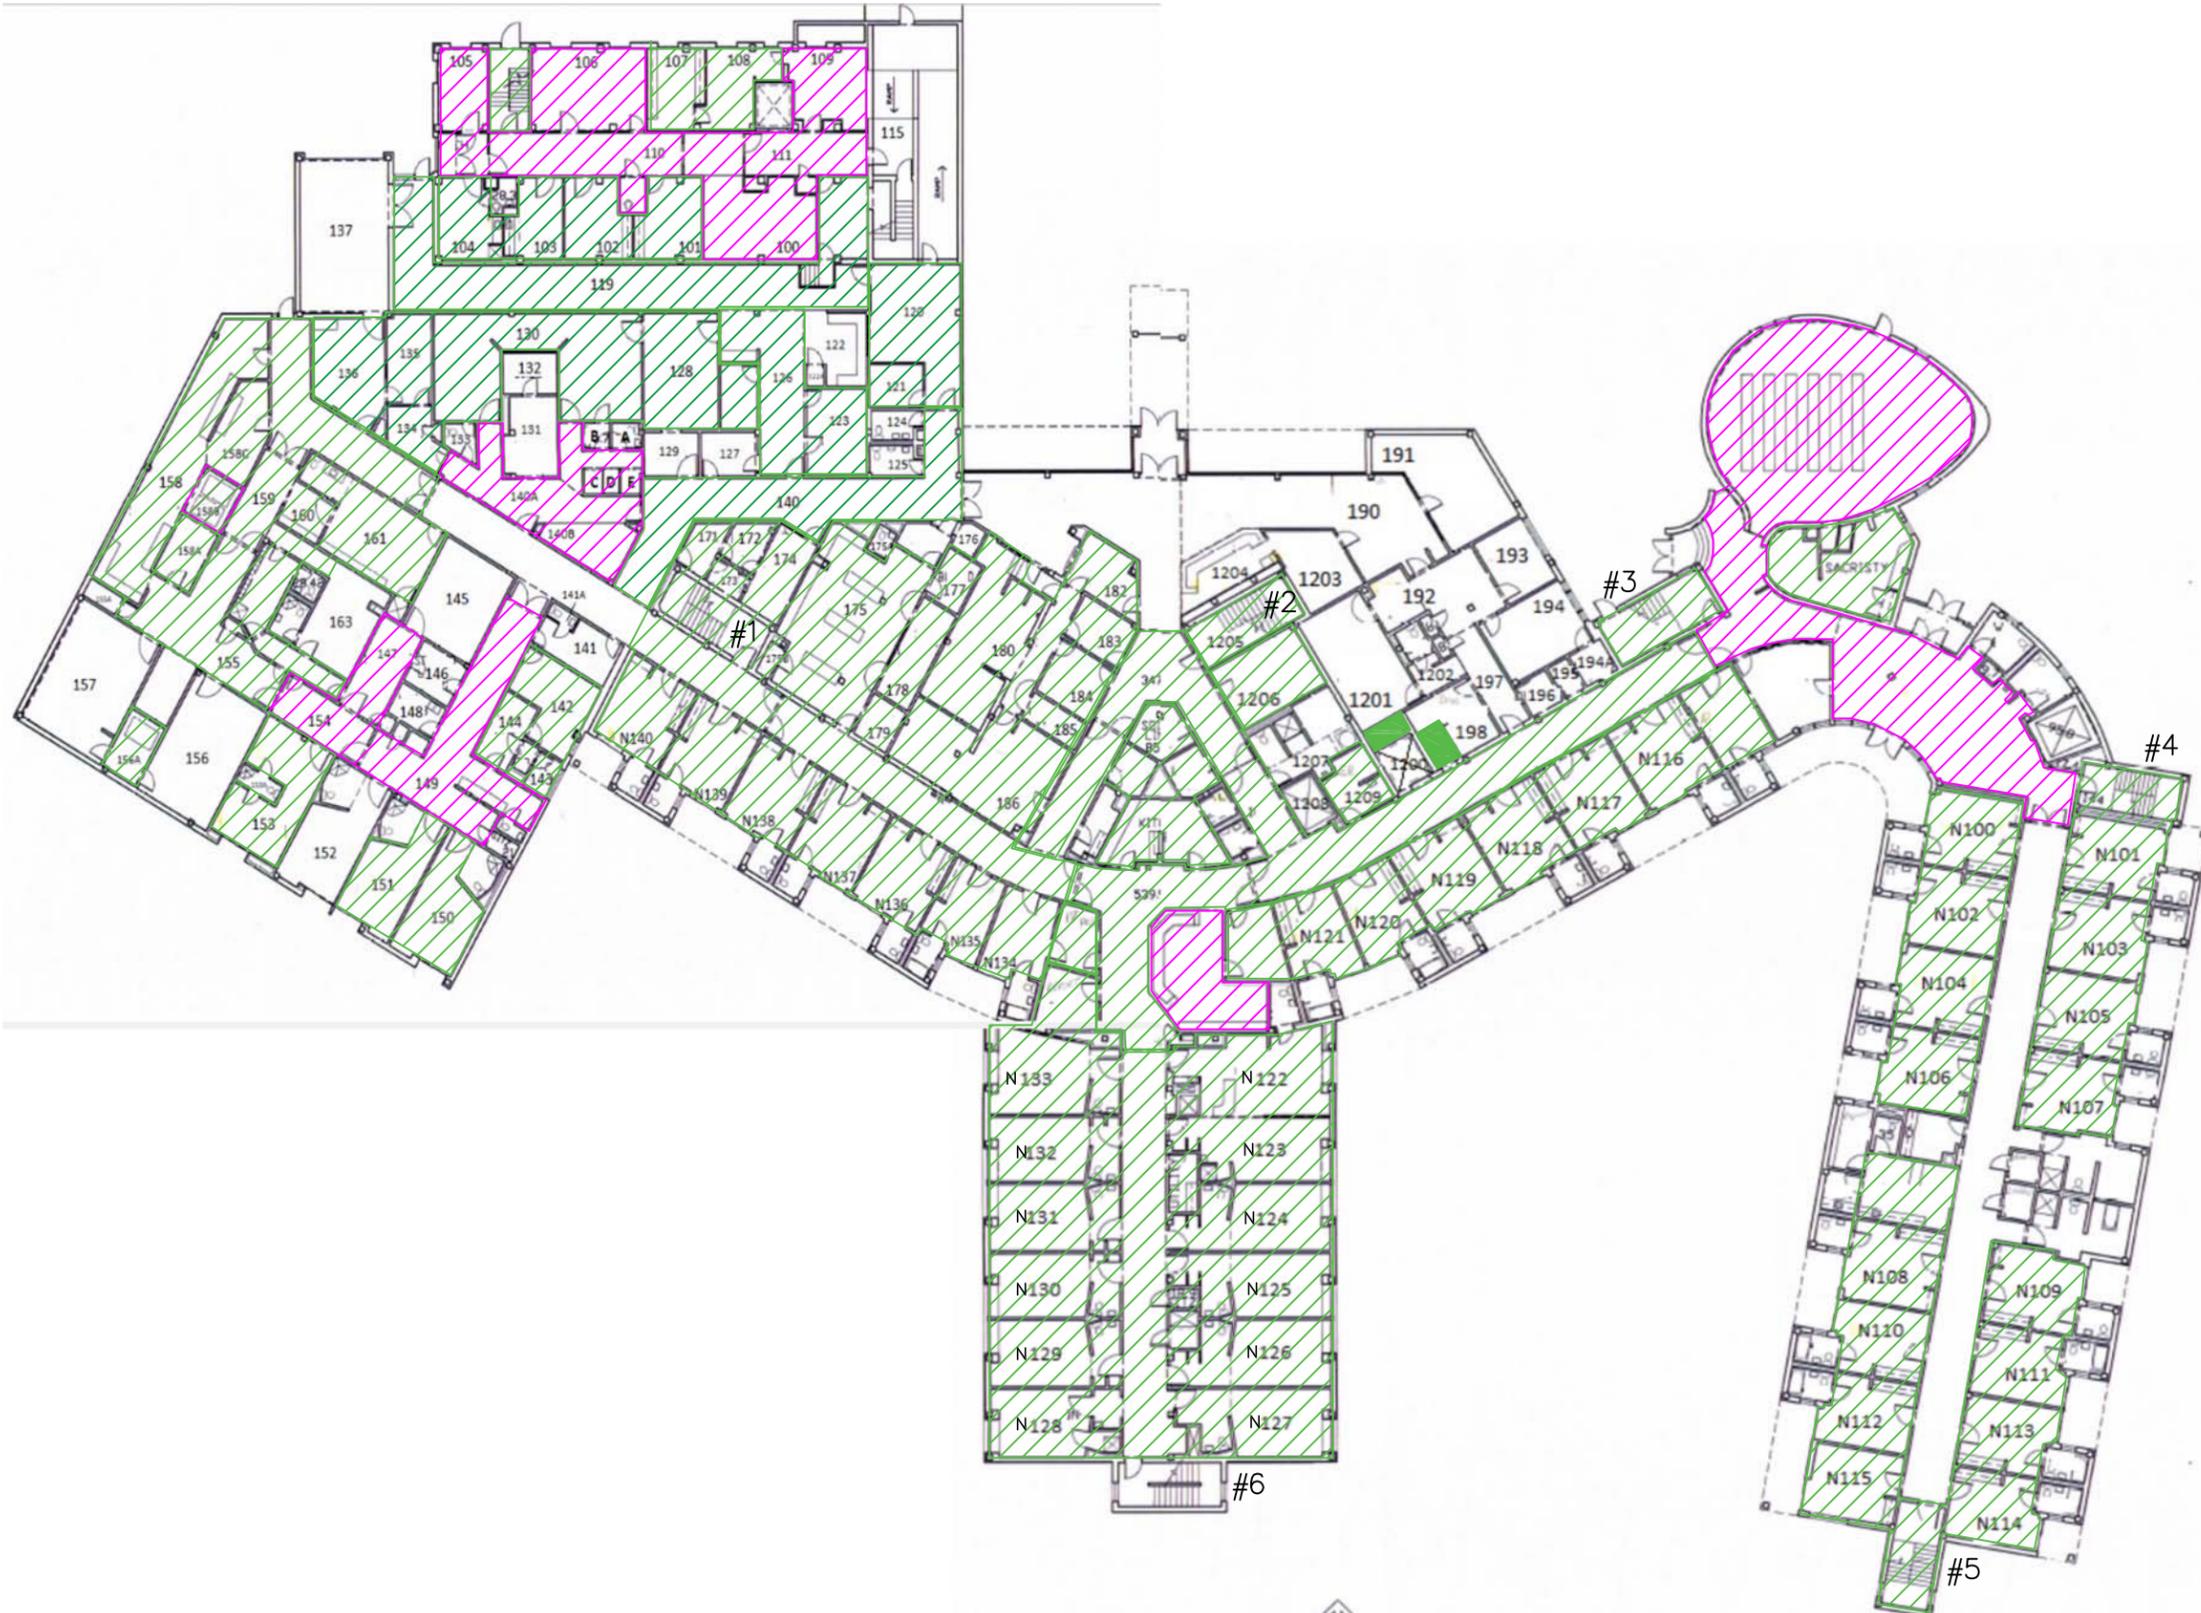
- ACM WINDOW GLAZE
- ACM DOOR FILL
- ACM SINK UNDERCOATING

ACM door caulk is present on all doors set in concrete block walls in the 1964 vintage. This is not shown on the diagram.

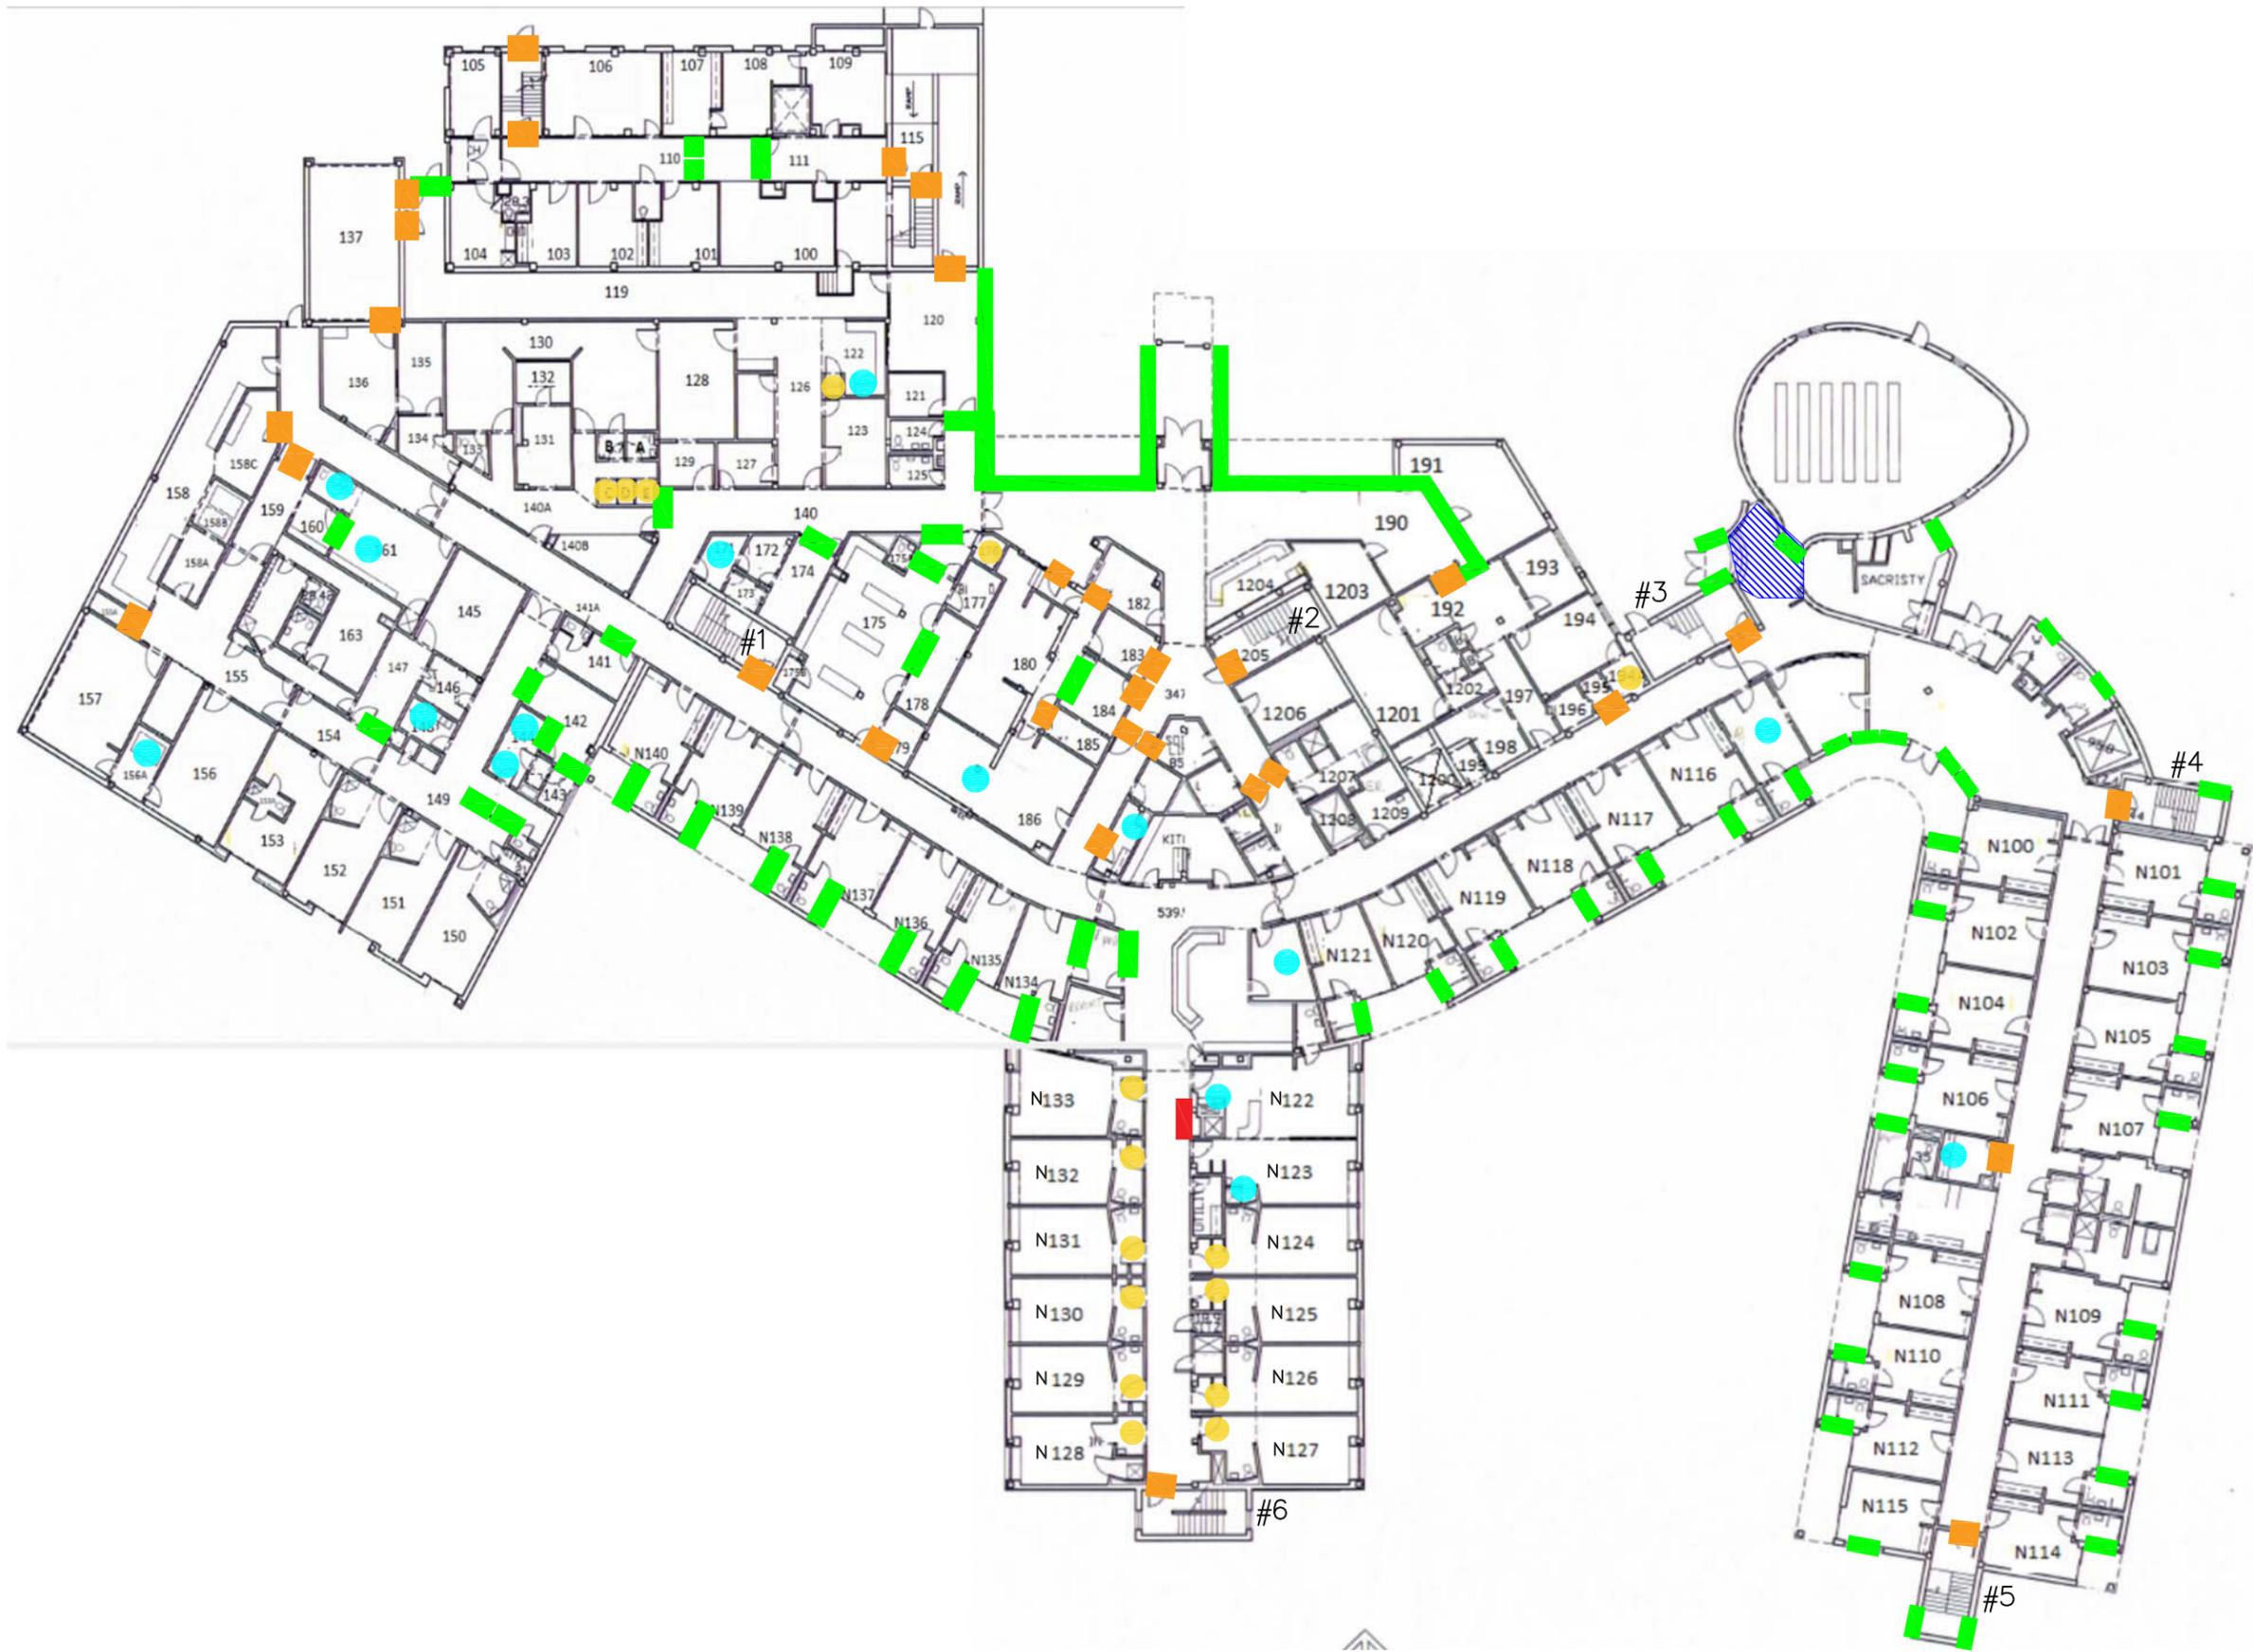
900 College Avenue W
Ladysmith, WI 54848
1st Floor
ACM Diagram (Floors)

ACM FLOOR TILE AND BLACK MASTIC
-

ACM BLACK MASTIC

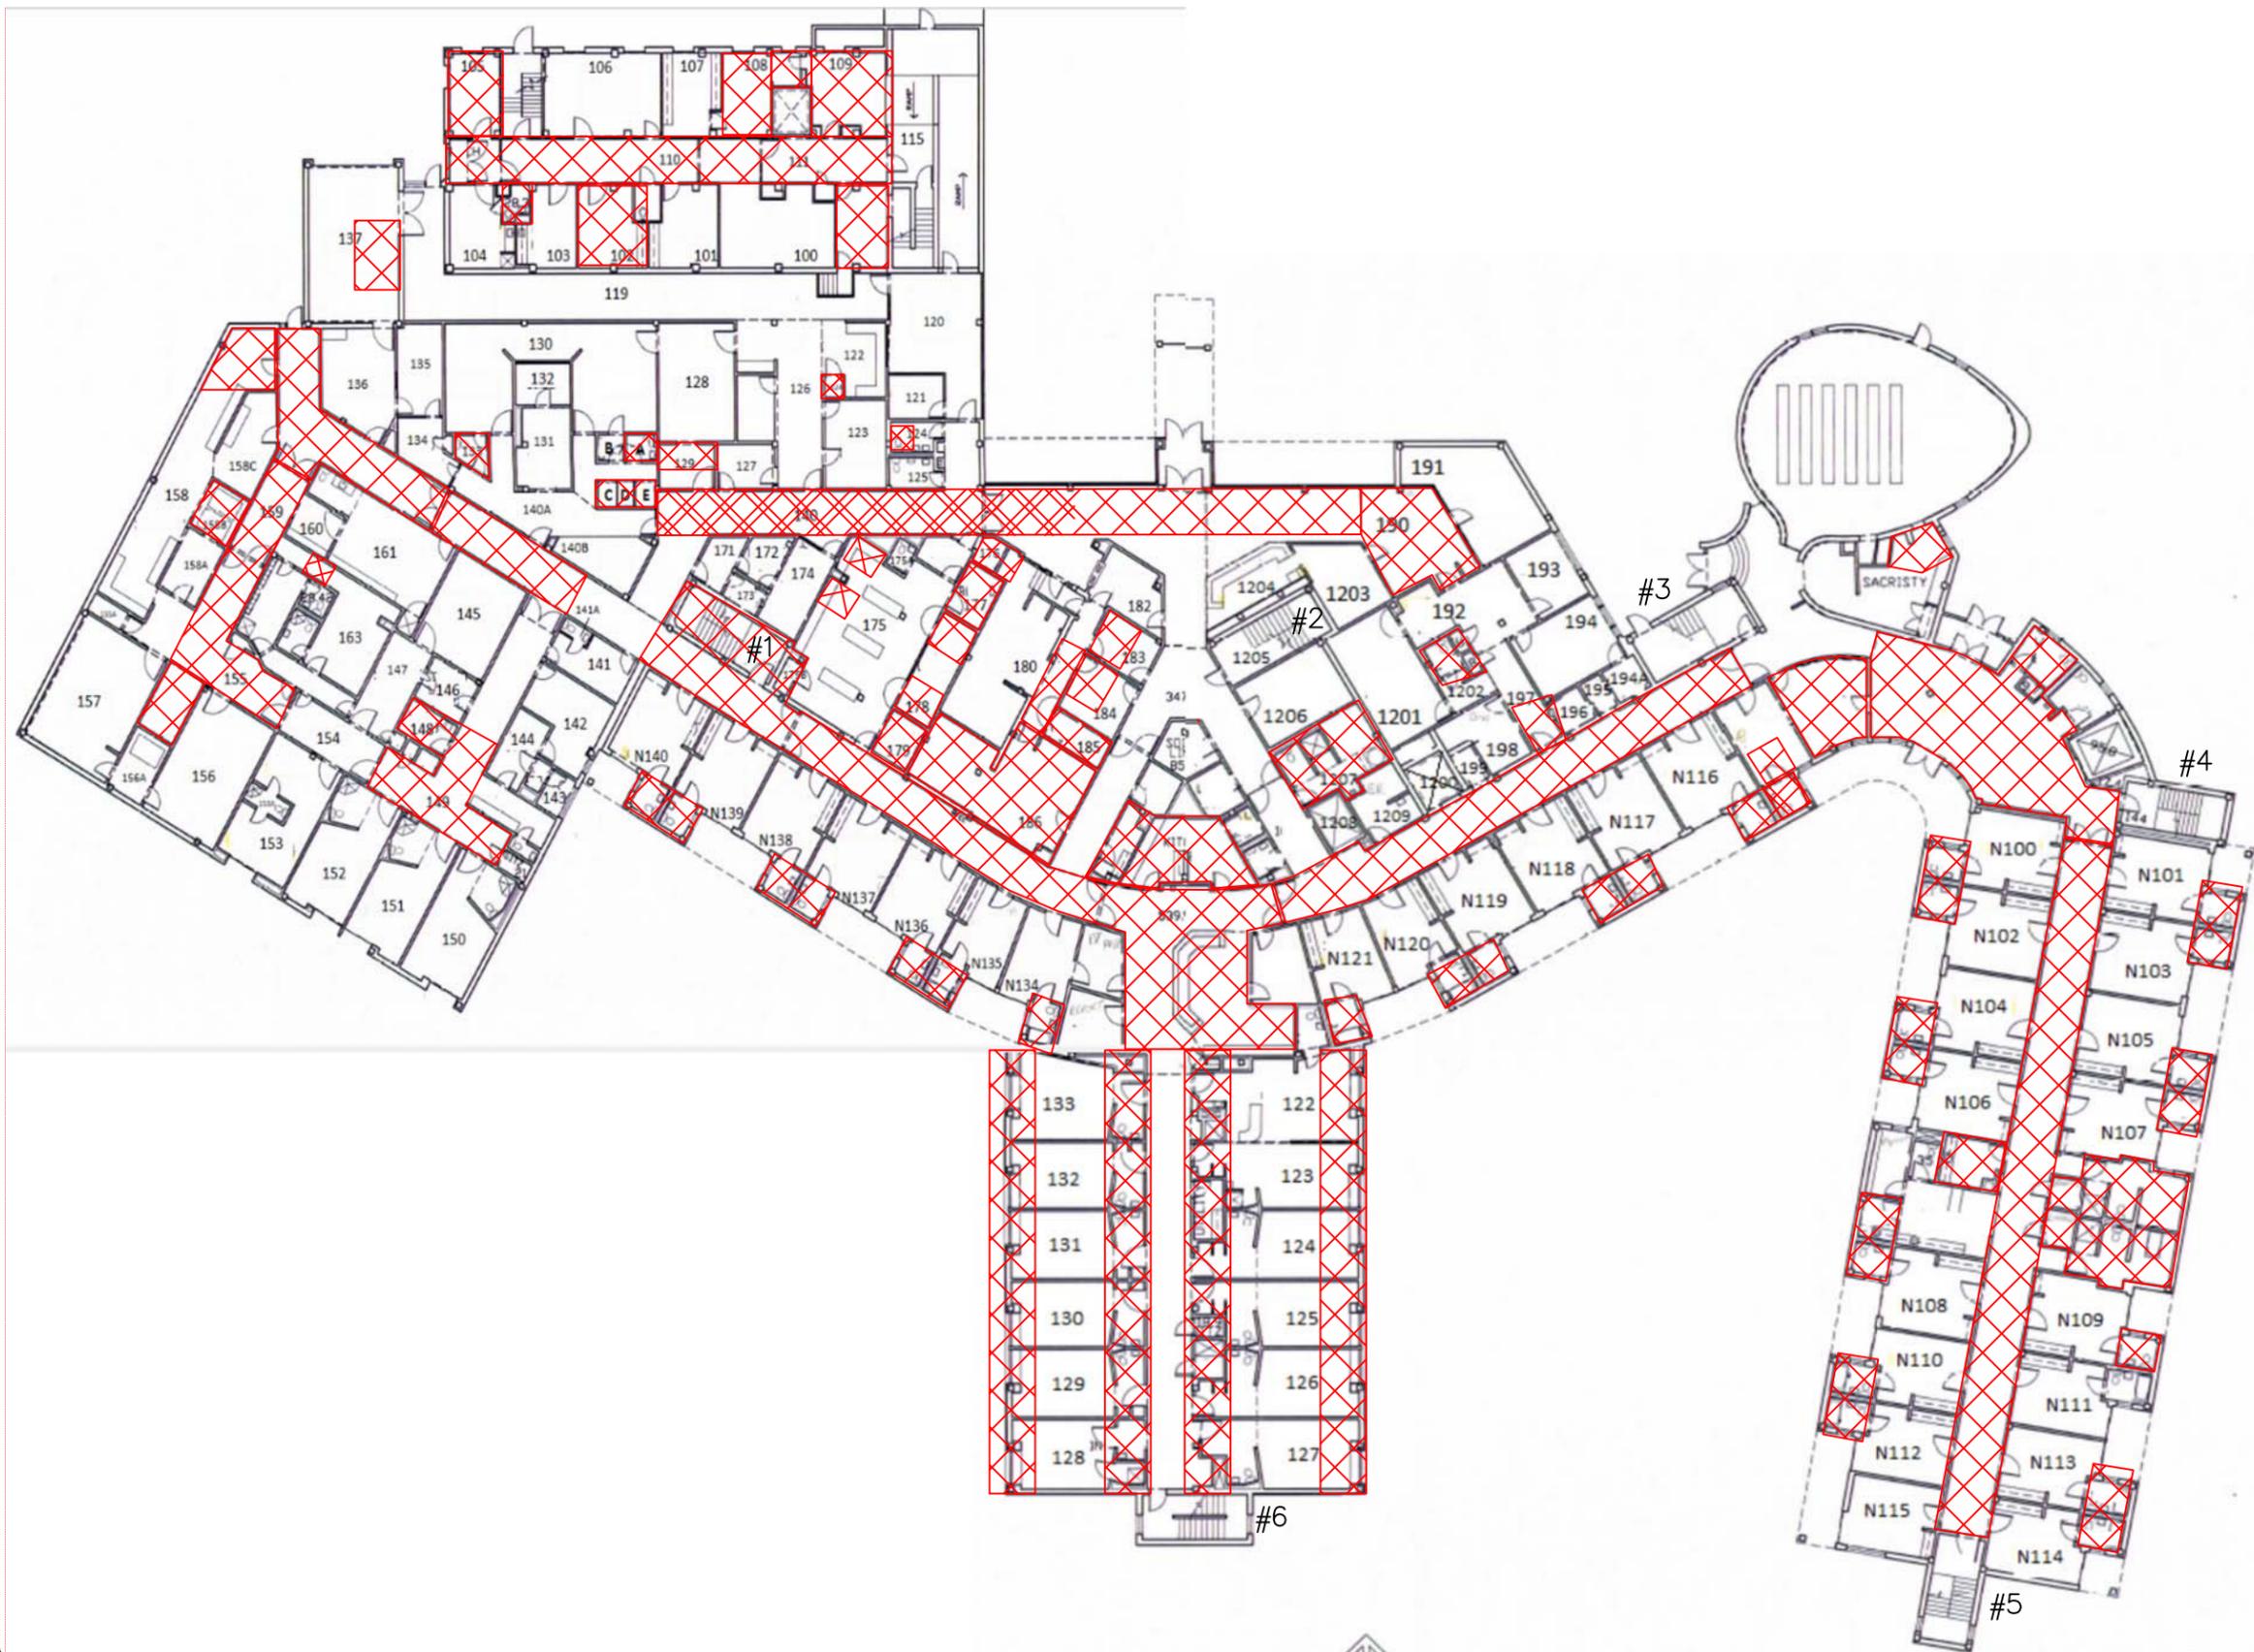
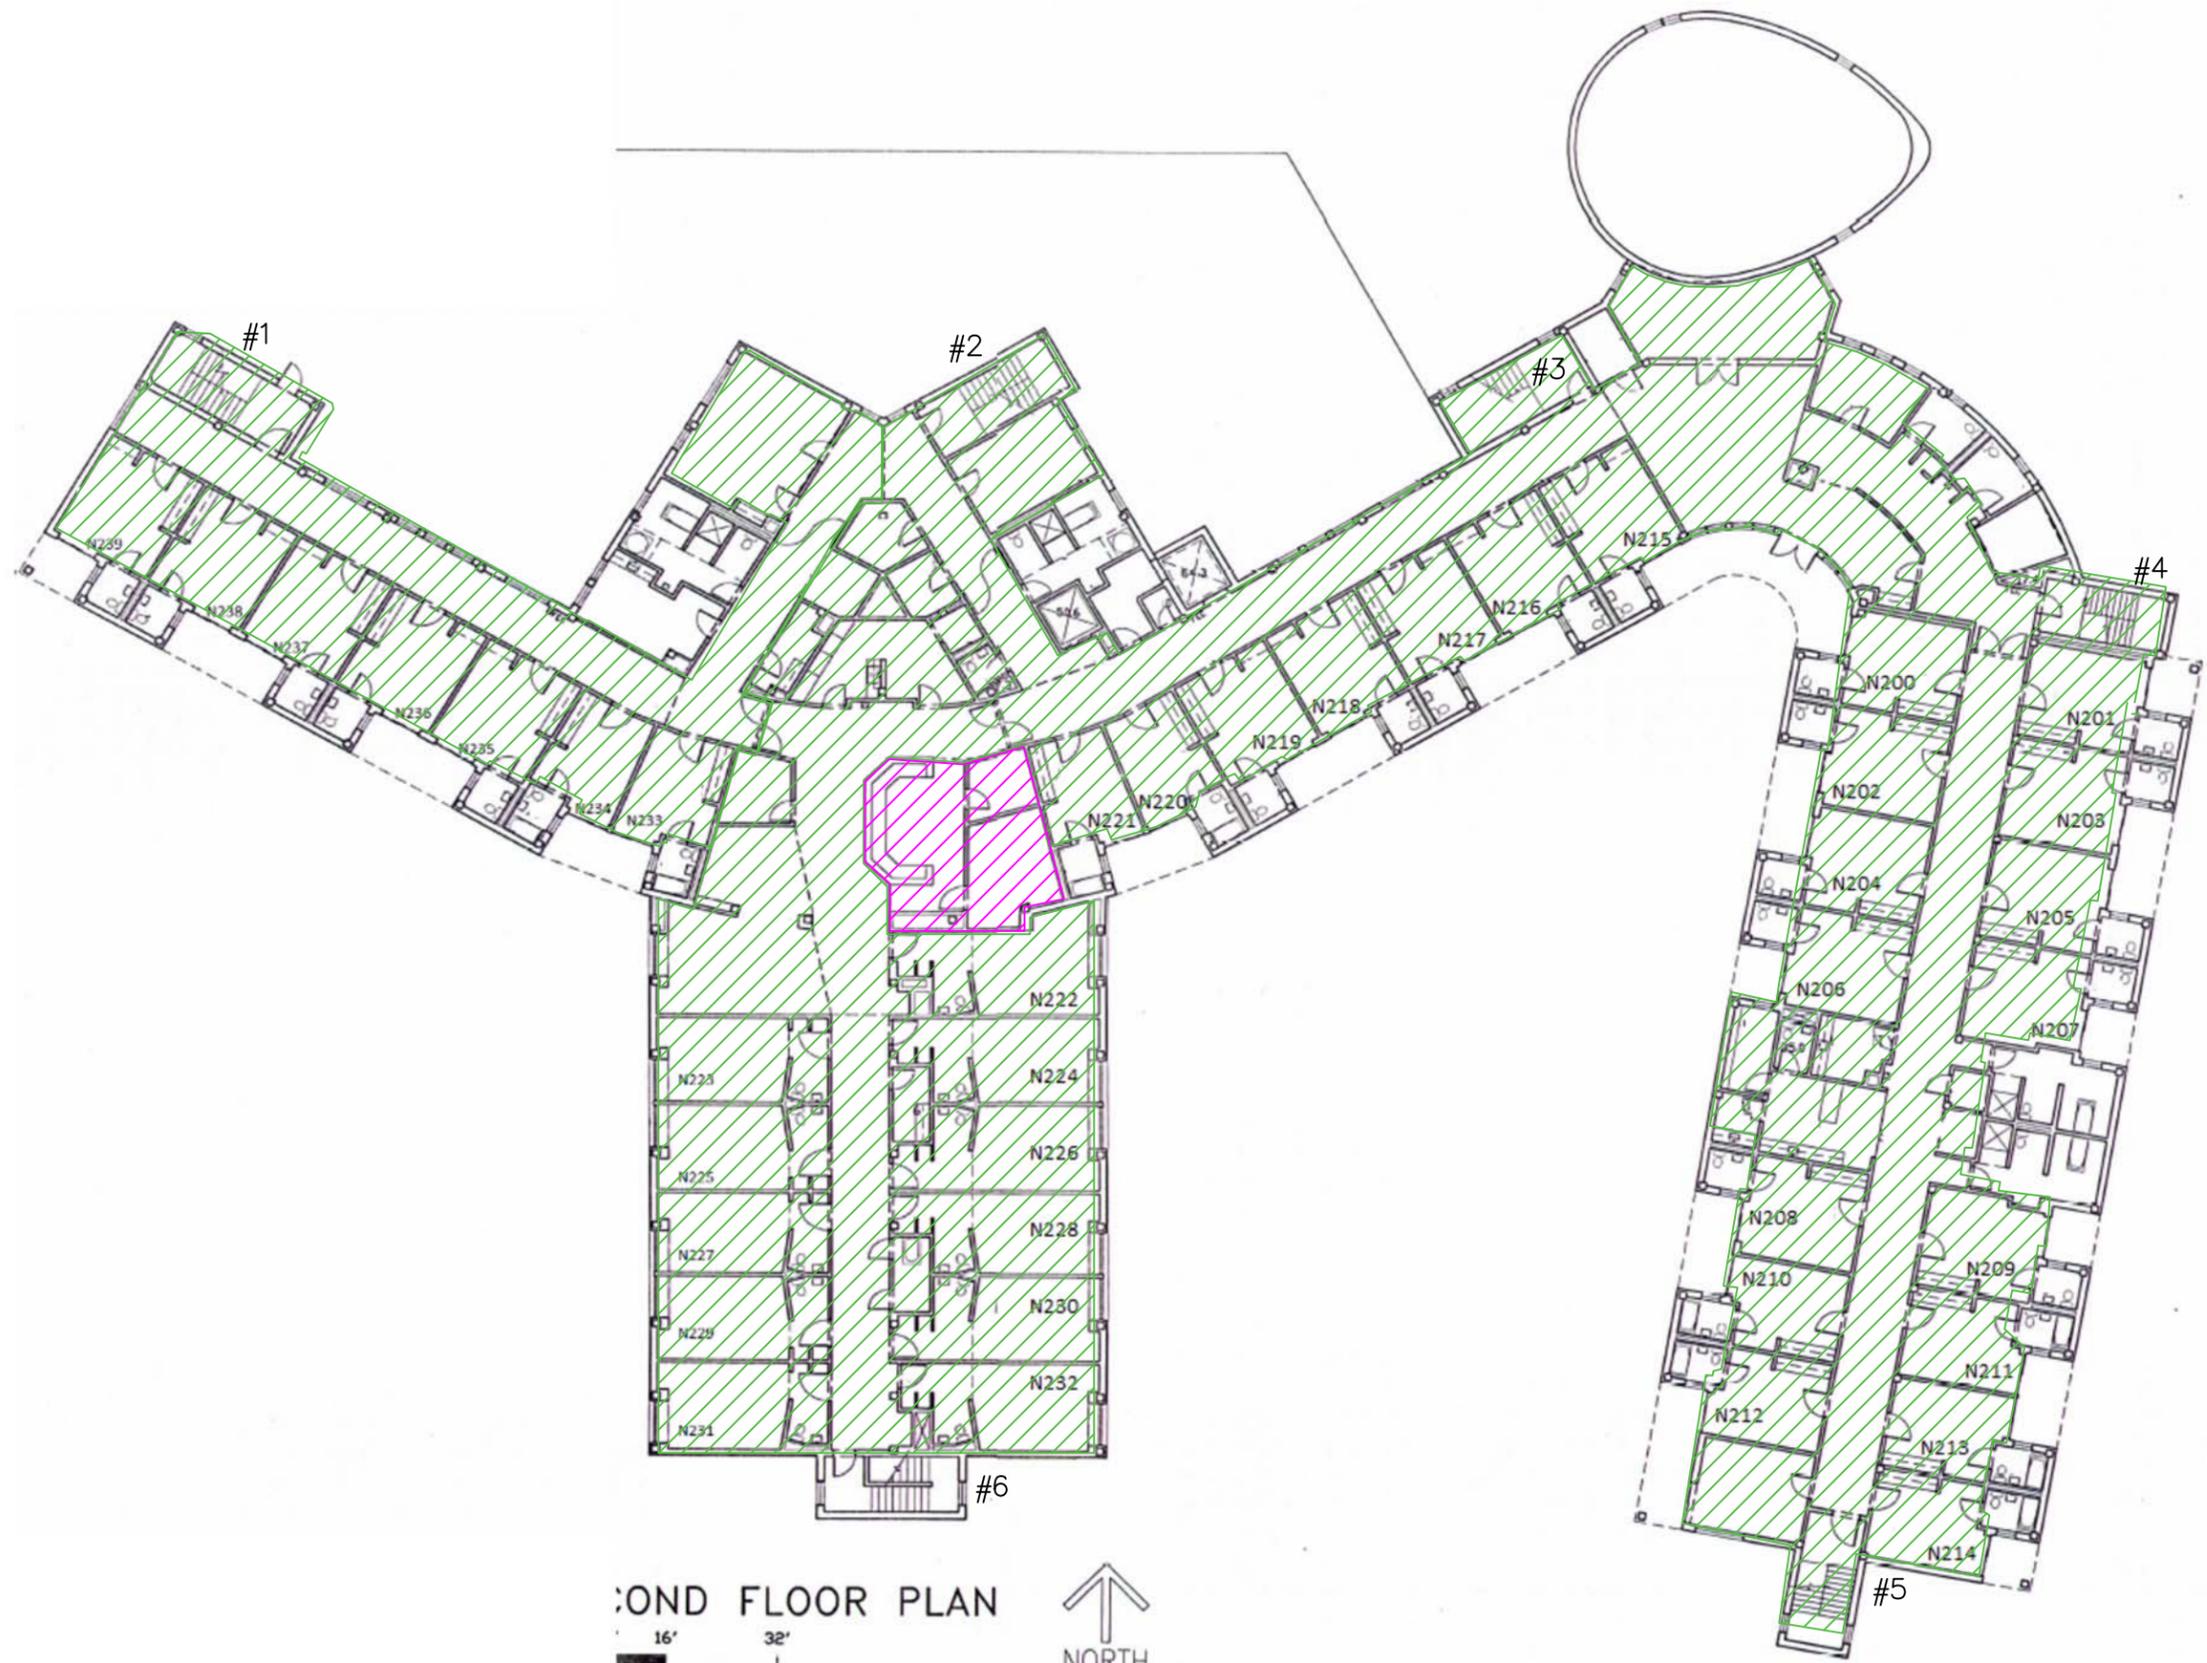
900 College Avenue W
Ladysmith, WI 54848
1st Floor
ACM Diagram

- █ ACM WINDOW GLAZE
- █ ACM WALL ADHESIVE
- ACM POPCORN TEXTURE
- ACM DOOR FILL
- ACM LIGHT FIXTURE
- ACM SINK UNDERCOATING

ACM door caulk is present on all doors set in concrete block walls in the 1964 vintage. This is not shown on the diagram.

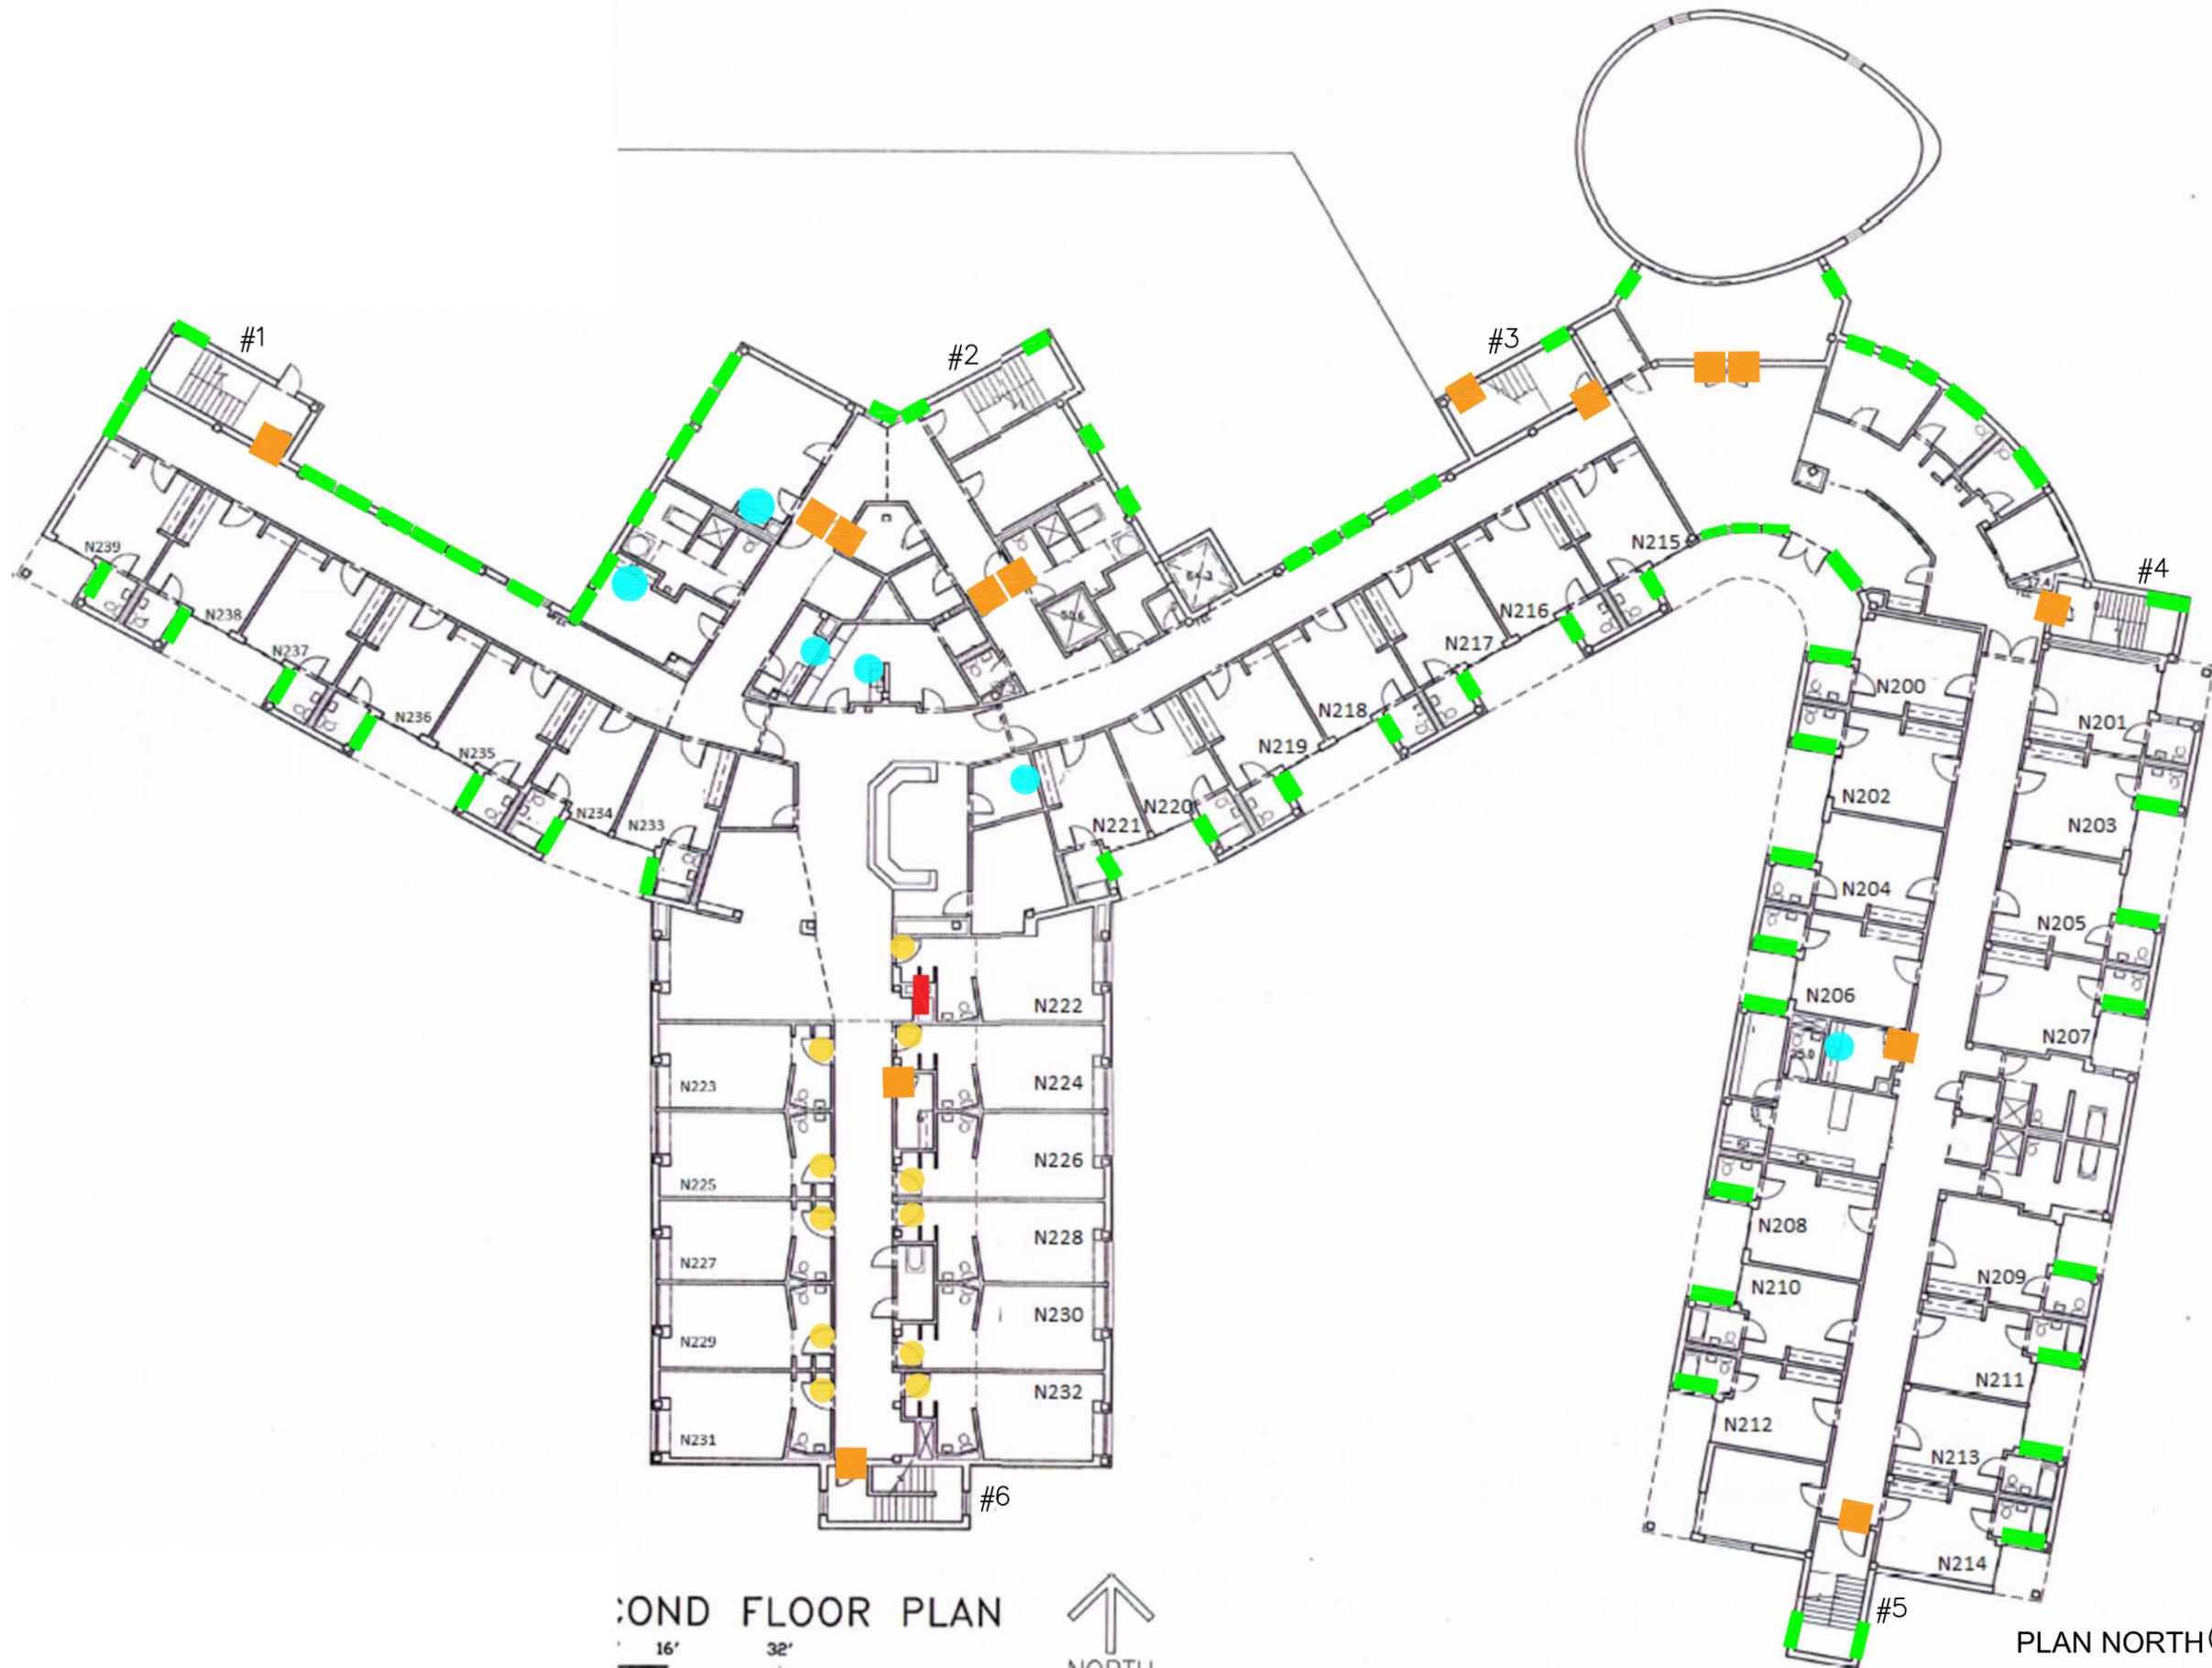
900 Colleve Avenue W
Ladysmith, WI 54848
2nd Floor
ACM Diagram

ACM FLOOR AND BLACK MASTIC
-

ACM BLACK MASTIC
