Advertisement for Bids – Asbestos Abatement and Building Demolition

RE: Final Report- Pre-Demolition Services
 LEGEND No. 23WI059

This report presents the results of the pre-demolition inspection of the Marshfield Medical Center located at 900 College Avenue W in Ladysmith, WI conducted by LEGEND Technical Services, Inc. (LEGEND) representative Mr. Lucas Sokol, WI Asbestos Inspector #AII-267101 and Katia Castro Lopez, WI Asbestos Inspector #AII-290508 on May 2, 3, 13 and 24; June 7, 29, 2023. LEGEND's services were requested and authorized by Gary Shilts with Rusk County.

900 Colleve Avenue W
Ladysmith, WI 54848
Ground Floor
ACM Diagram

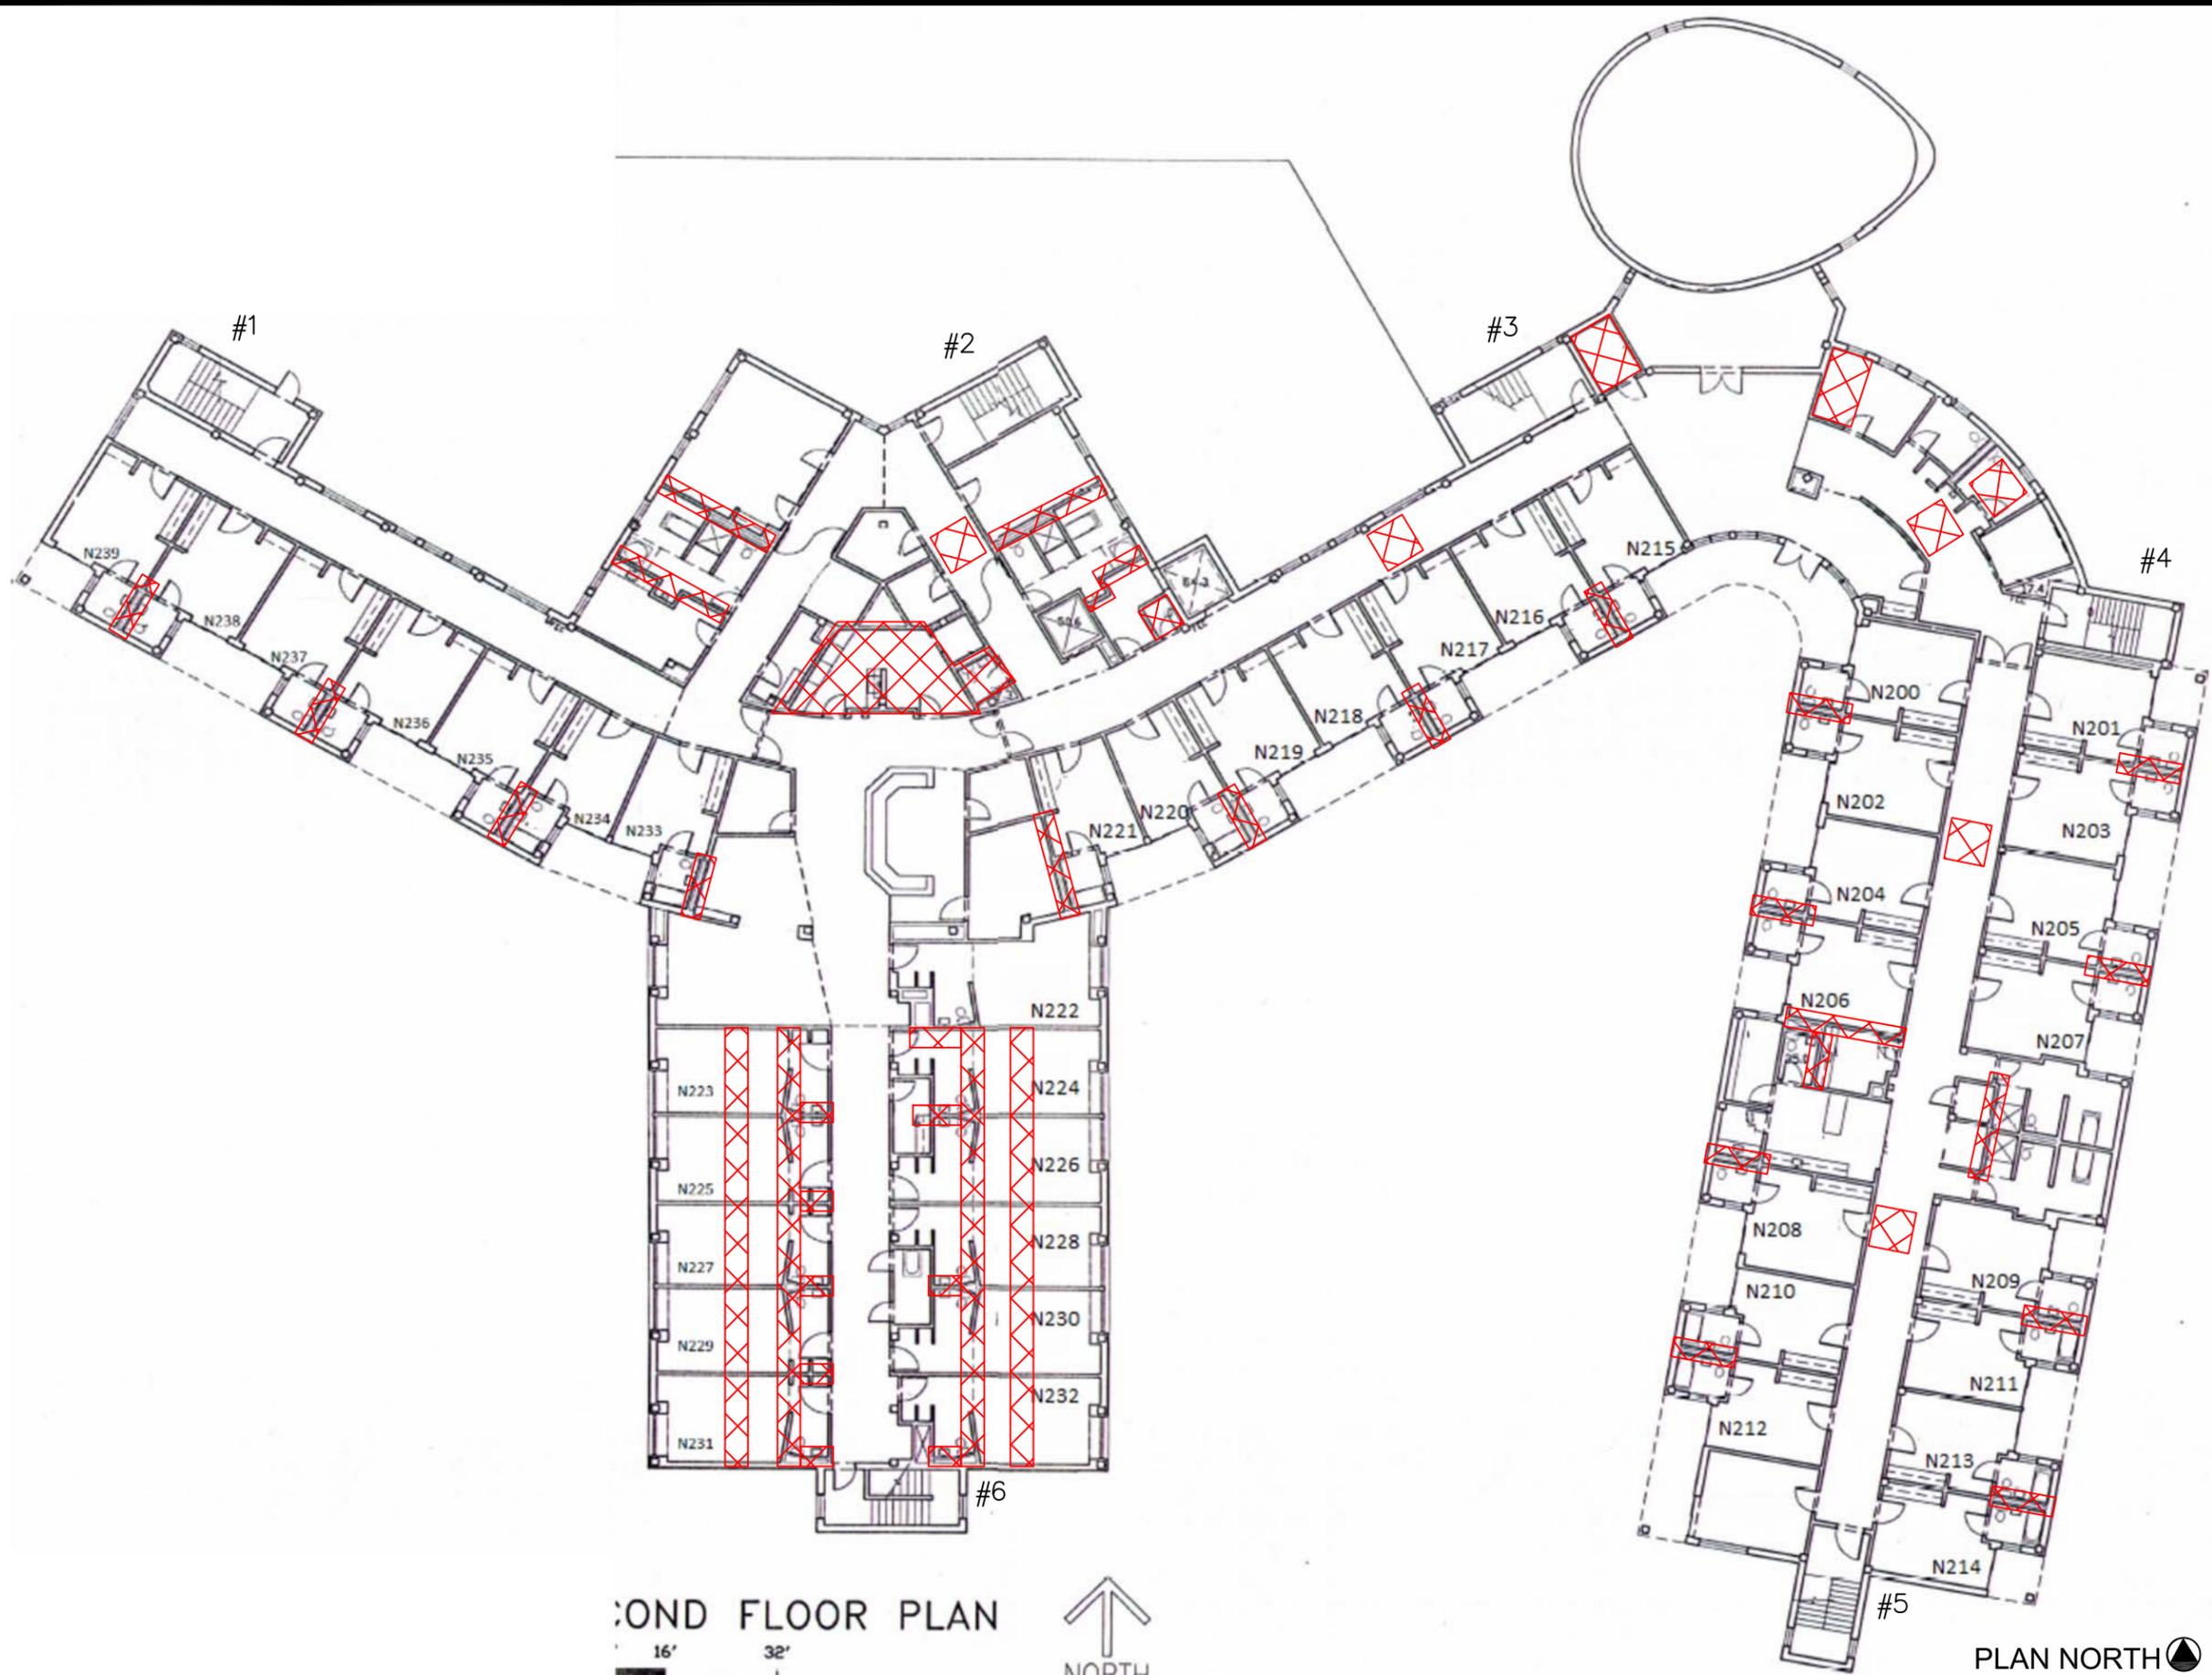
900 College Avenue W
Ladysmith, WI 54848
2nd Floor
ACM Diagram

- ACM WINDOW GLAZE
- ACM WALL ADHESIVE
- ACM POPCORN TEXTURE
- ACM DOOR FILL
- ACM LIGHT FIXTURE
- ACM SINK UNDERCOATING

ACM door caulk is present on all doors set in concrete block walls in the 1964 vintage. This is not shown on the diagram.

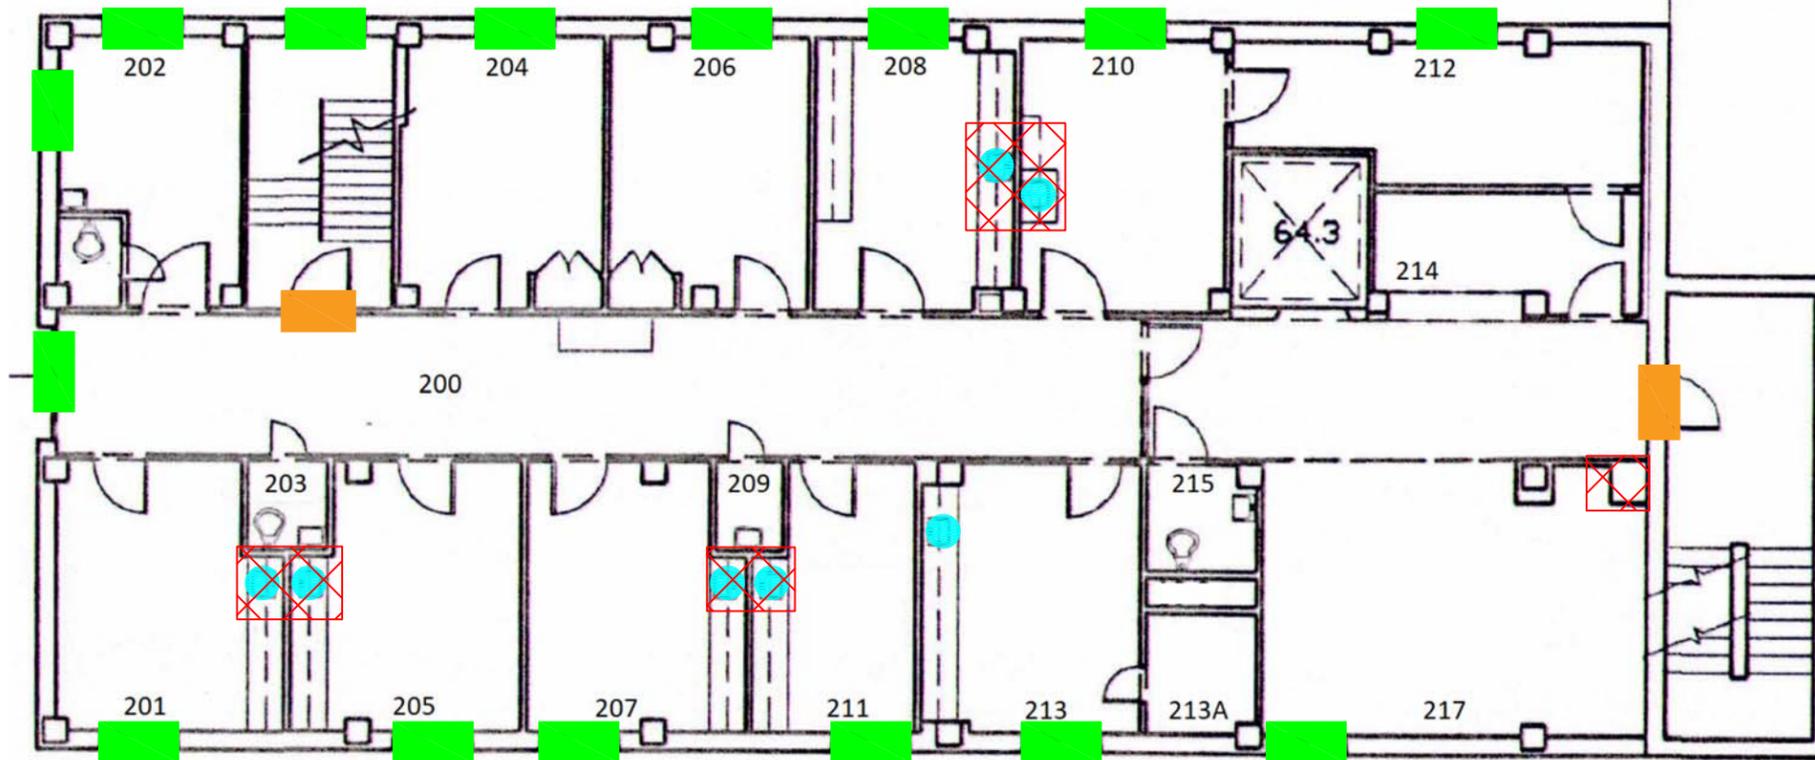
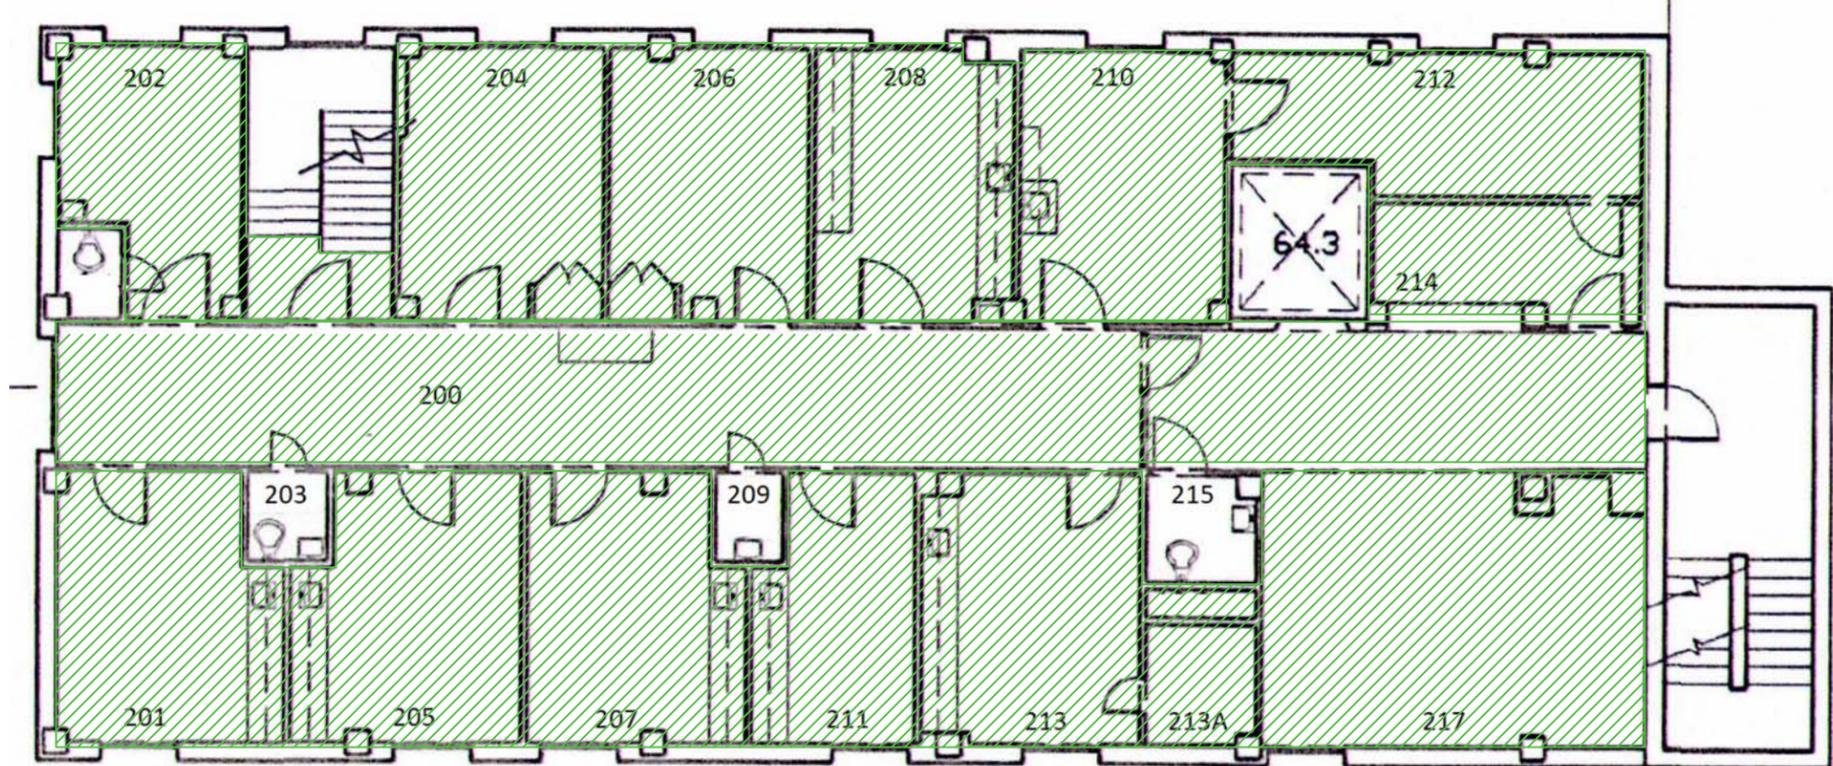
900 College Avenue W
Ladysmith, WI 54848
2nd Floor
ACM Diagram (TSI)

ACM PIPE INSULATION

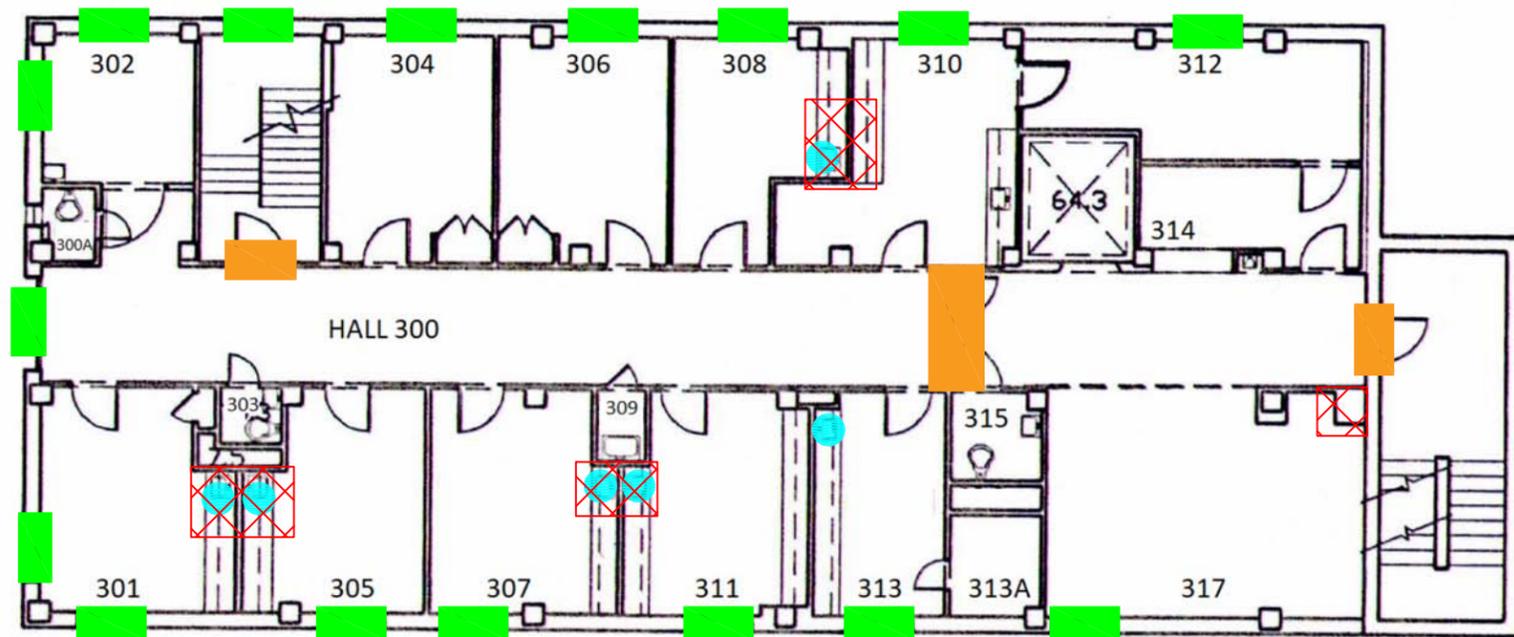
900 College Avenue W
Ladysmith, WI 54848
1947-2nd Floor
ACM Diagram

- ACM WINDOW CAULK
- ACM FLOOR TILE AND BLACK MASTIC
- ACM DOOR/WINDOW GLAZE
- ACM SINK UNDERCOATING
- ACM PIPE INSULATION

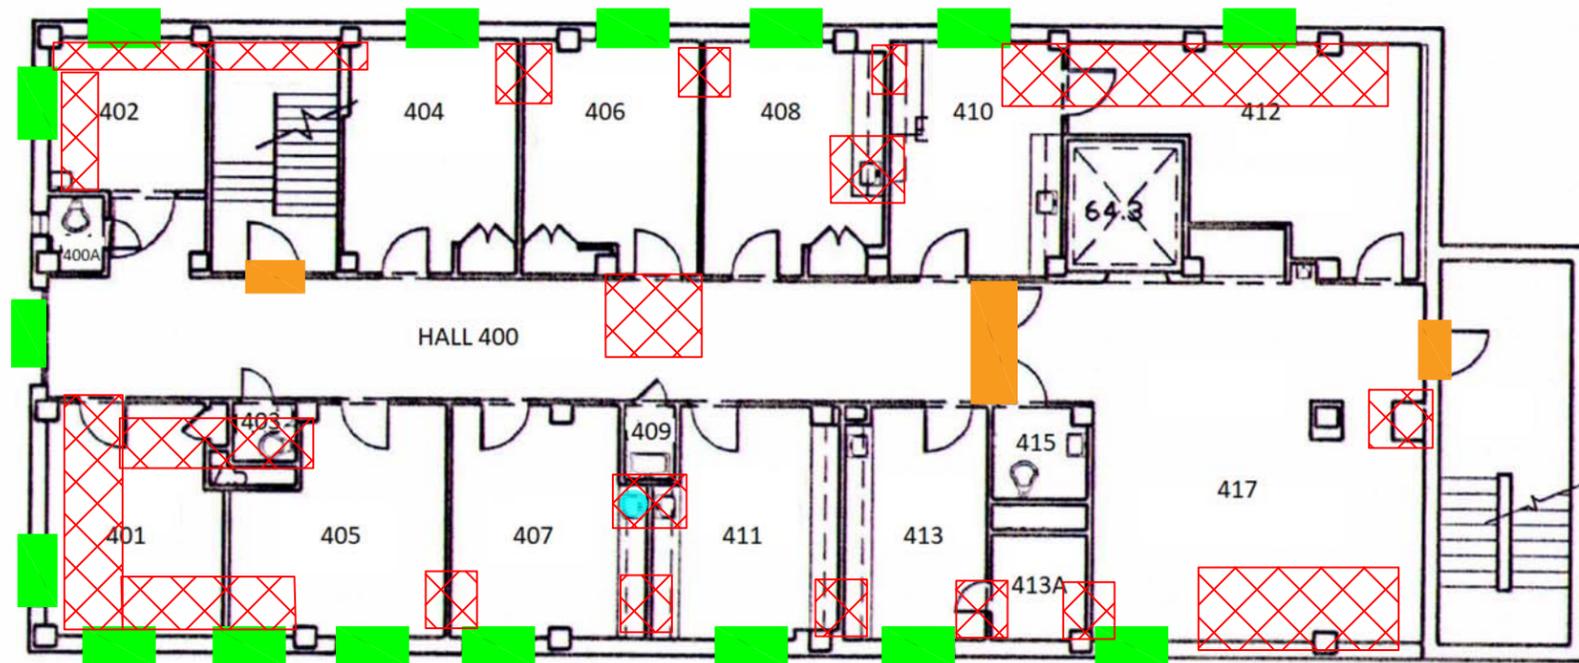
900 College Avenue W
Ladysmith, WI 54848
1947-3rd Floor
ACM Diagram

- ACM WINDOW CAULK
- ACM FLOOR TILE AND BLACK MASTIC
- ACM DOOR/WINDOW GLAZE
- ACM SINK UNDERCOATING
- ACM PIPE INSULATION

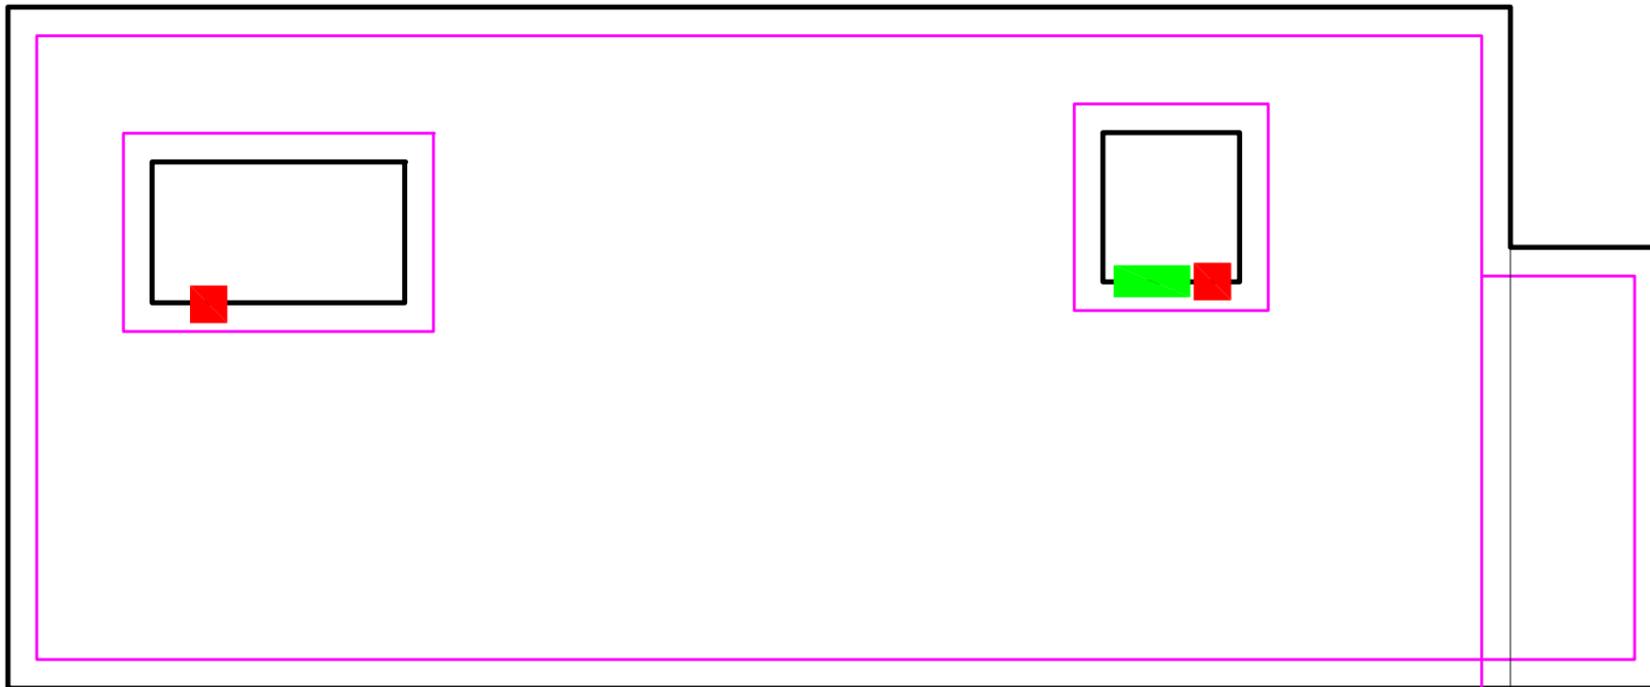
900 College Avenue W
Ladysmith, WI 54848
1947-4th Floor
ACM Diagram

- ACM WINDOW CAULK
- ACM FLOOR TILE AND BLACK MASTIC
- ACM DOOR/WINDOW GLAZE
- ACM SINK UNDERCOATING
- ACM PIPE INSULATION

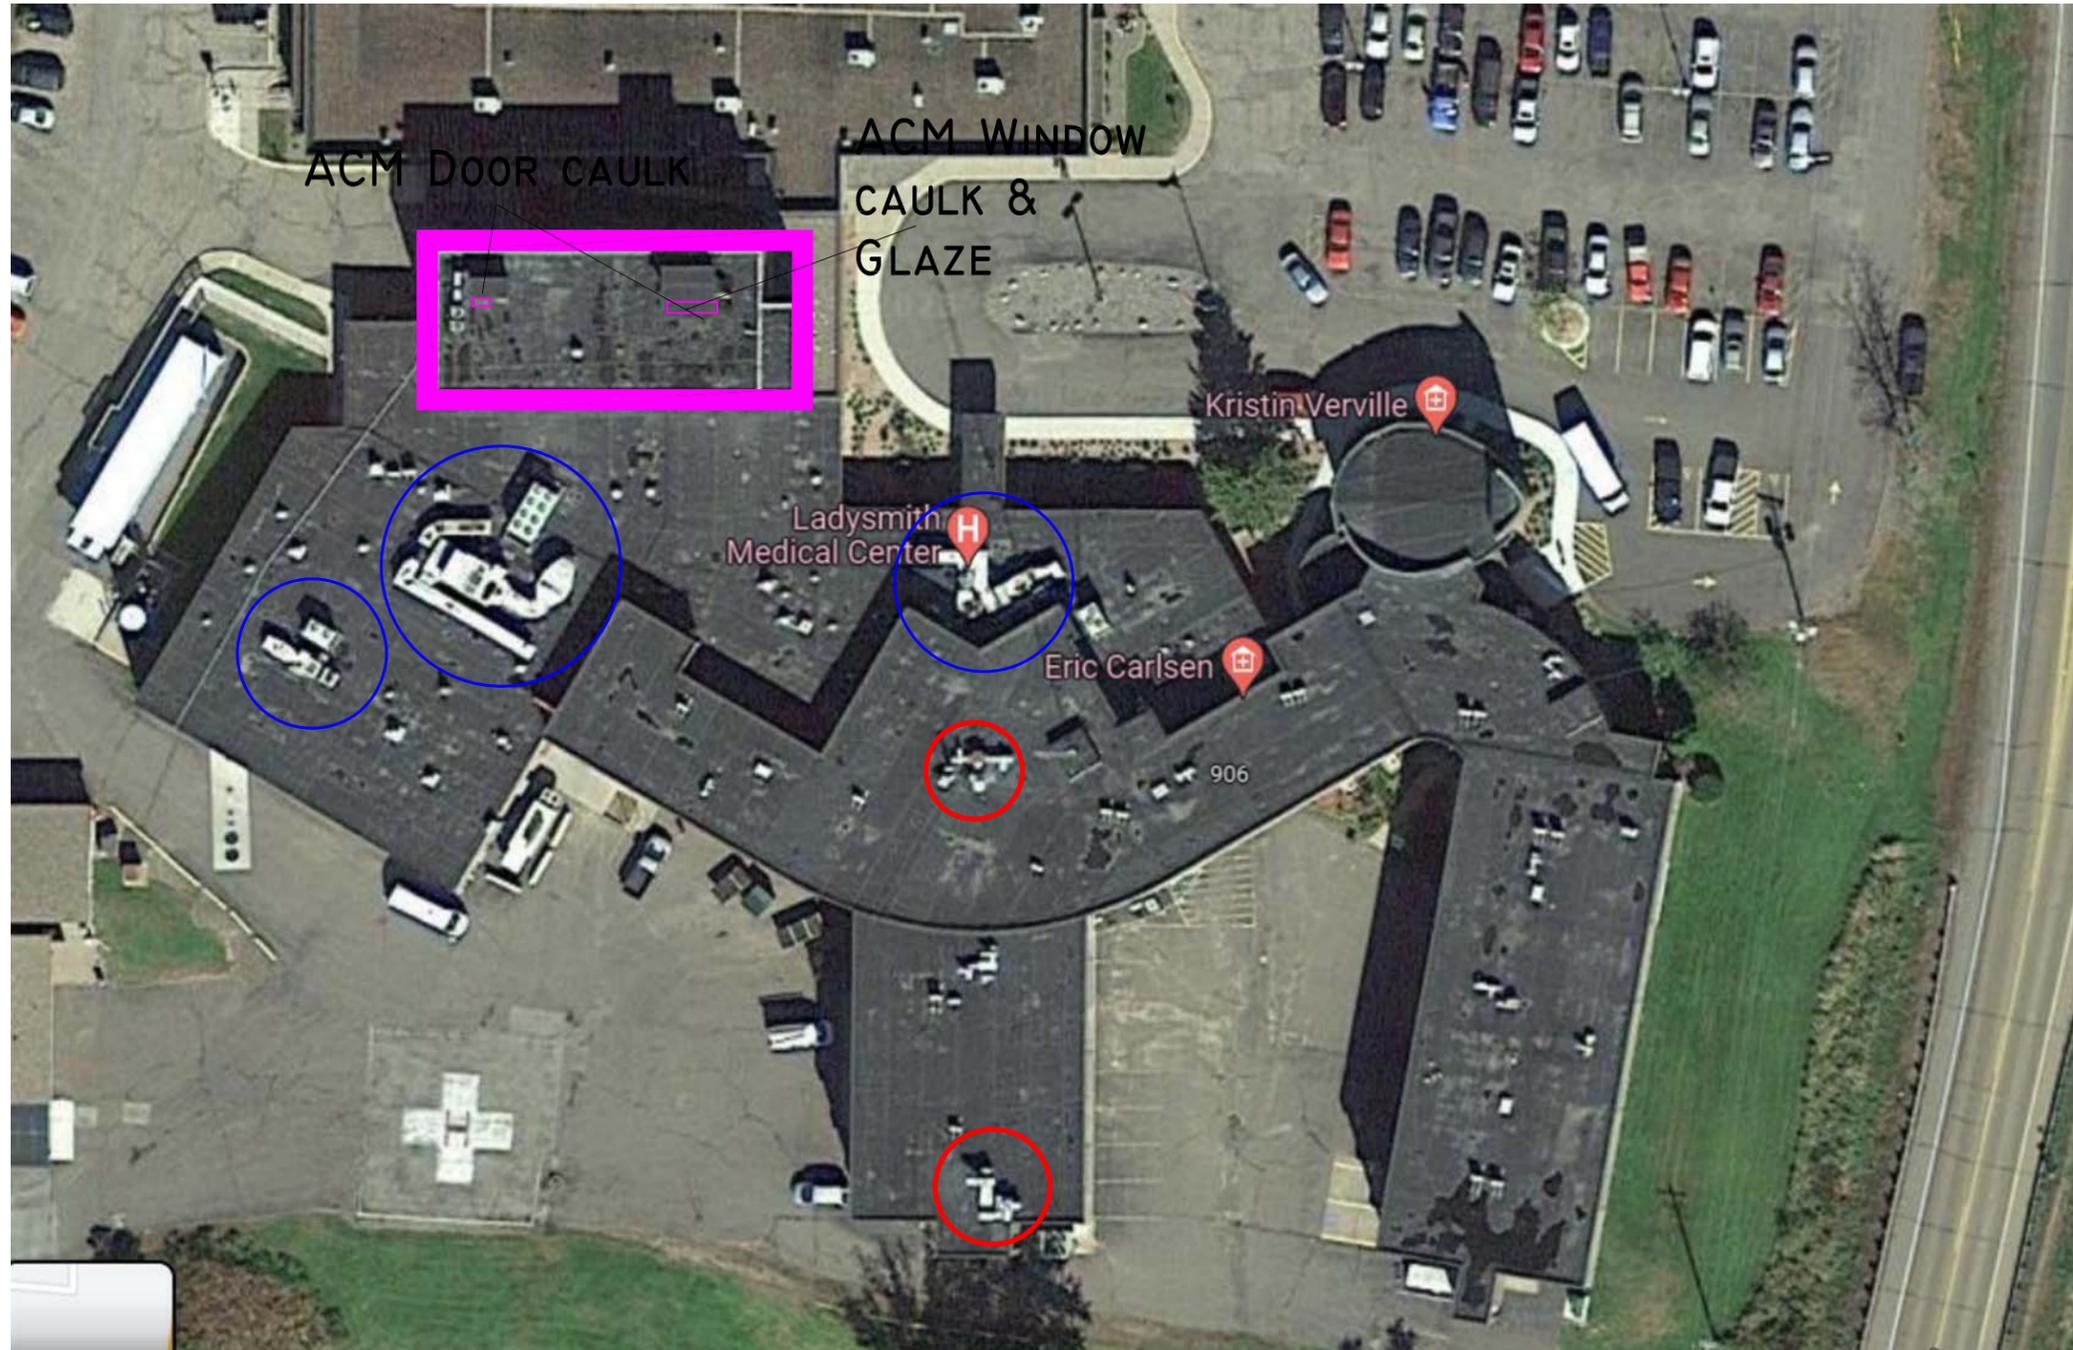
900 Colleve Avenue W
Ladysmith, WI 54848
1947-Roof
ACM Diagram

ACM ROOFING- ASPHALT LAYER THROUGHOUT; BLACK/GRAY SEALANT ON PERIMETER AND PENETRATIONS

ACM WINDOW CAULK & GLAZE
-

ACM DOOR CAULK
-

ACM WHITE CAULK AROUND PERIMETER

The asphalt roof layers contain asbestos.

The sealant on the roof perimeter and penetrations is also ACM. These are not shown on the diagram.

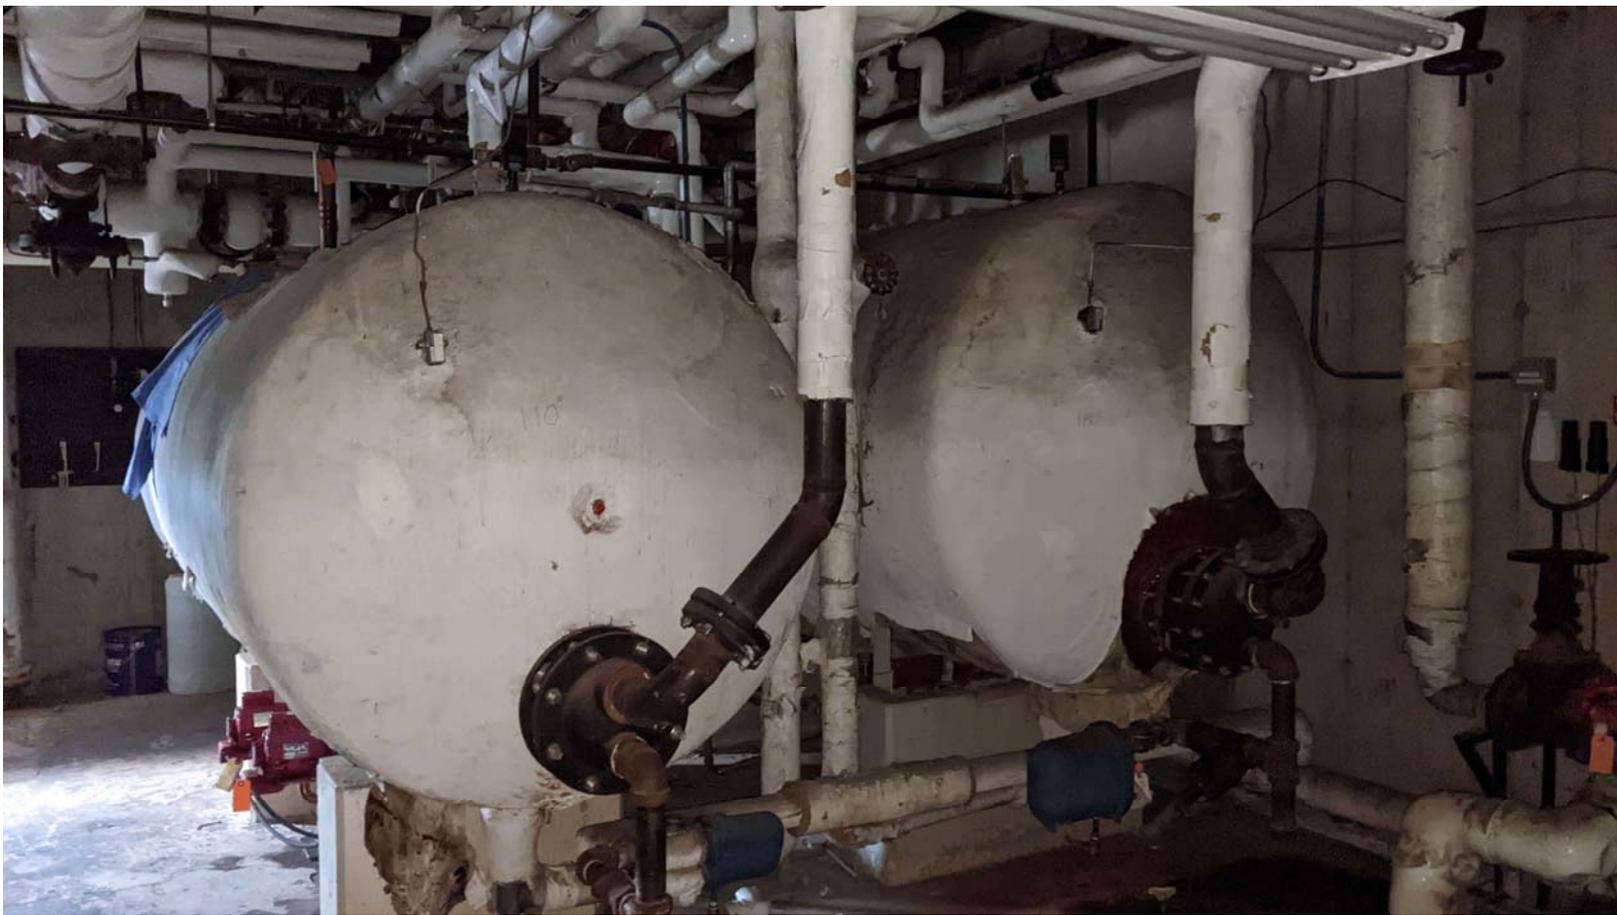
Ground floor Mech Room C- ACM Tank insulation

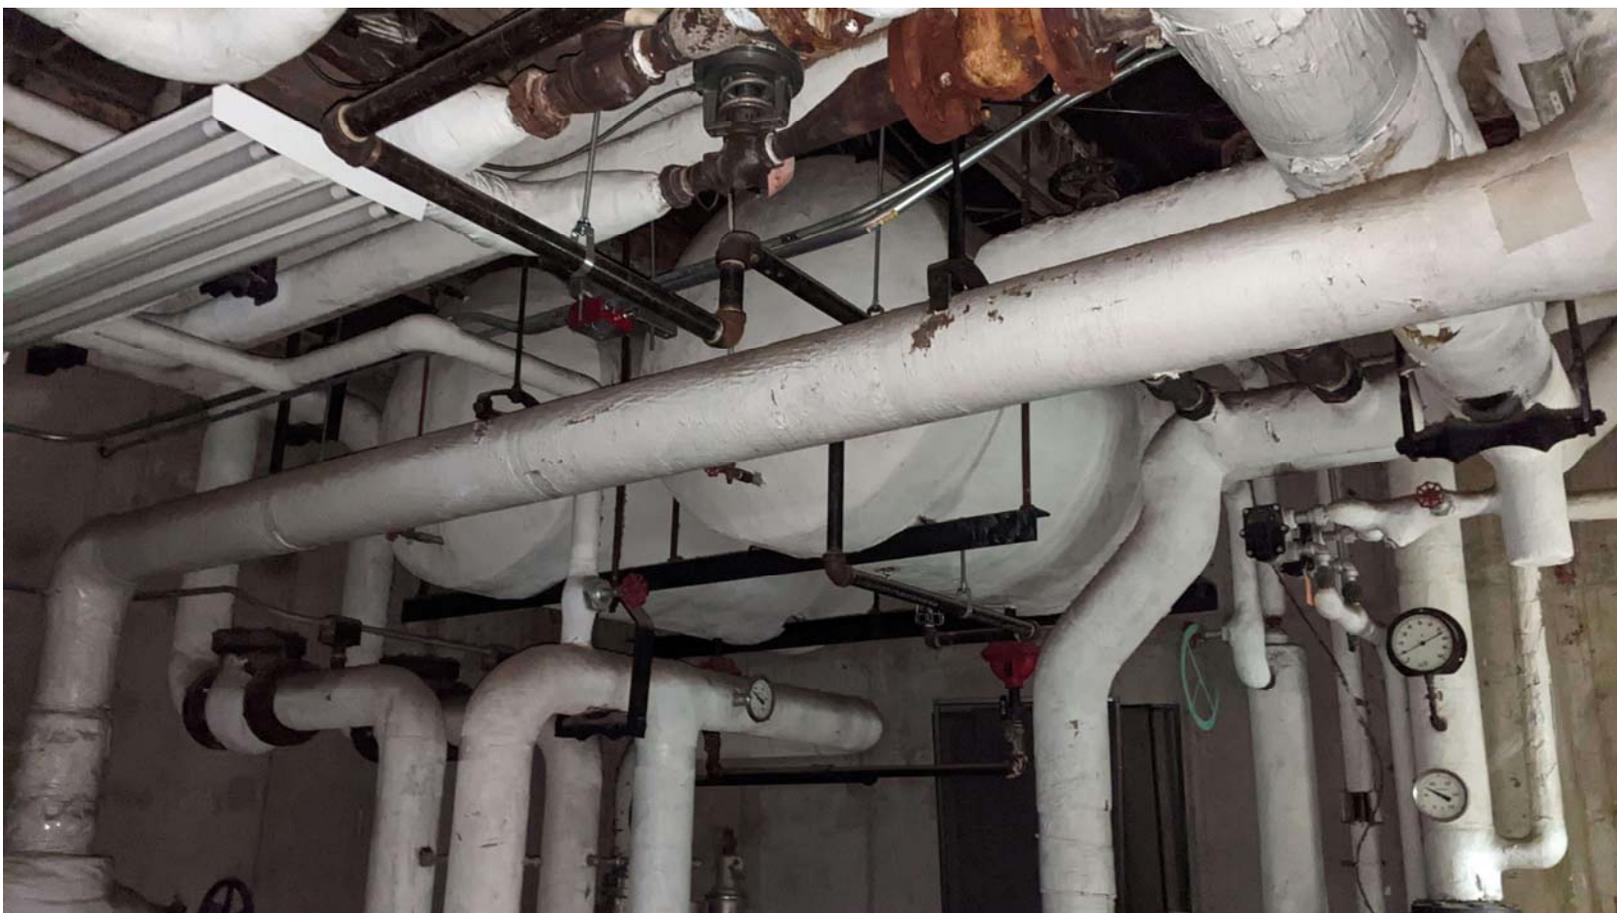
Ground floor Mech Room C- ACM Tank insulation (2)

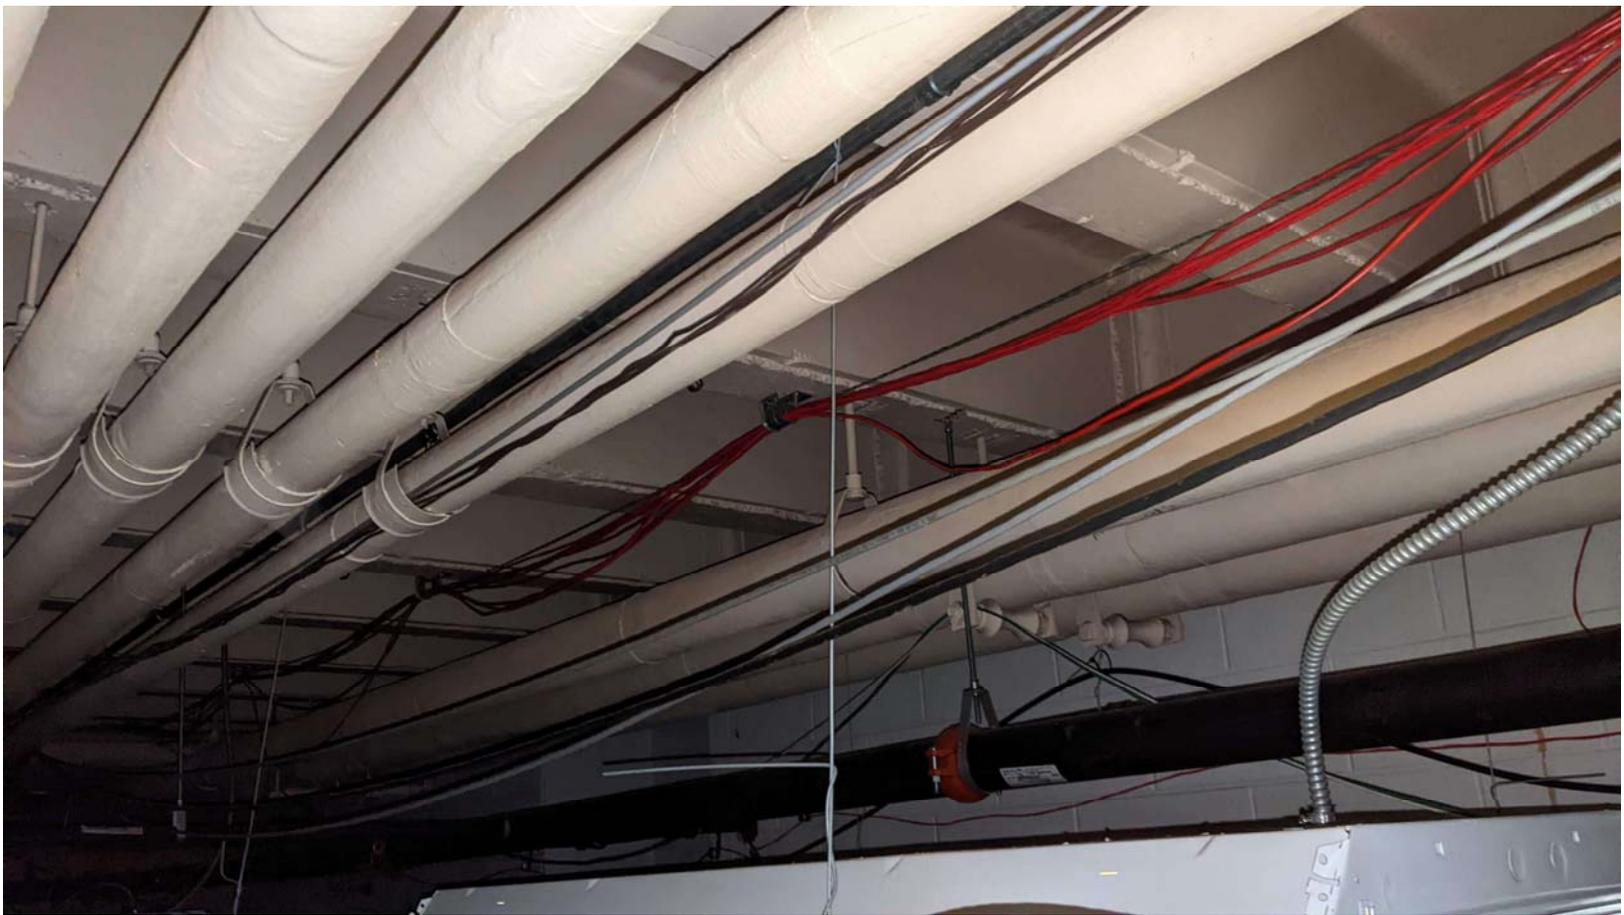
Ground floor ACM mag Pipe insulation-typical

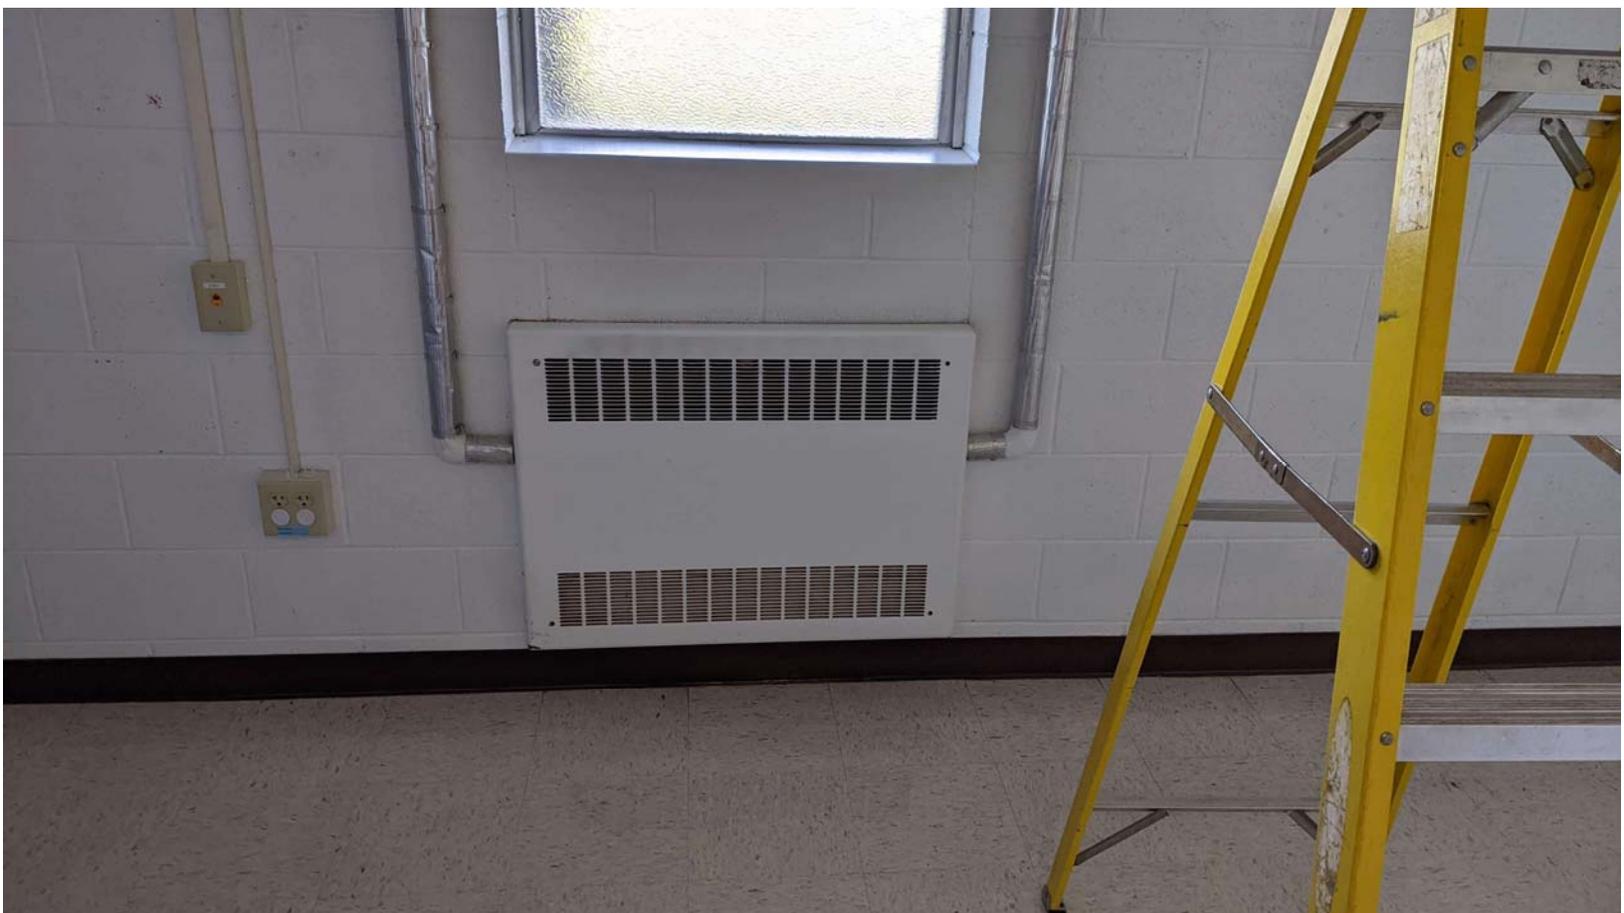
Ground floor- ACM pipe insulation (hard fittings on fiberglass)-typical

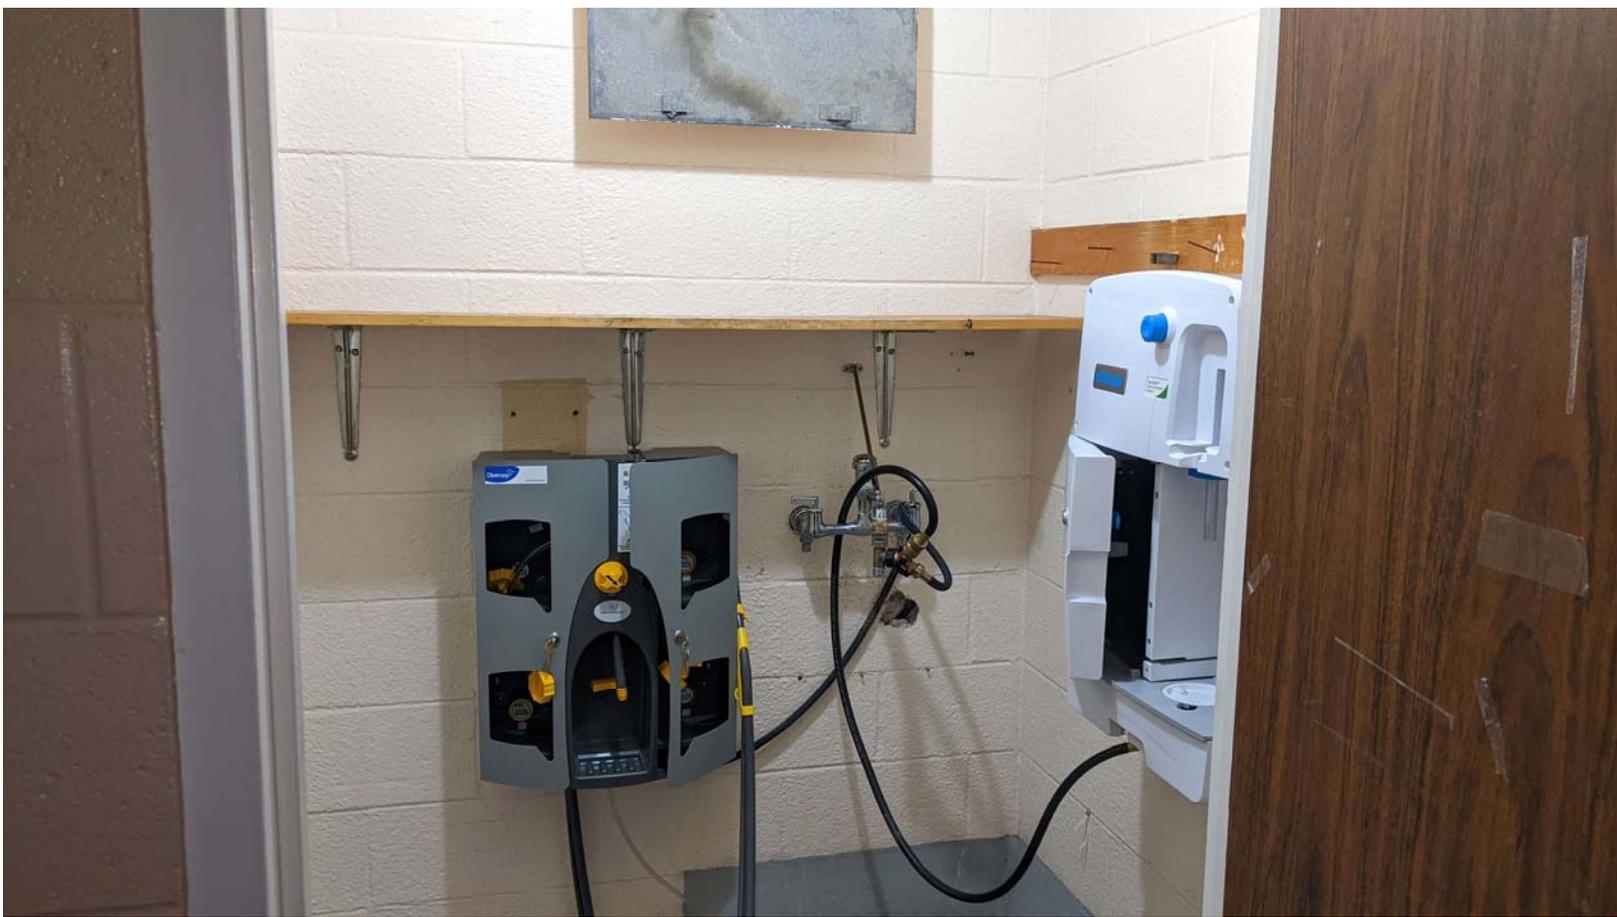
ACM pipe insulation concealed in concrete block walls- typical throughout

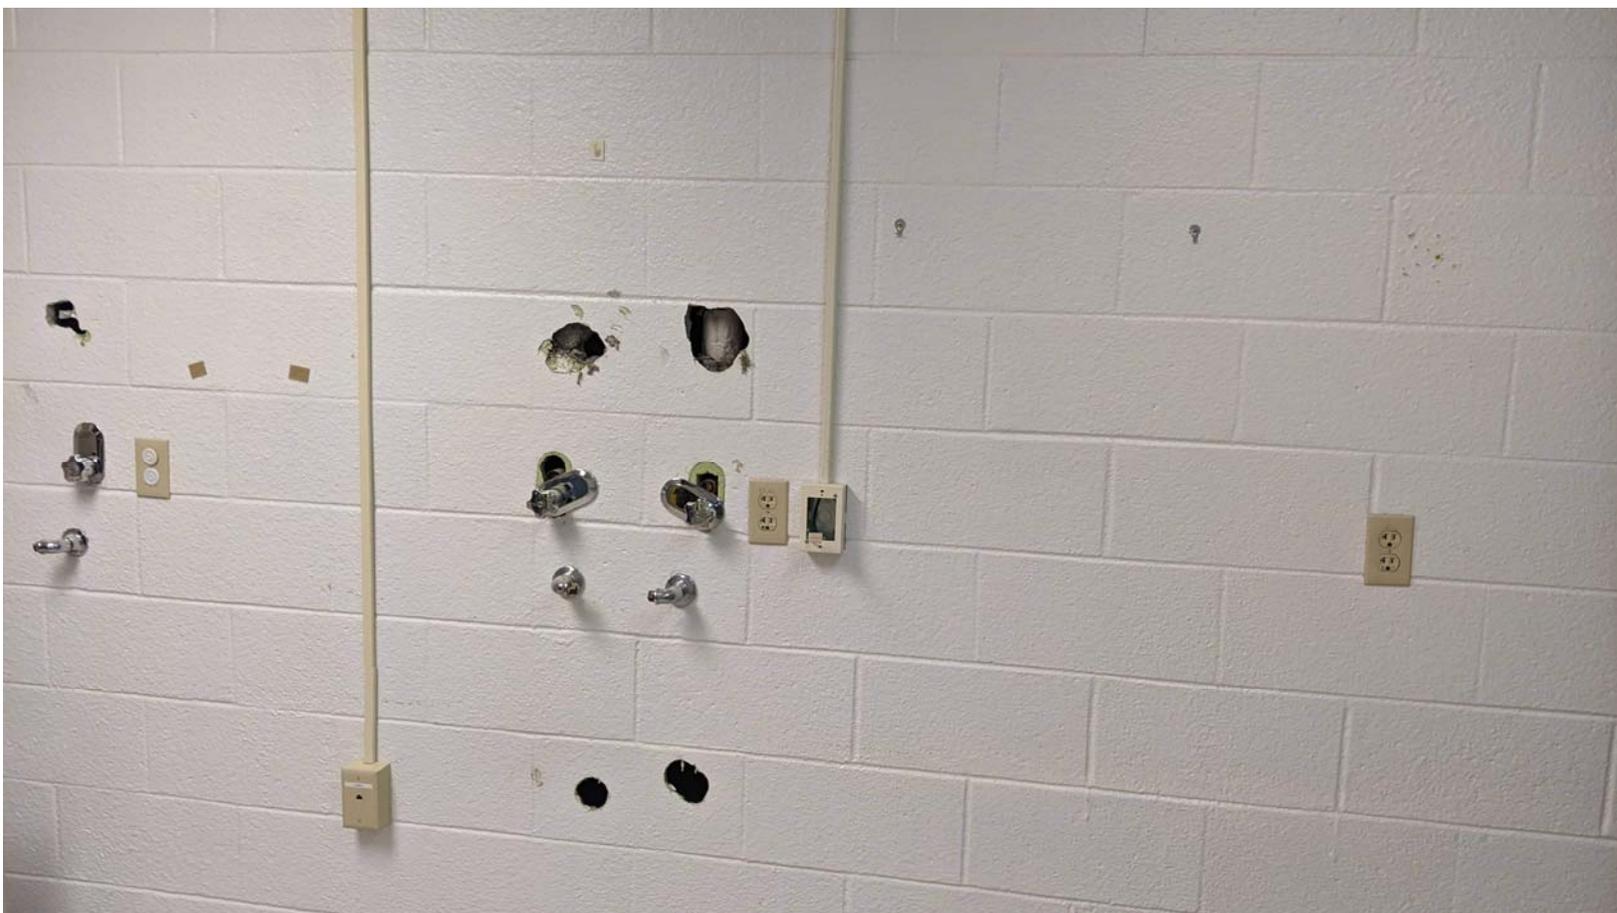
ACM pipe insulation concealed in concrete block walls- typical throughout (2)

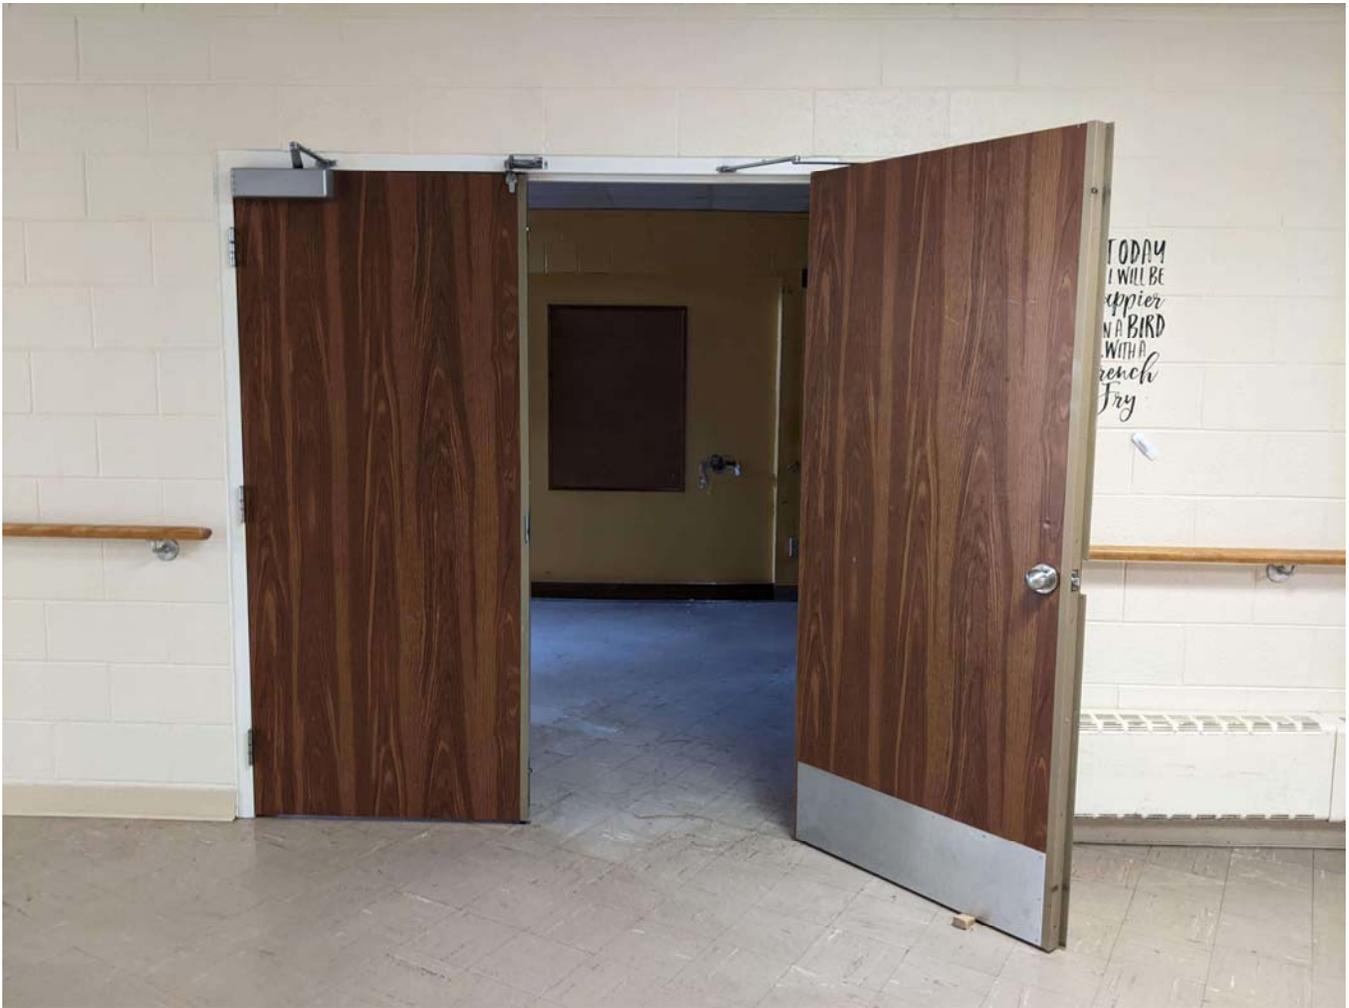
ACM Door Fill, ACM floor tile-typical
