Advertisement for Bids – Asbestos Abatement and Building Demolition

RE: Final Report- Pre-Demolition Services
 LEGEND No. 23WI059

This report presents the results of the pre-demolition inspection of the Marshfield Medical Center located at 900 College Avenue W in Ladysmith, WI conducted by LEGEND Technical Services, Inc. (LEGEND) representative Mr. Lucas Sokol, WI Asbestos Inspector #AII-267101 and Katia Castro Lopez, WI Asbestos Inspector #AII-290508 on May 2, 3, 13 and 24; June 7, 29, 2023. LEGEND's services were requested and authorized by Gary Shilts with Rusk County.

900 Colleve Avenue W
Ladysmith, WI 54848
Ground Floor
ACM Diagram

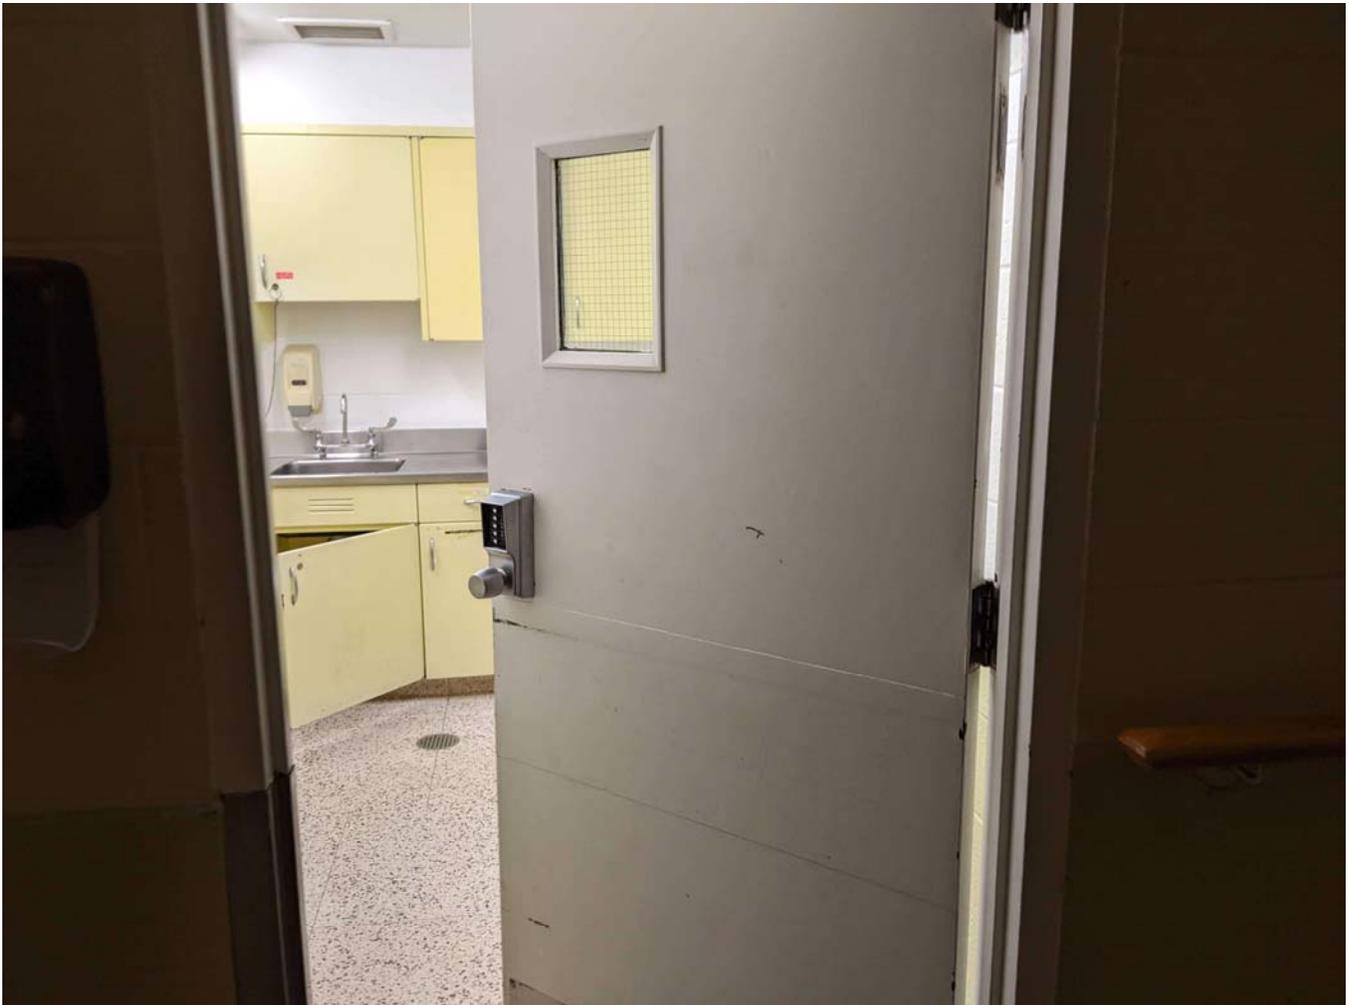
ACM Fire door fill with ACM glazing-typical

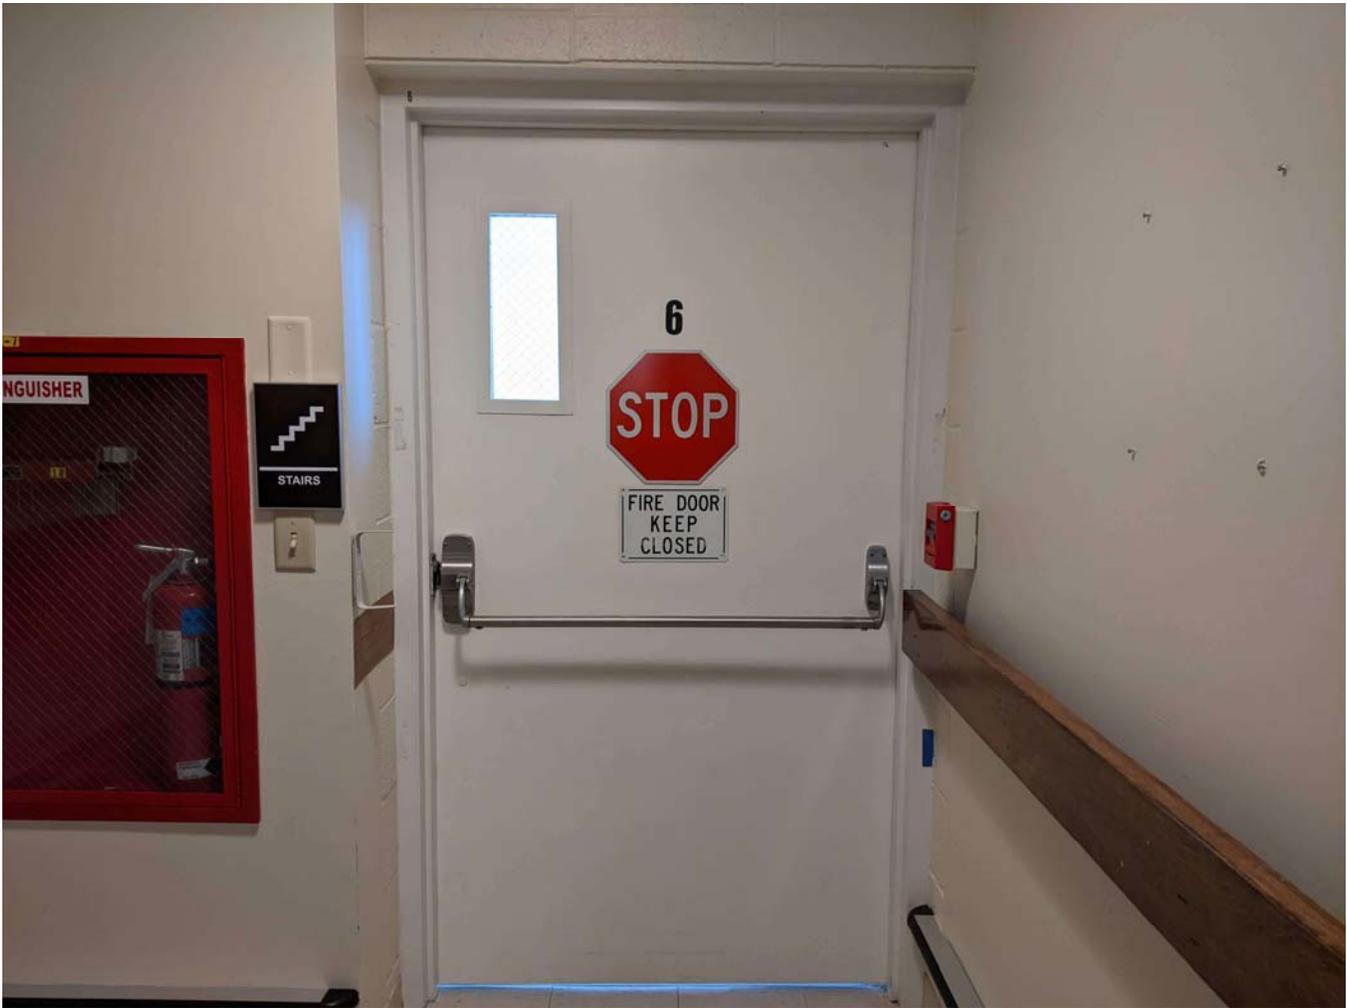
ACM Firedoor with ACM glazing

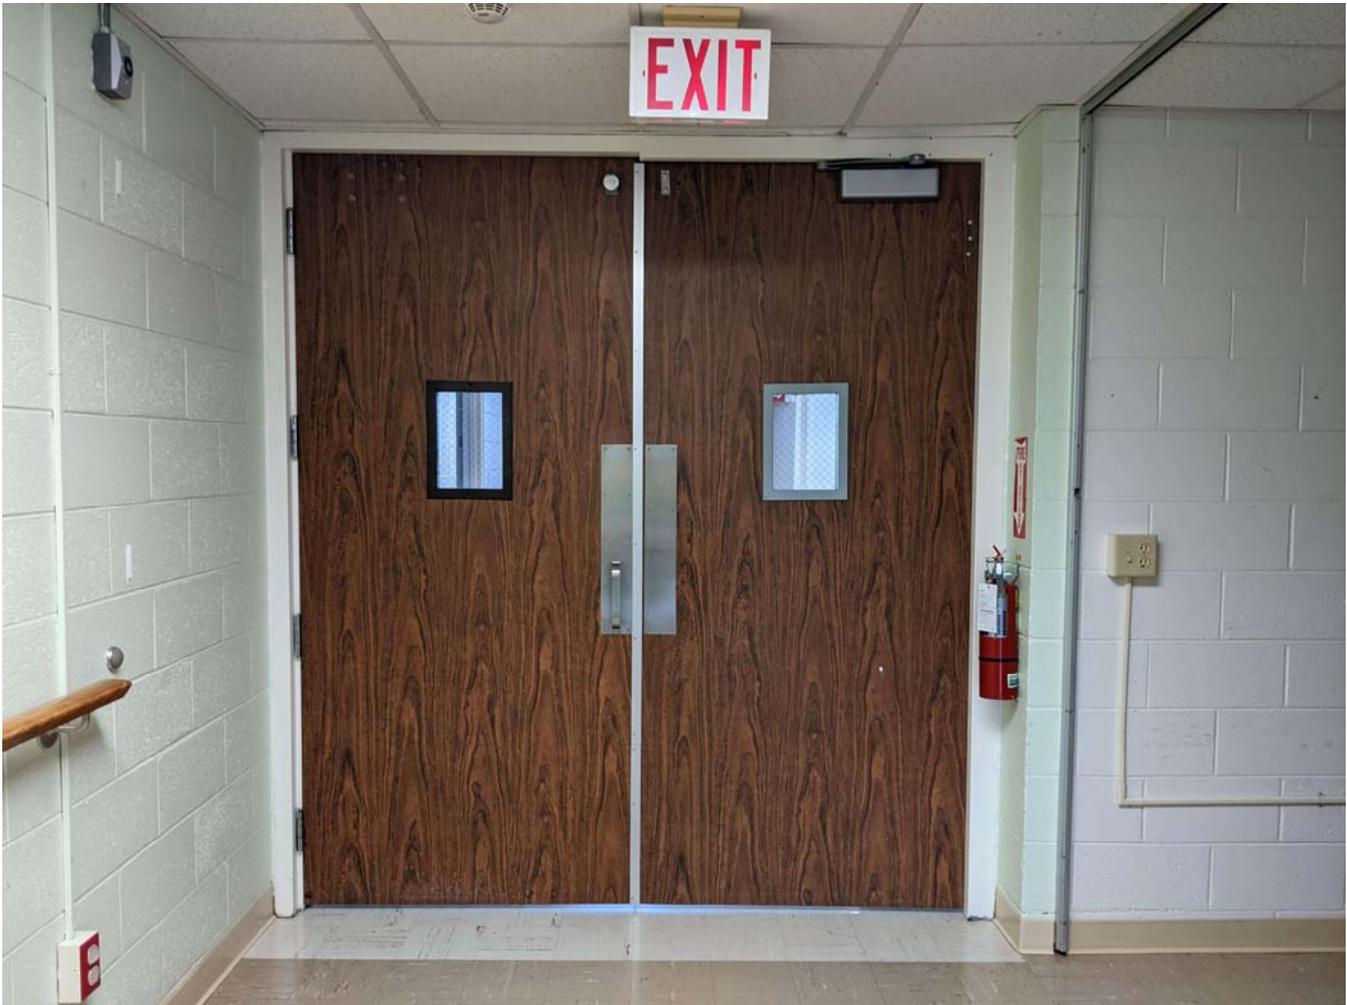
ACM fire door with ACM glazing

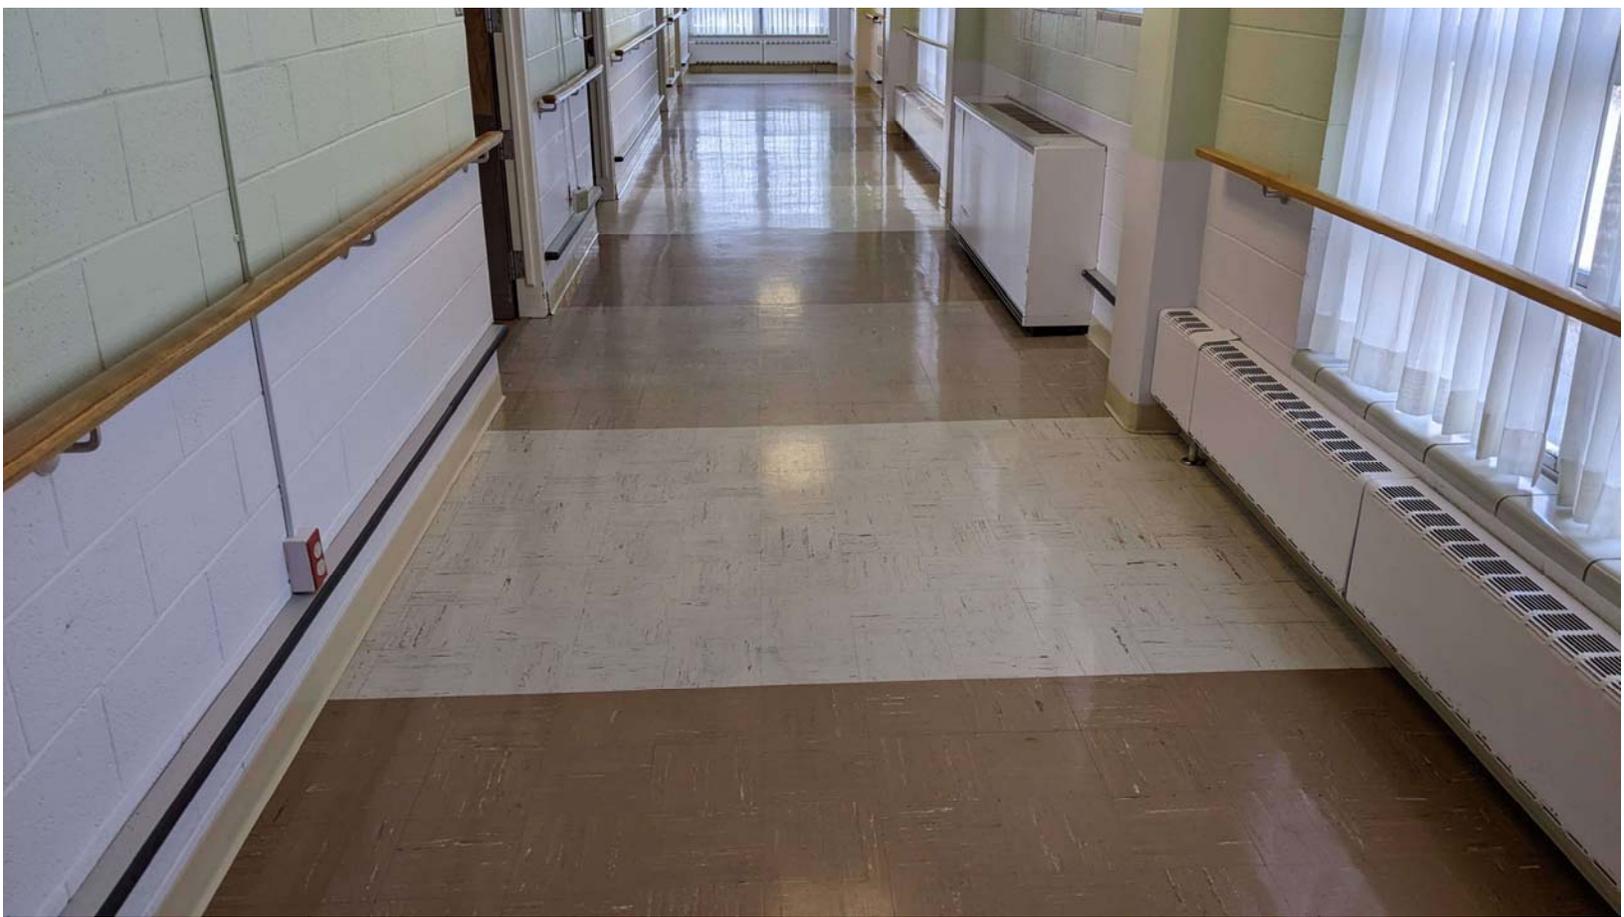
ACM Floor tile and mastic

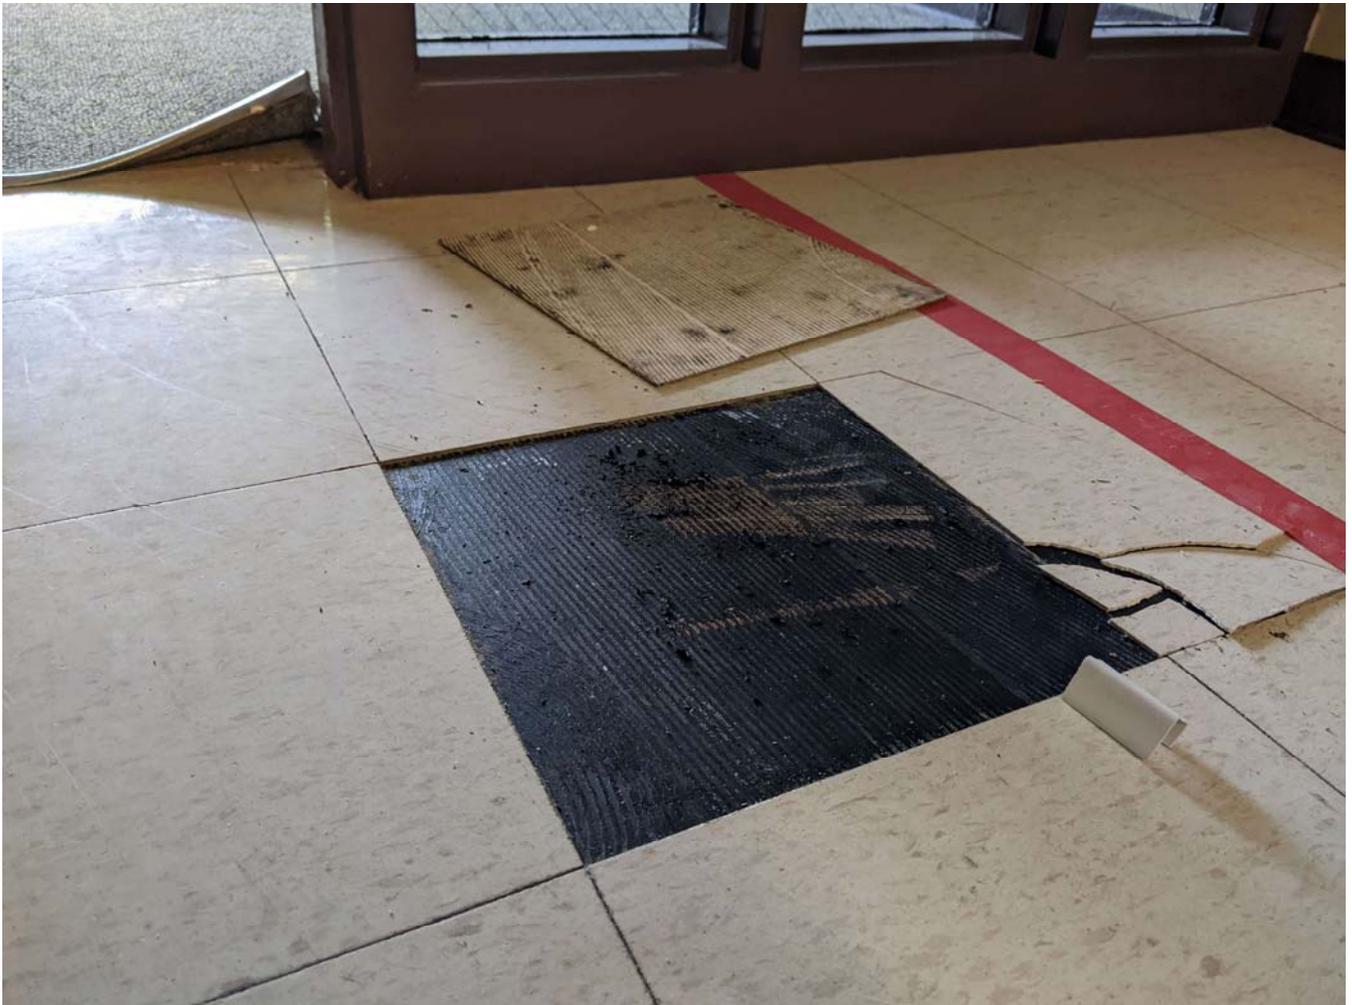
ACM tile and mastic (2)

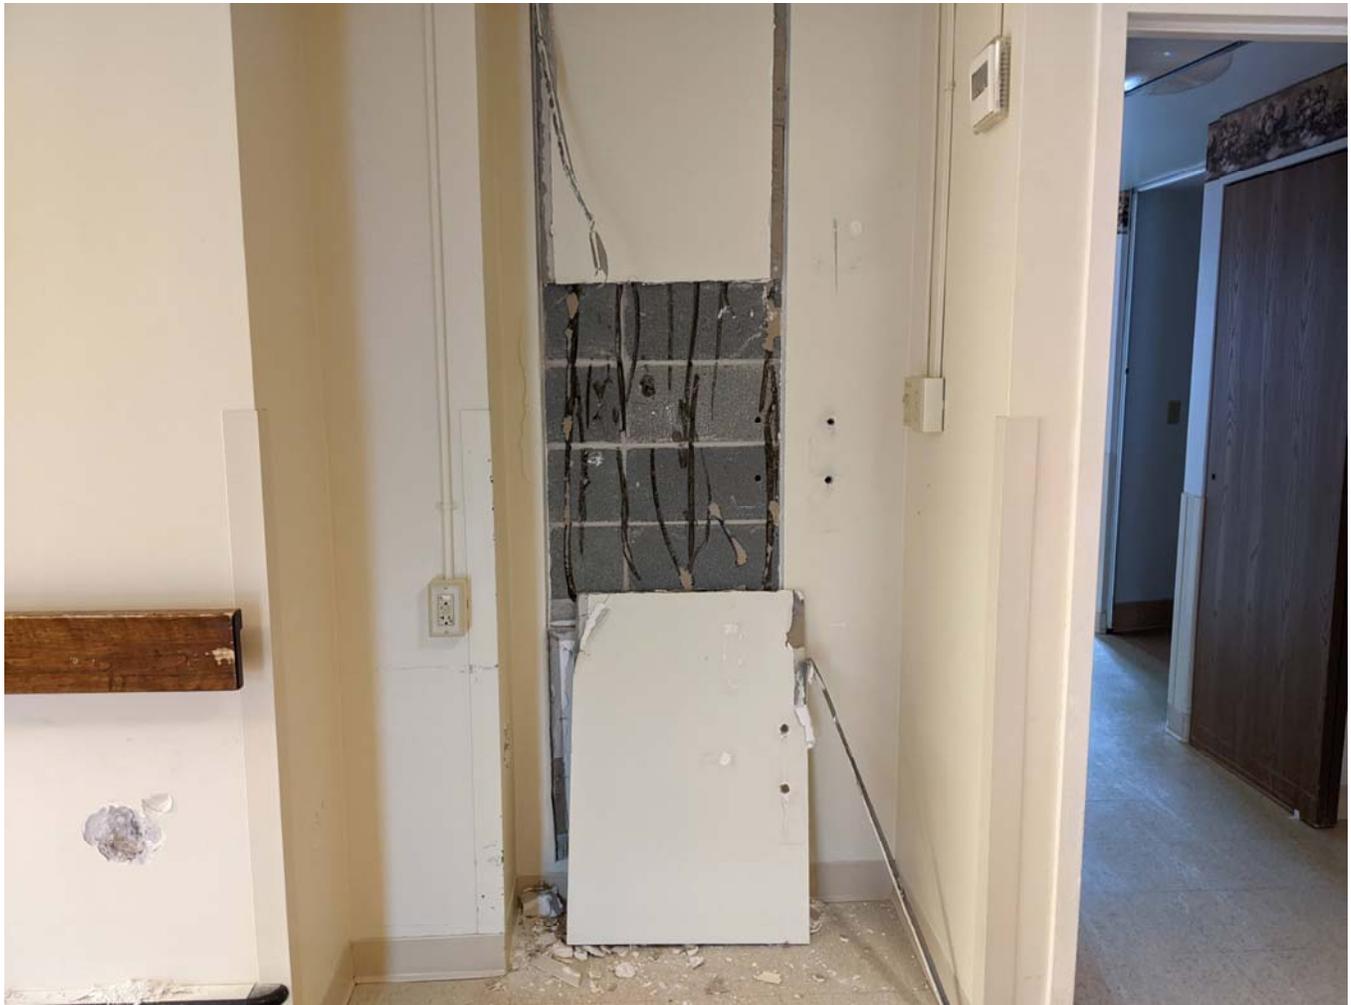
74-140	Wall Adhesive	Hallways by N224 and N124	32 ft ²	CAT II
	ACM black wall adhesive is used for a drywall patch in two areas of the central south wing. Hallway by N224 and the Hallway by N124.			
524-7, 8	Ceiling Texture	Chapel lobby	415 ft ²	RACM
	An ACM white ceiling texture is in the lobby/doorway area to the Chapel.			
74-98, 99, 100, 102, 103; 524-38, 42, 43; 607-35 629-2,3,49	Window Glaze	Throughout structure	202 ea.	CAT II
	ACM window glazing is present on several varieties of windows. This includes all the bathroom windows throughout the 1964 structure, windows along the main north side entrance, and several windows in the west wing of the 1974 addition.			
524-44, 45, 47; 629-16, 17, 18	Door Caulk	1964 vintage-throughout	160	CAT II
	ACM Door caulks are found on door frames set in concrete block throughout the interior of the 1964 vintage.			
629-80	Insulation between ductwork seams	Ground floor Kitchen	60 LF	RACM

ACM Adhesive on Wall

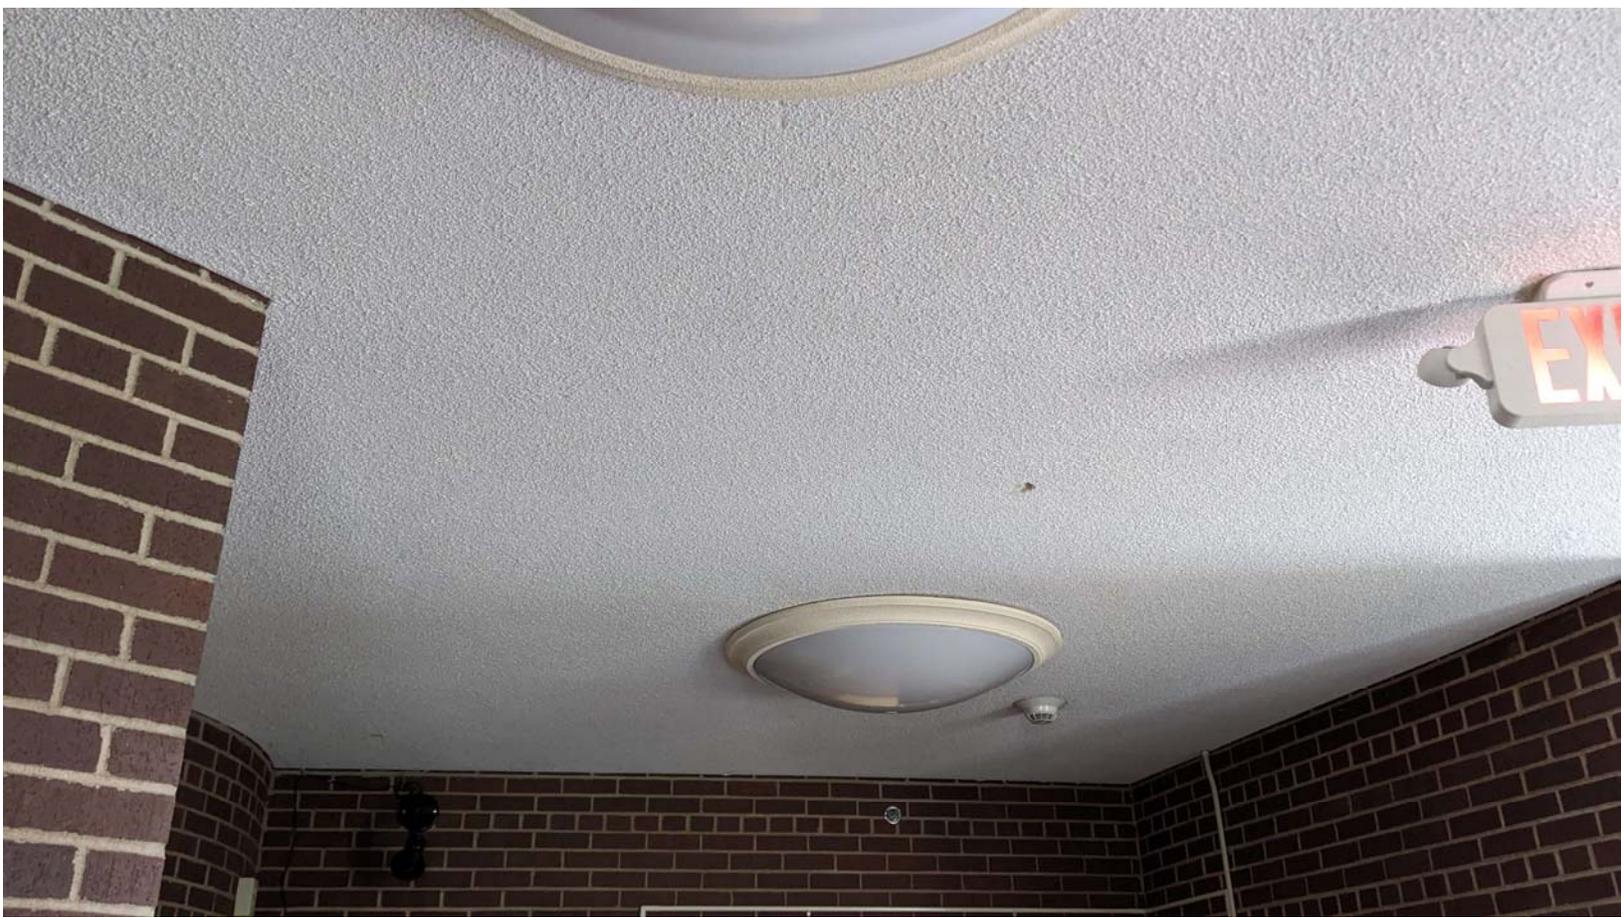
ACM white ceiling texture-entry by chapel

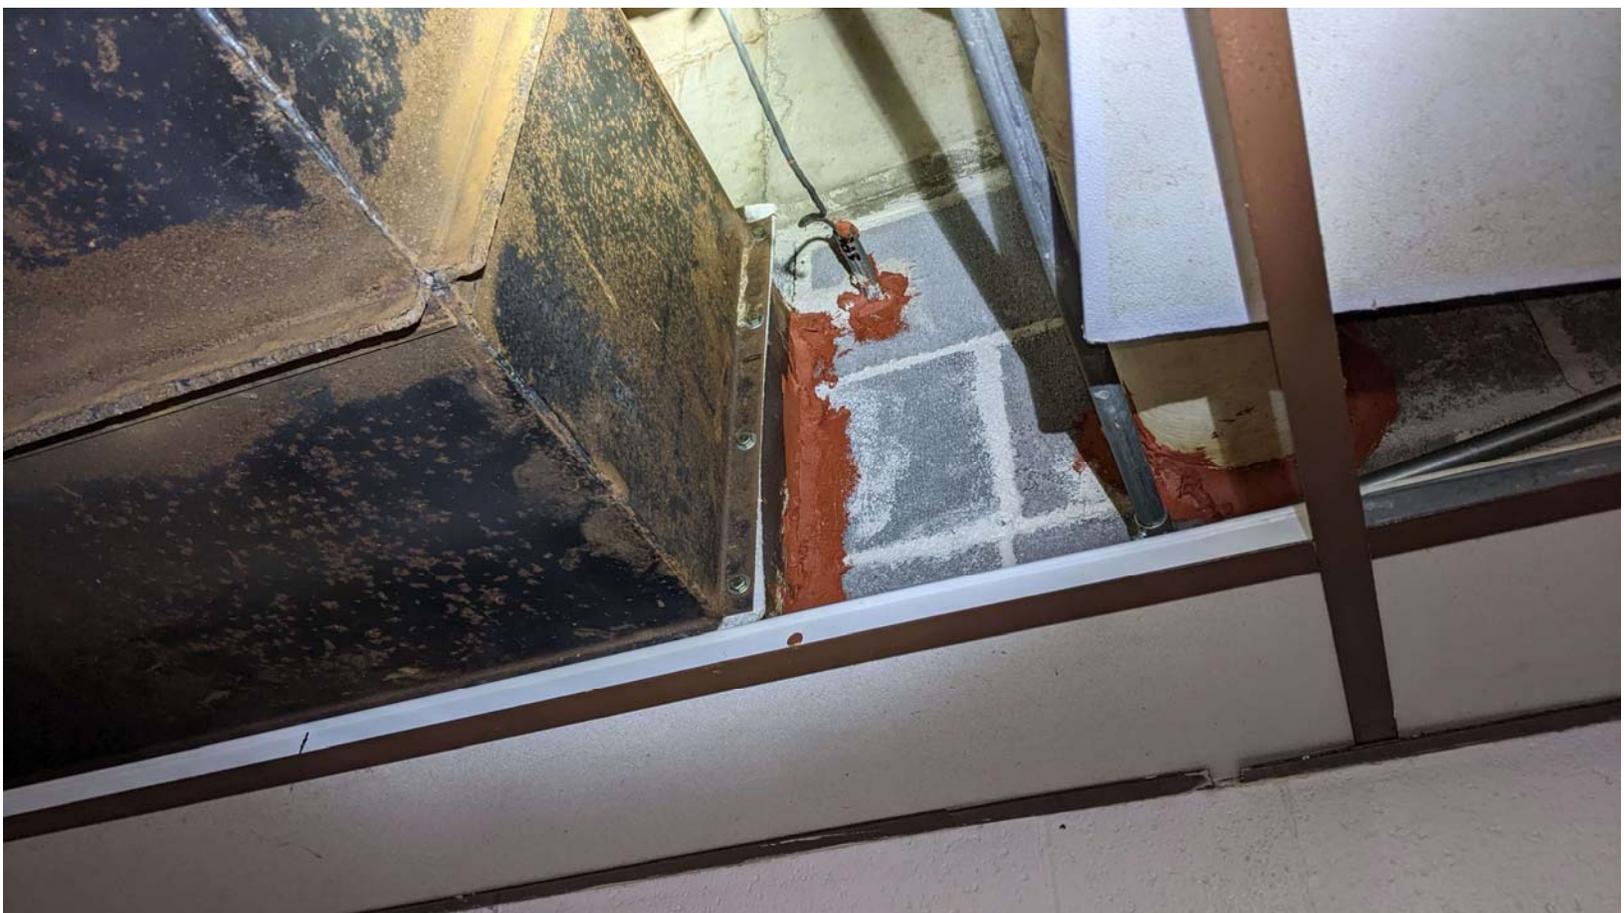
A white ACM insulation is installed between ductwork seams above the ceiling tile in the ground floor kitchen. There are approximately 6 seams with the ACM material.			
74-113 to 115 524-63 607-56	Sink Undercoating	See diagram	21 ea.	CAT II
	Aluminum sinks with an ACM undercoating are found throughout the structure. Several brands/styles of sinks are present. ACM undercoating colors include pink, gold, gray, and black.			
74-109, 145	Light Fixture Insulation Paper	122, 140A dressing rooms, 140 hall closet, 197; N124-N133; N222-N232	27 ea.	RACM
	An ACM light fixture insulation paper is on the ceiling light fixtures of the listed rooms.			
629-82	Black Foundation Coating	Basement Central Storage- Assumed throughout	See note.	CAT II
	An ACM black coating is visible on the concrete walls in the ground floor central storage room. It should be assumed that the entire foundation has a similar ACM coating until excavated and proven otherwise. The quantity is unknown.

ACM white insulation on duct seams-Ground floor kitchen

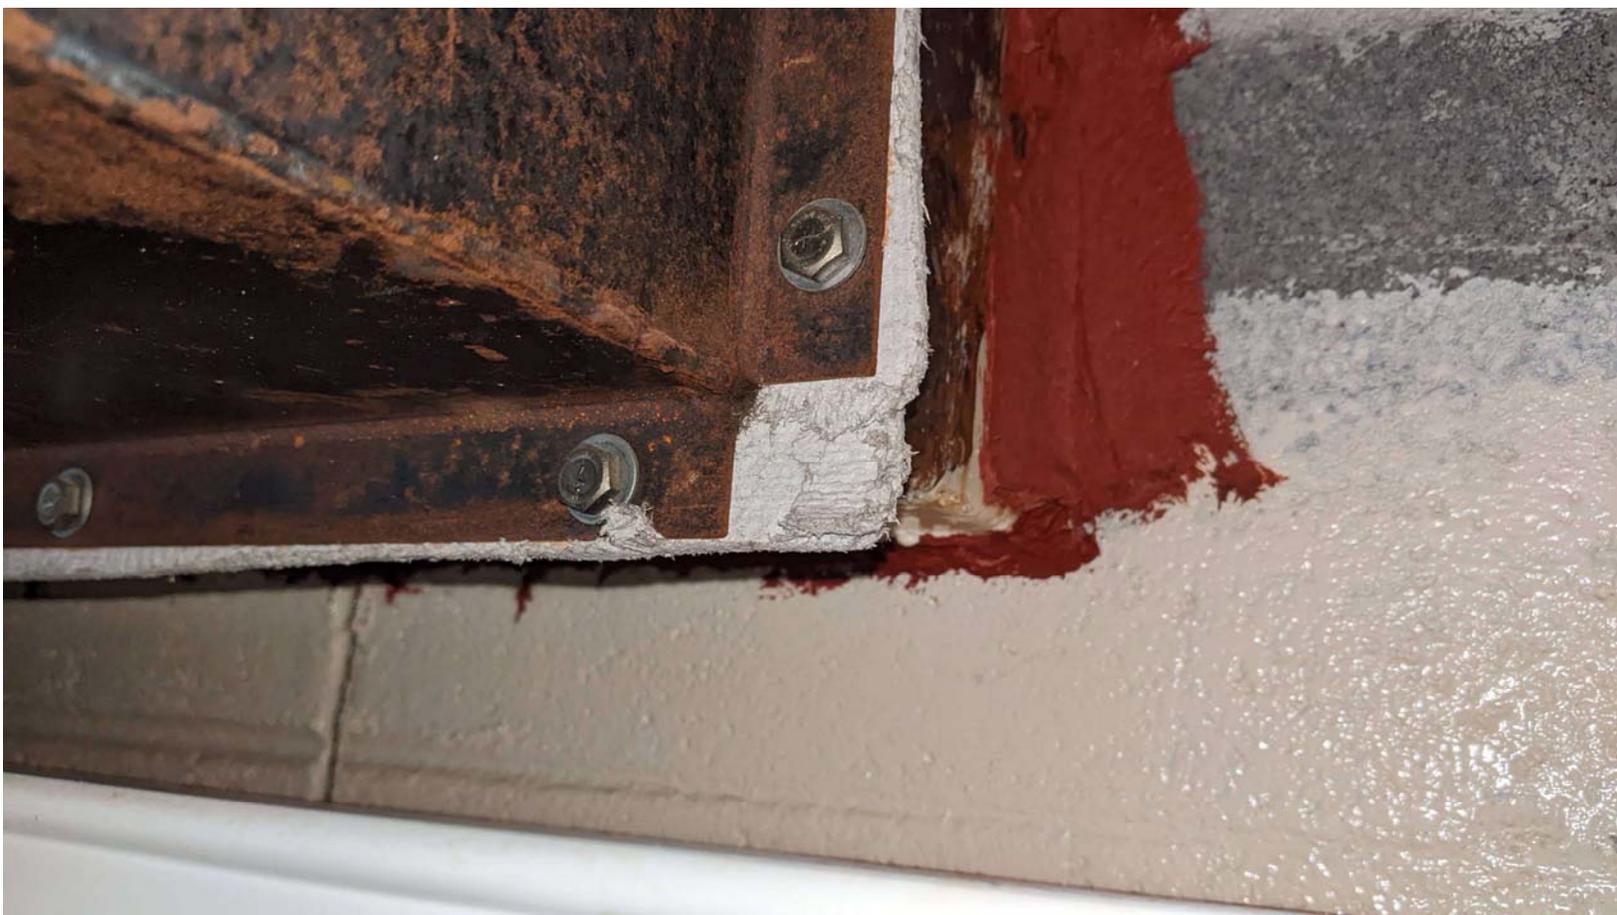
ACM white insulation on duct seams-Ground floor kitchen (2)

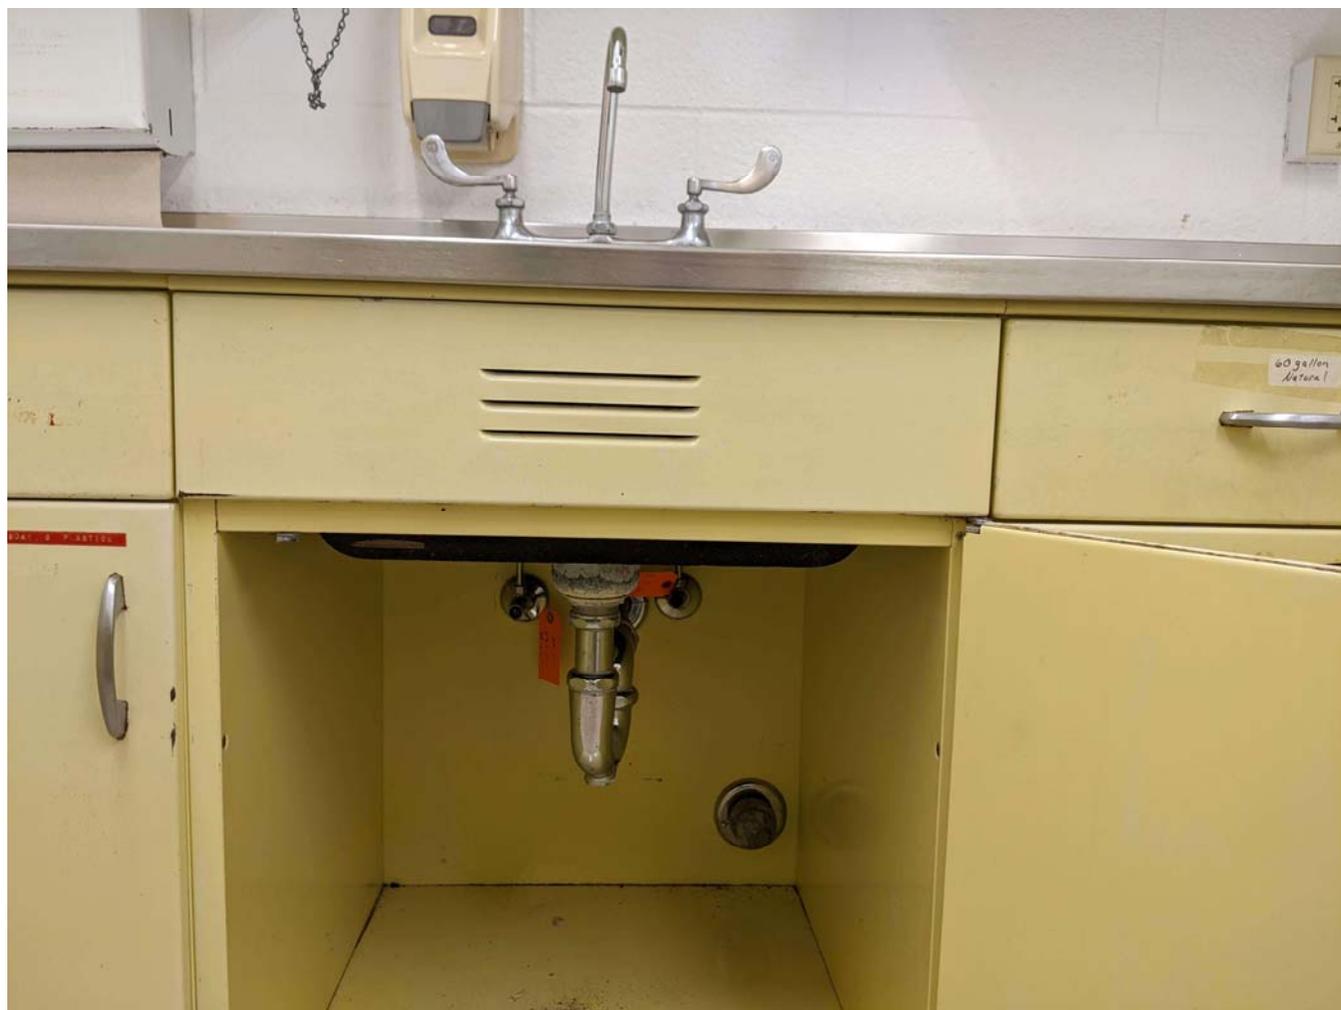
ACM Black Sink Undercoating

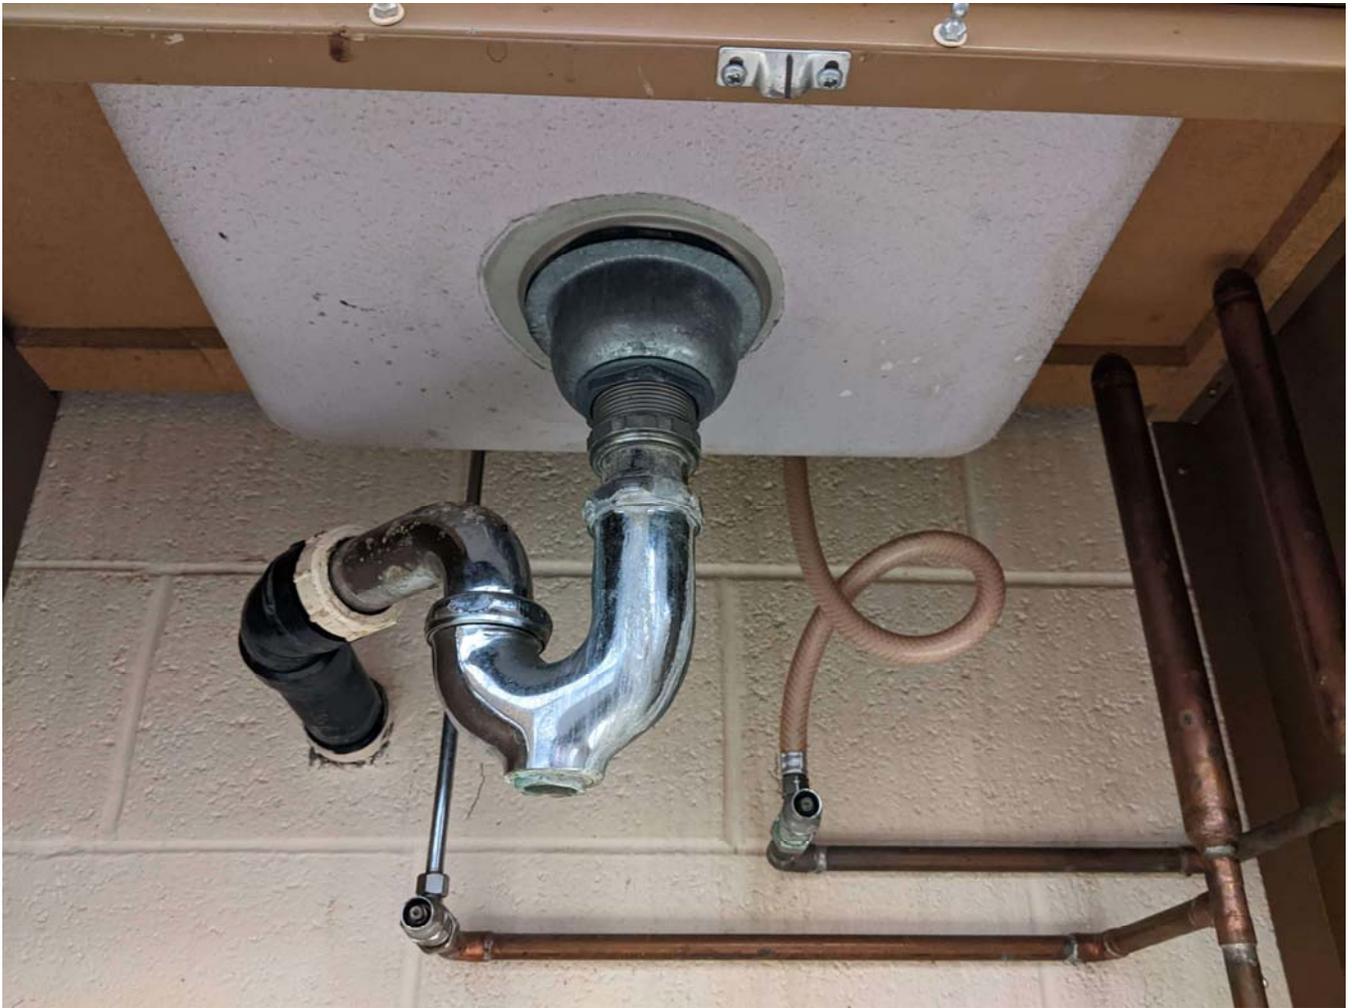
ACM Sink Undercoating Typical

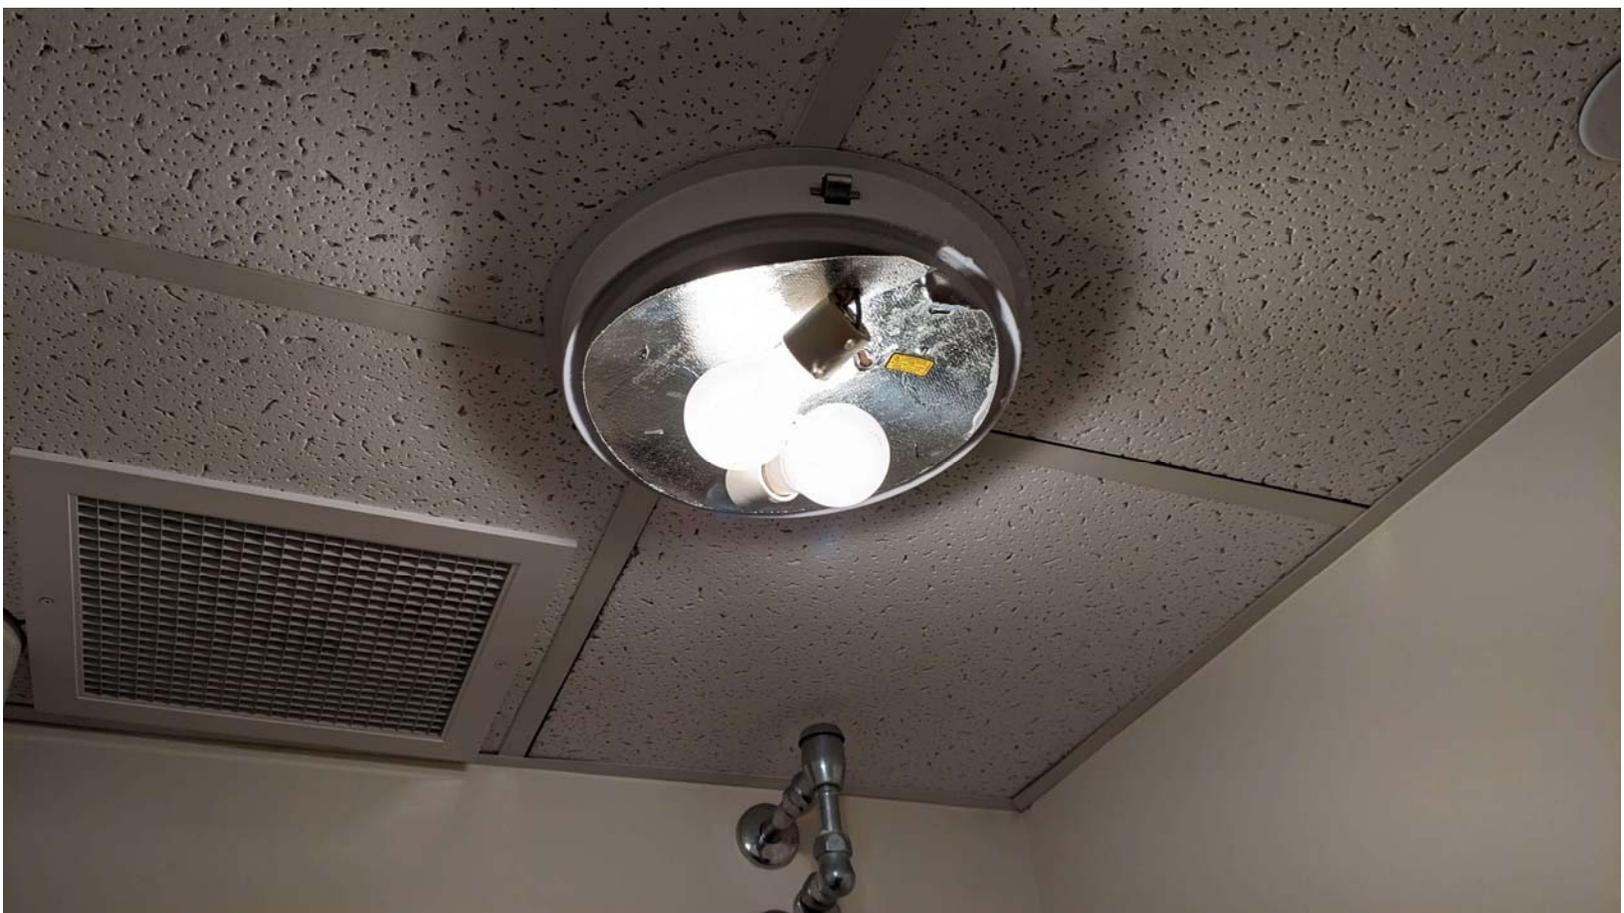
ACM light fixture insulation-Typical

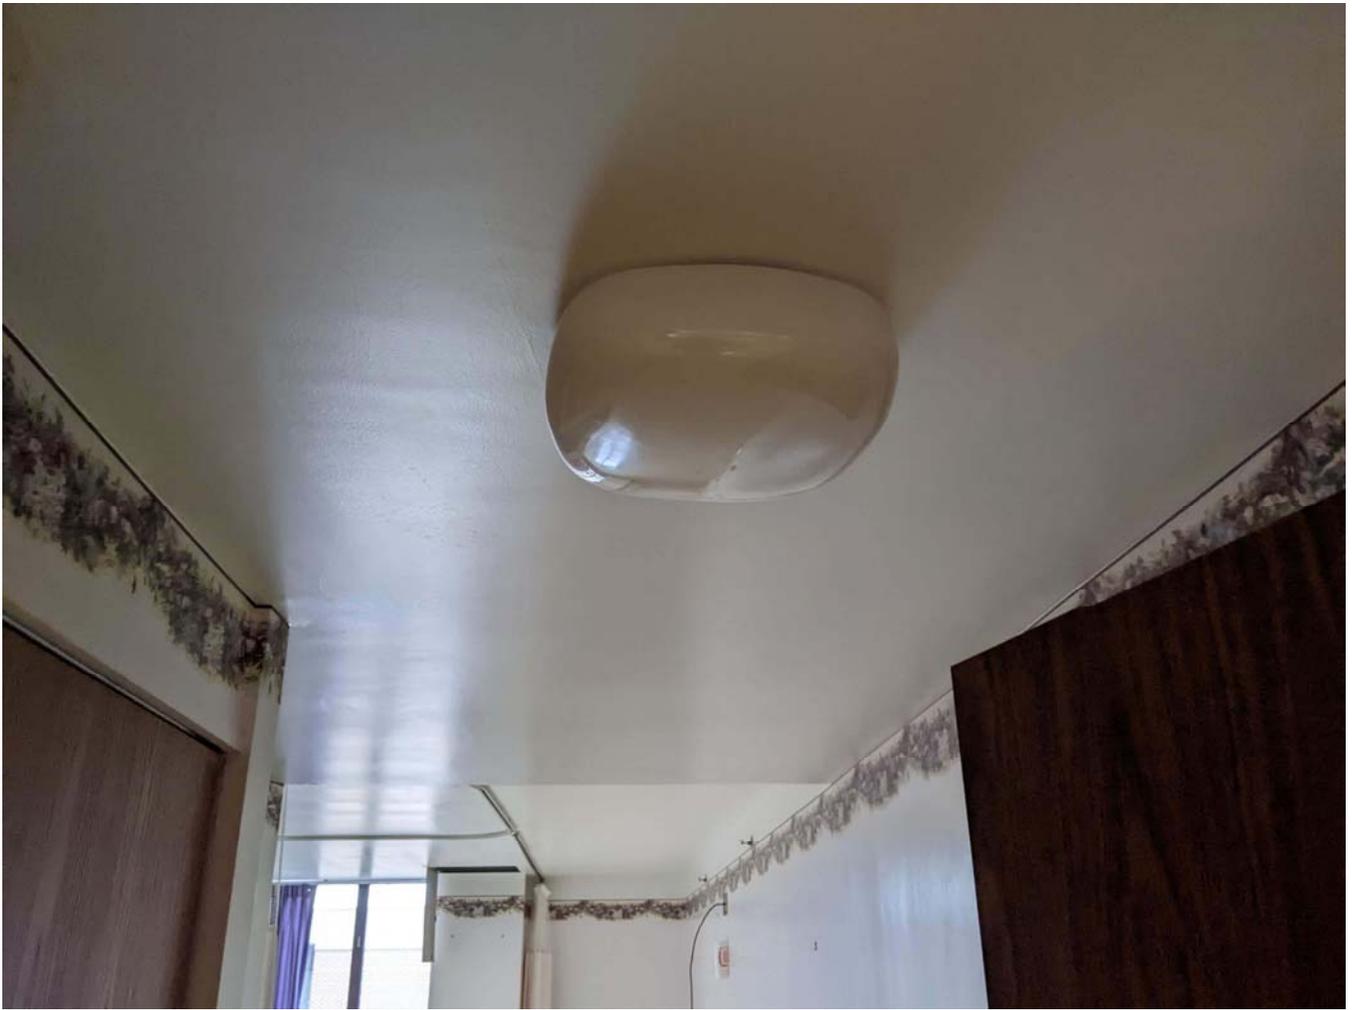
ACM Light Fixture-Typical

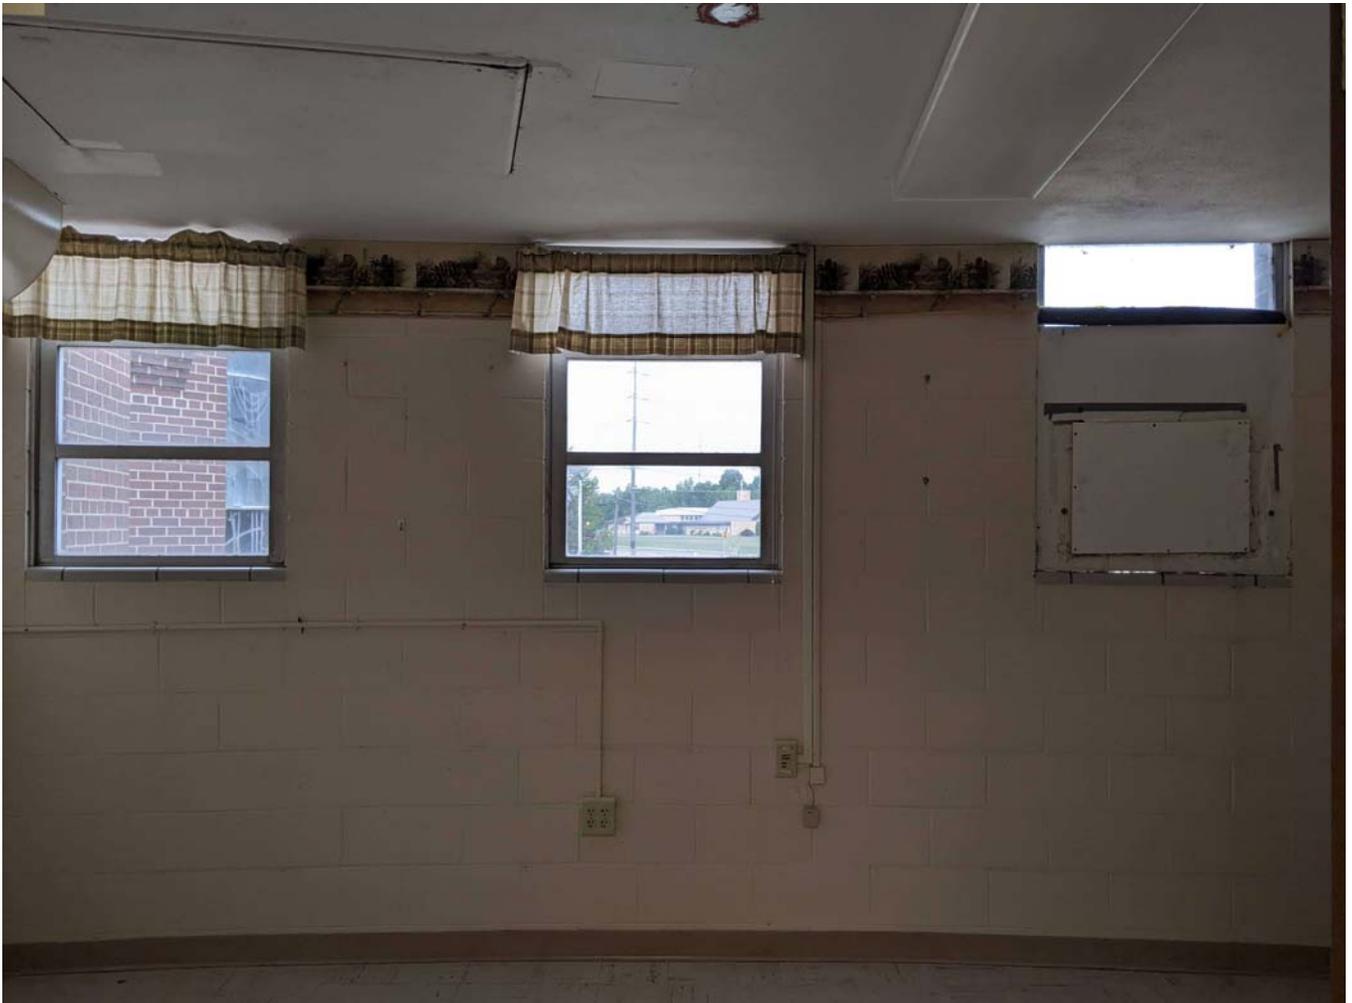
ACM Window Glaze on Windows

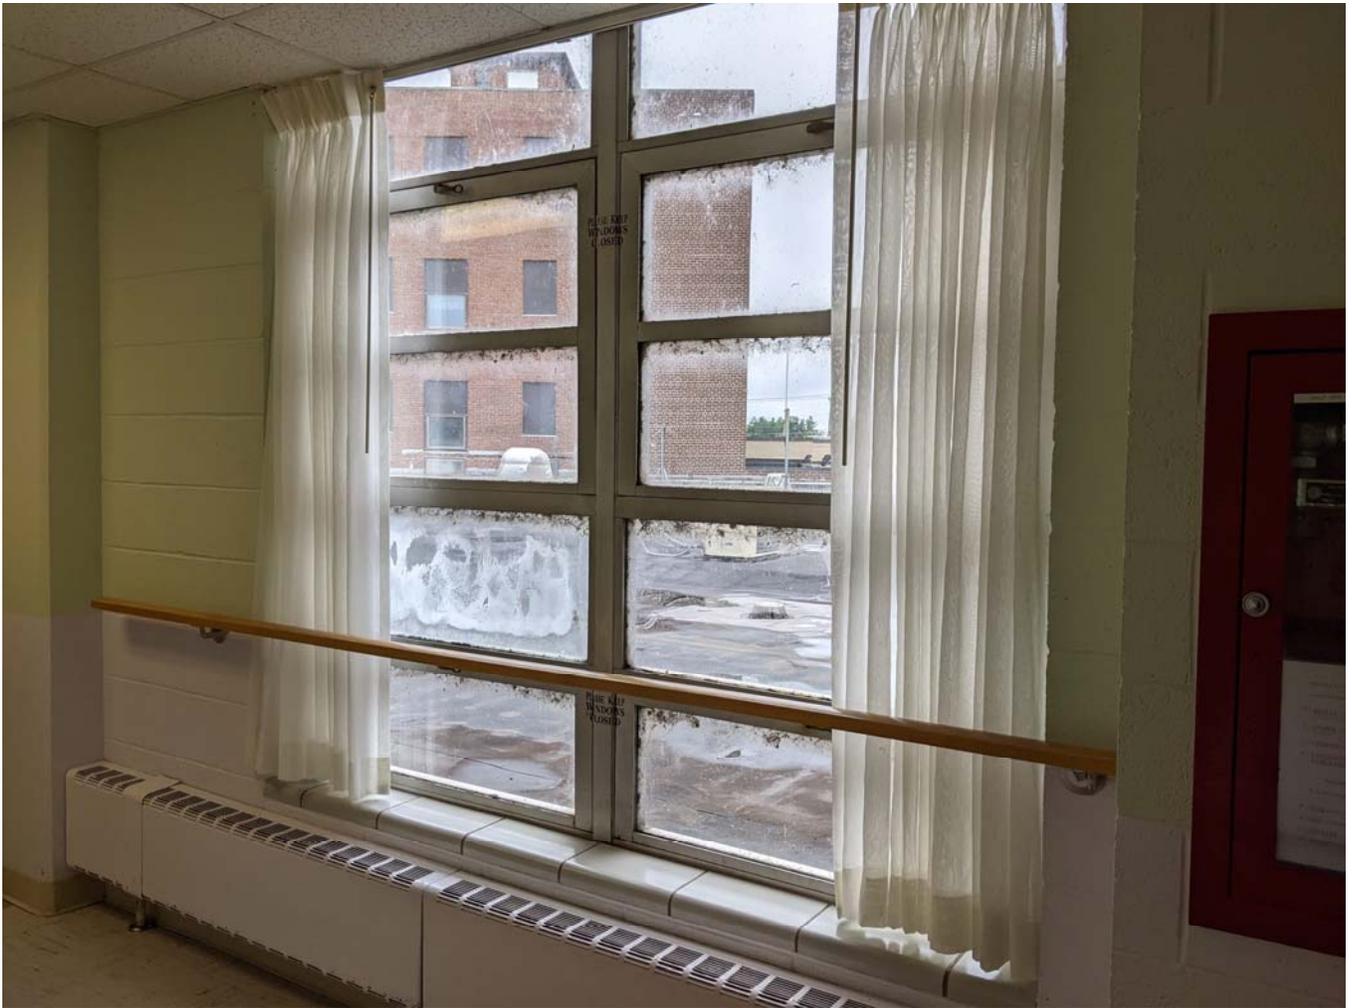
ACM Window Glaze-Typical

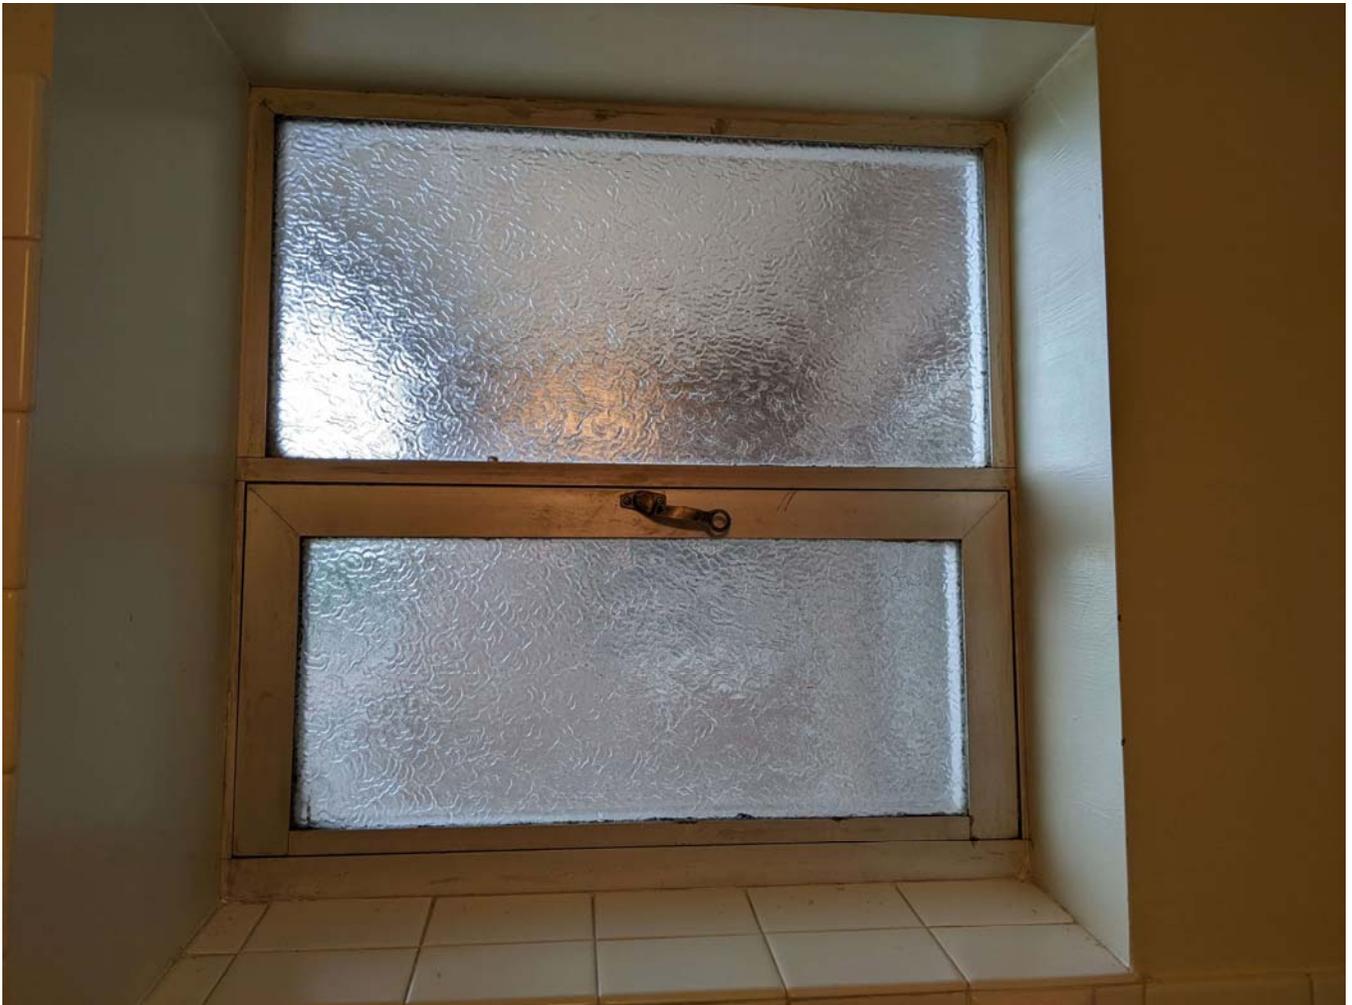
ACM Window Glaze-Typical (2)
