Advertisement for Bids – Asbestos Abatement and Building Demolition

RE: Final Report- Pre-Demolition Services
 LEGEND No. 23WI059

This report presents the results of the pre-demolition inspection of the Marshfield Medical Center located at 900 College Avenue W in Ladysmith, WI conducted by LEGEND Technical Services, Inc. (LEGEND) representative Mr. Lucas Sokol, WI Asbestos Inspector #AII-267101 and Katia Castro Lopez, WI Asbestos Inspector #AII-290508 on May 2, 3, 13 and 24; June 7, 29, 2023. LEGEND's services were requested and authorized by Gary Shilts with Rusk County.

900 Colleve Avenue W
Ladysmith, WI 54848
Ground Floor
ACM Diagram

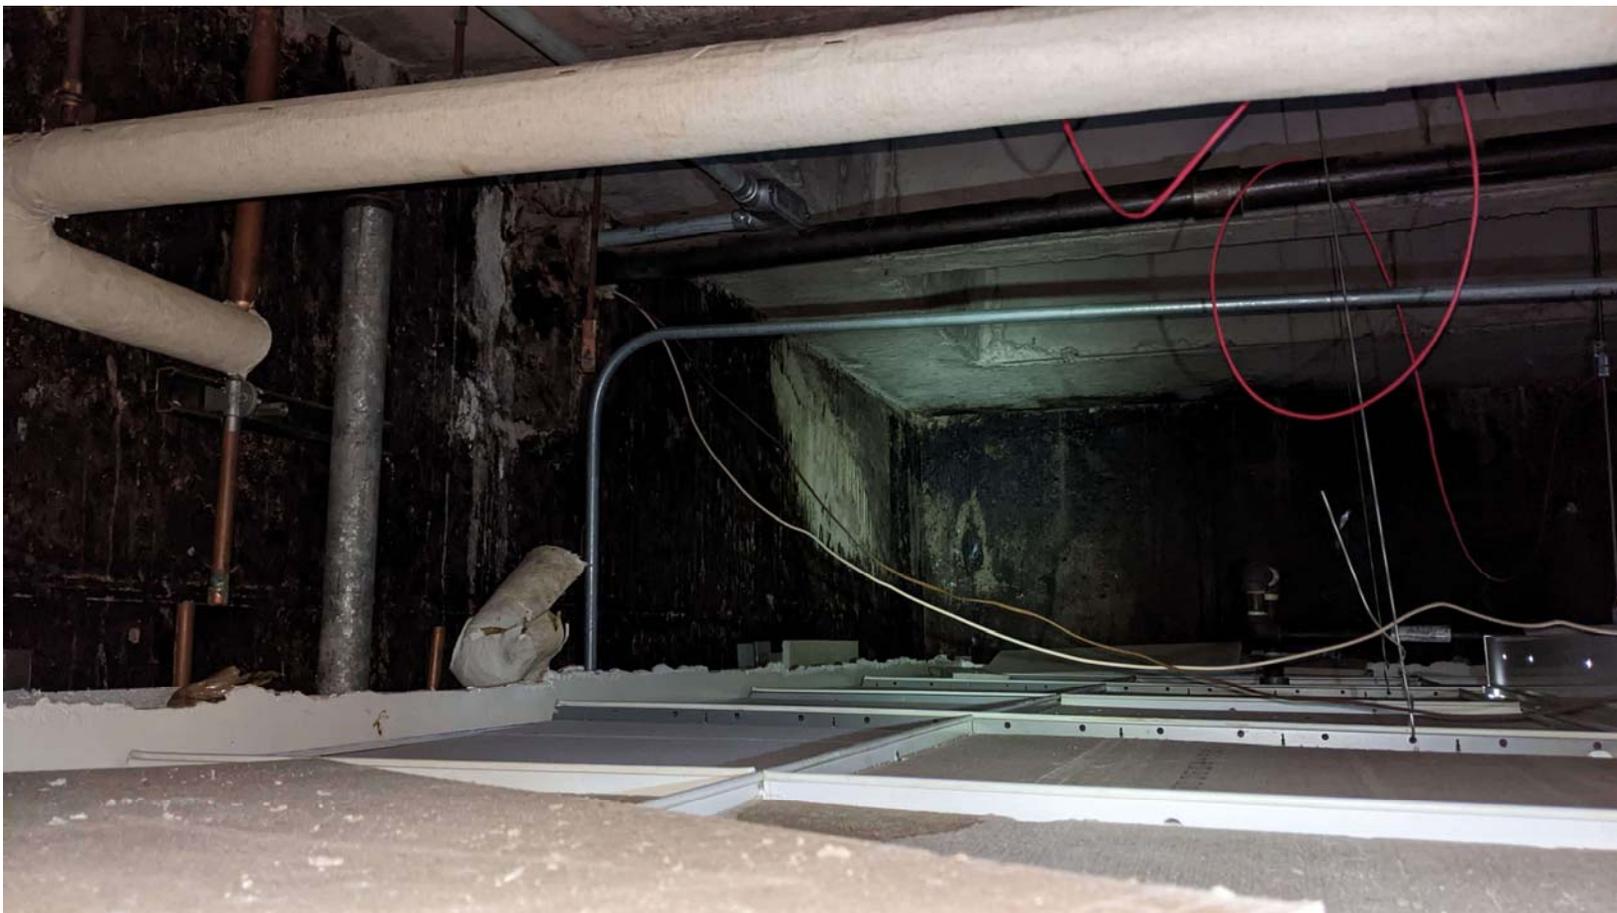
ACM black foundation coating (2)

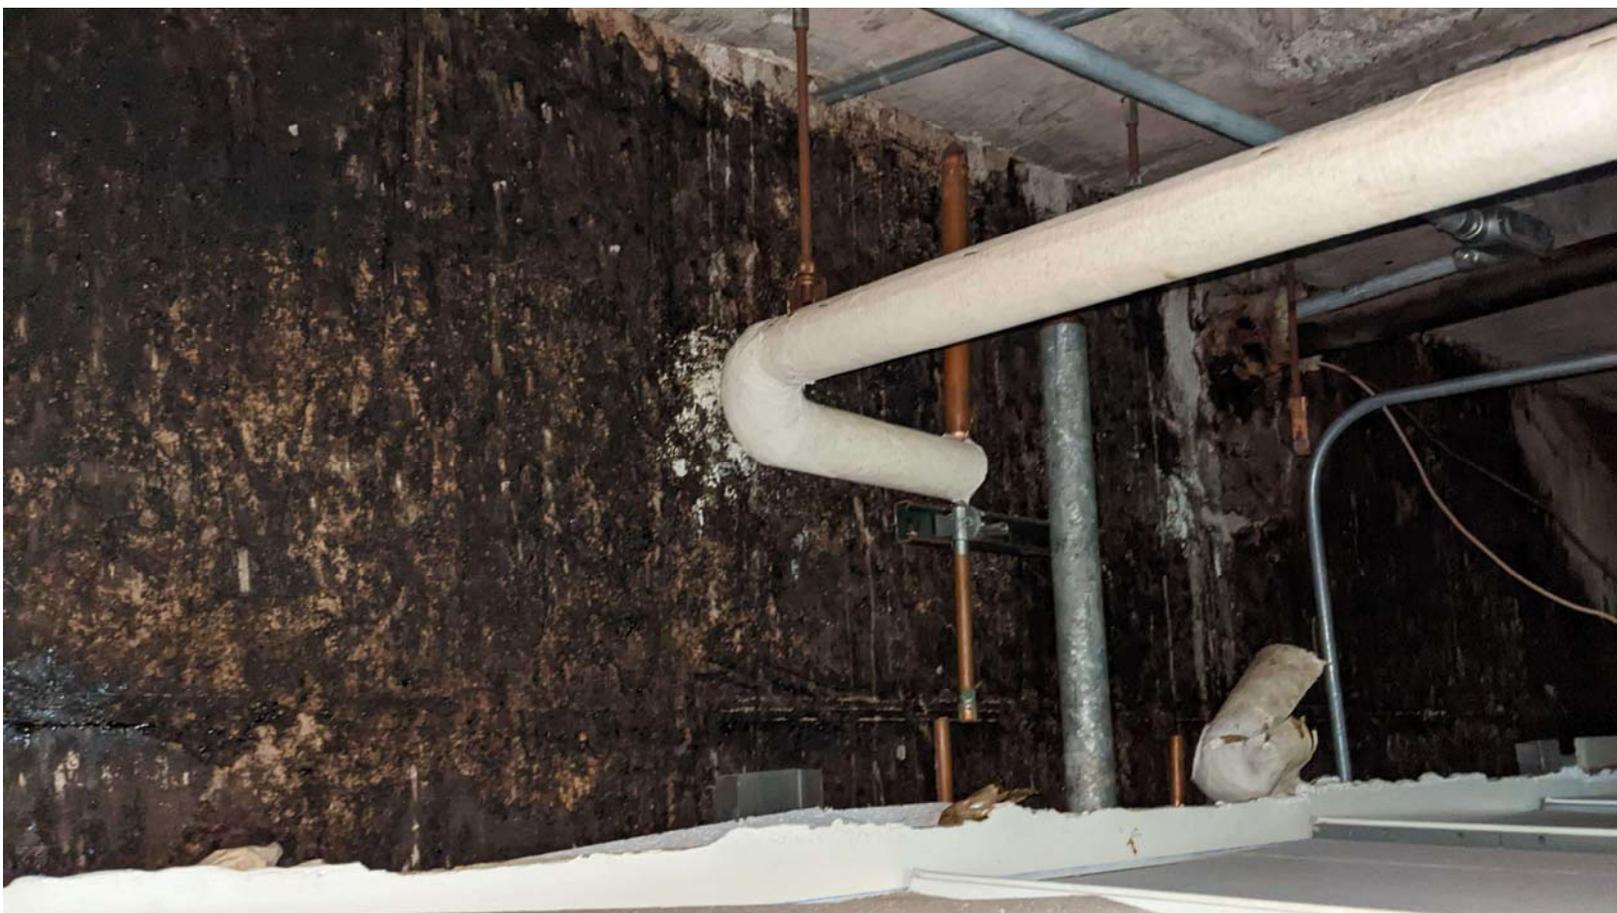
ACM black foundation coating

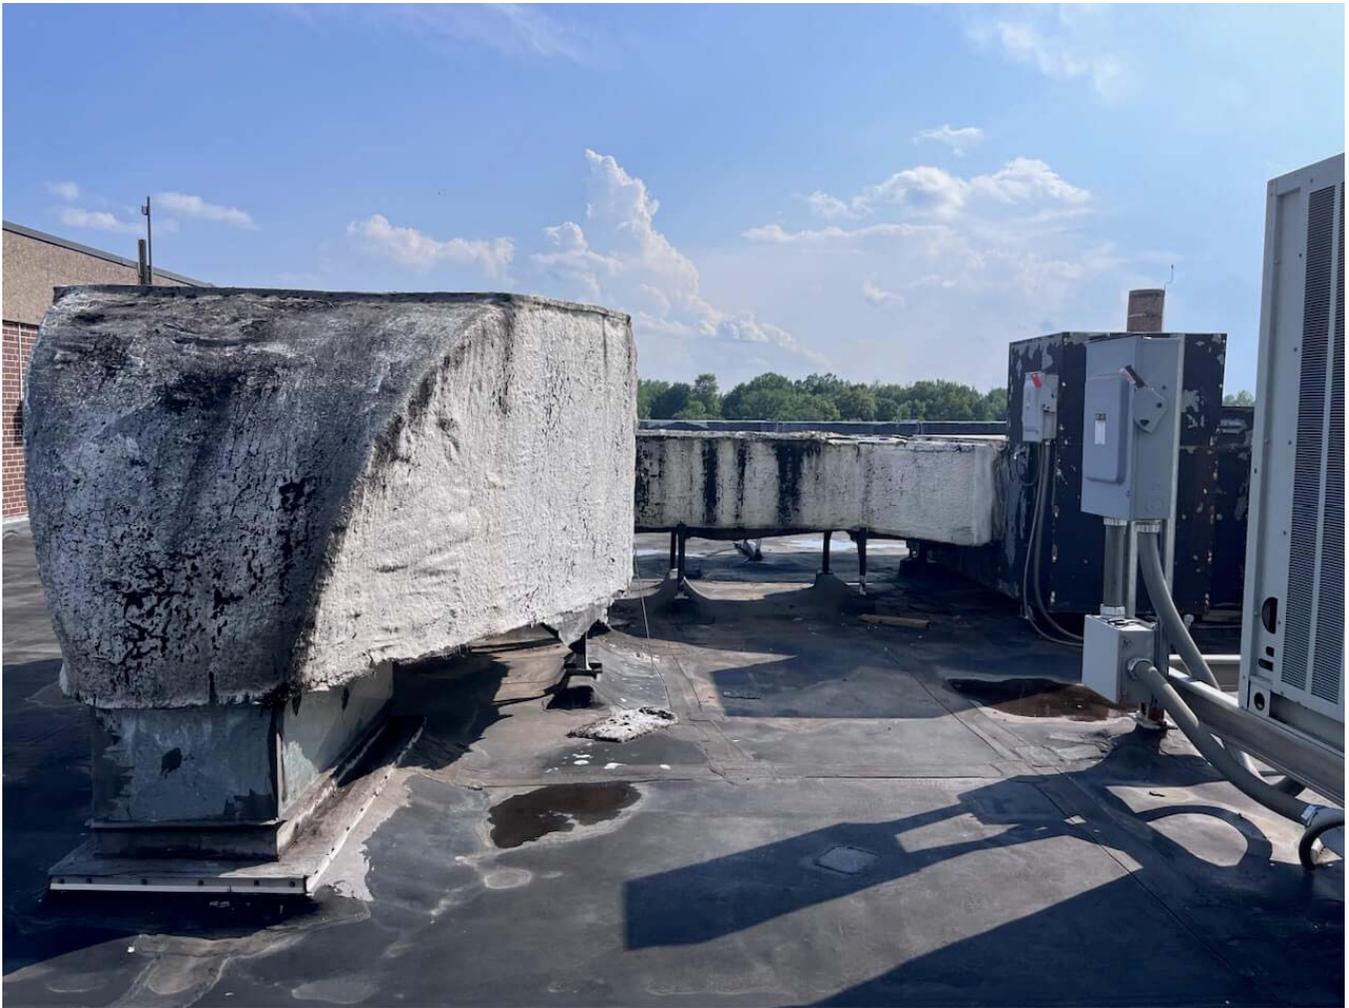
629-35	Coating on rooftop mechanical equipment	Rooftop over 1974 vintage	1,300 ft ²	CAT II
	The rooftop mechanical unit is coated with an ACM black coating. The outer layer is white (non-acm), but the second layer of this coating is black (ACM.)			
629-48	Vibration Dampener	Roof above 2 nd Floor	<20 ft ²	RACM
	White cloth vibration dampeners are on the rooftop air handling equipment above the 2 nd floor. 2 units with ACM are installed-1 on the south wing of the 1974 addition roof and another similar unit in the center of the 1964 vintage roof.

ACM coating on Rooftop equipment

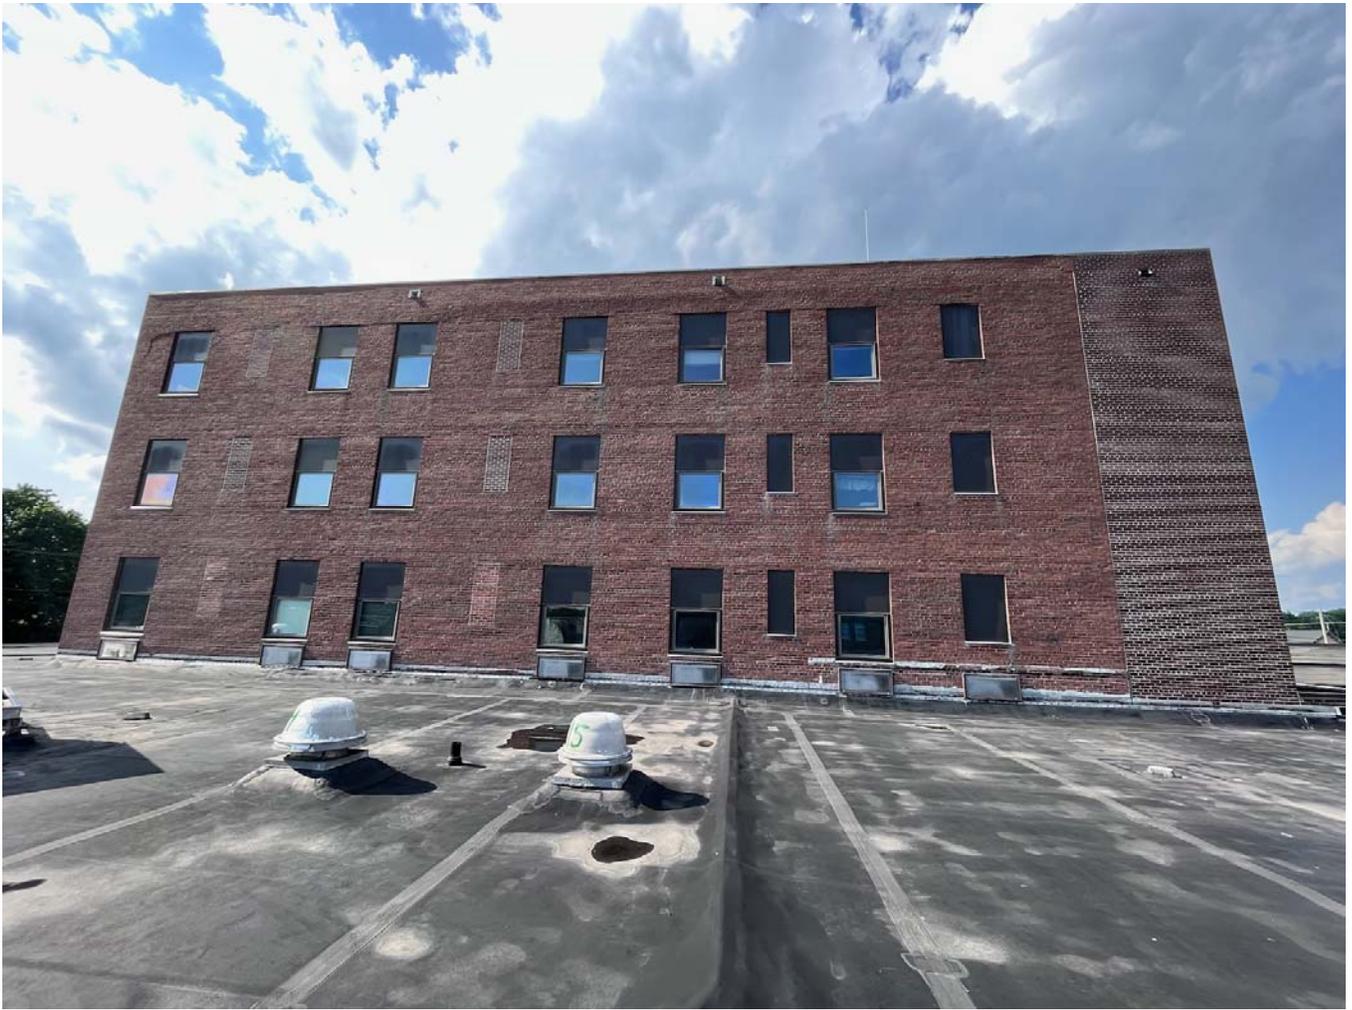
1947-Exterior ACM window caulk

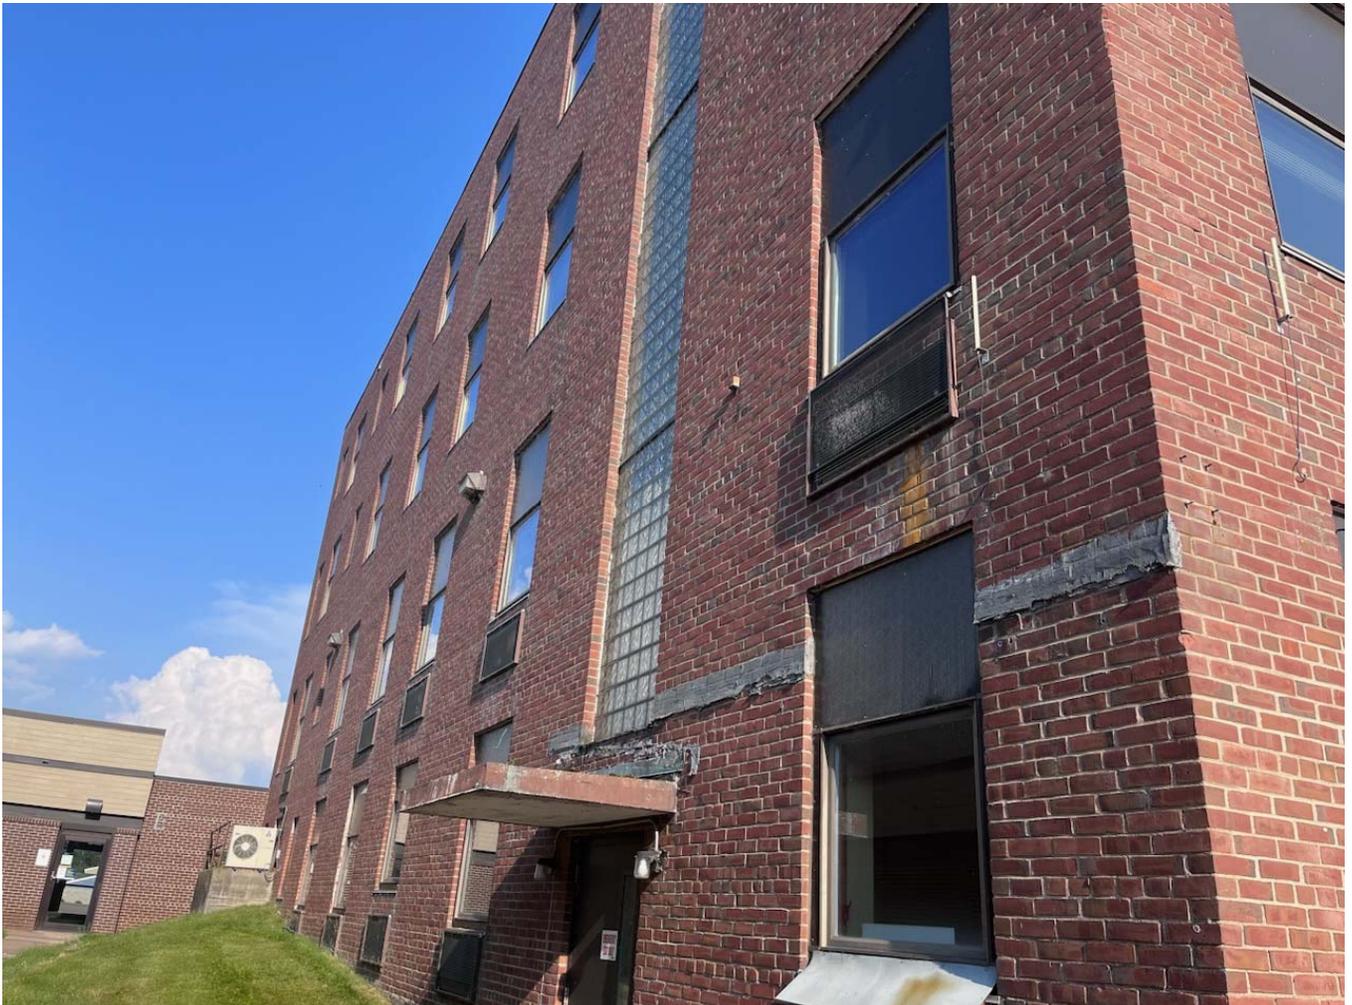
1947-Exterior-ACM window caulk and black gray sealant on brick

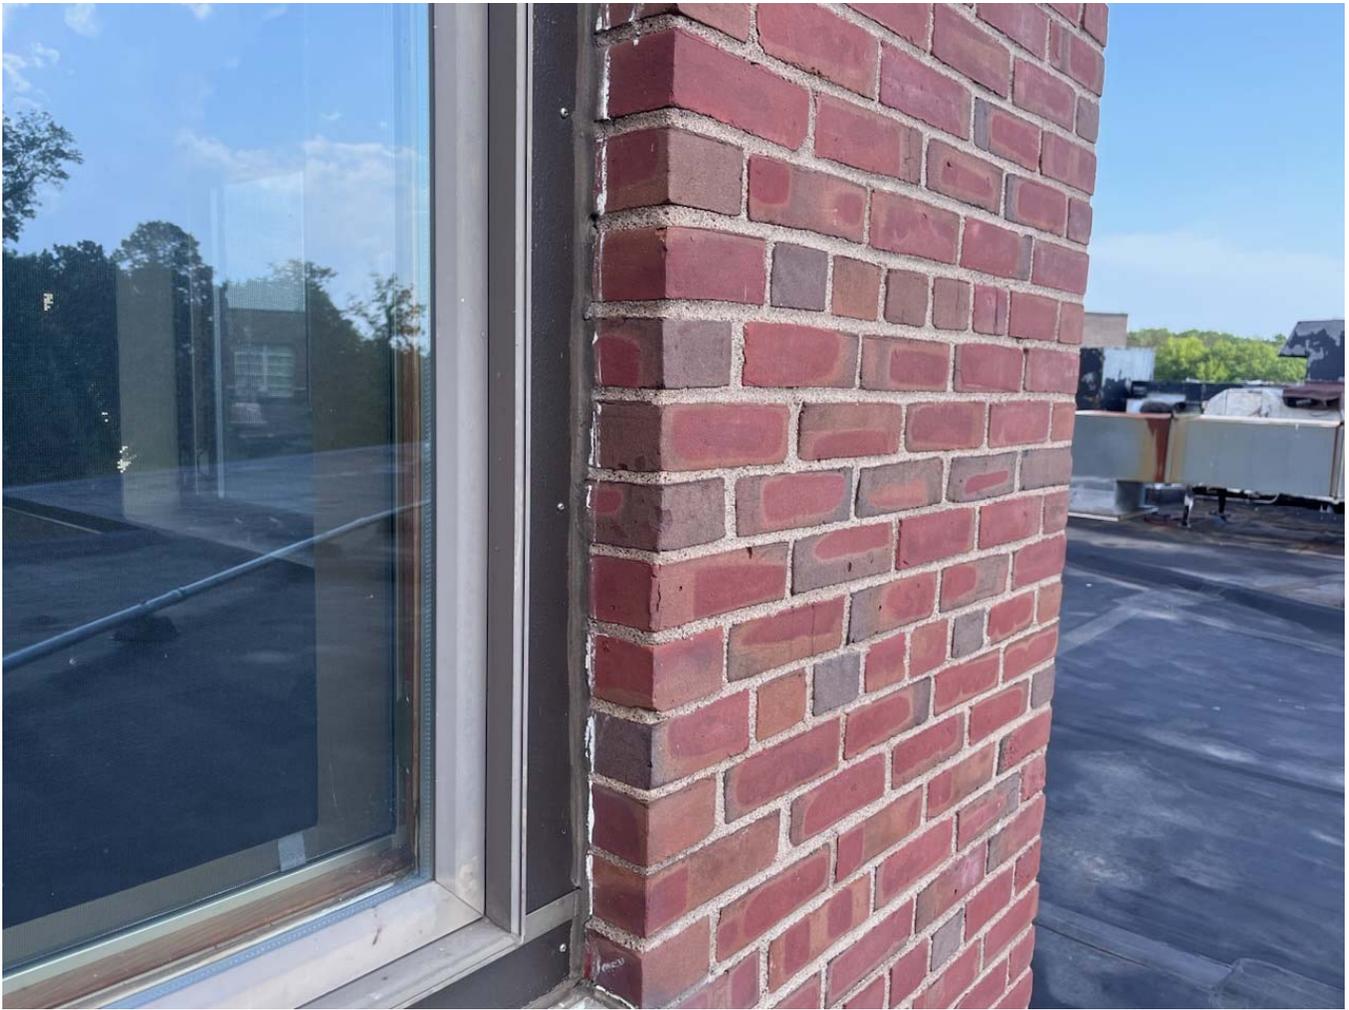
ACM window caulk-typical

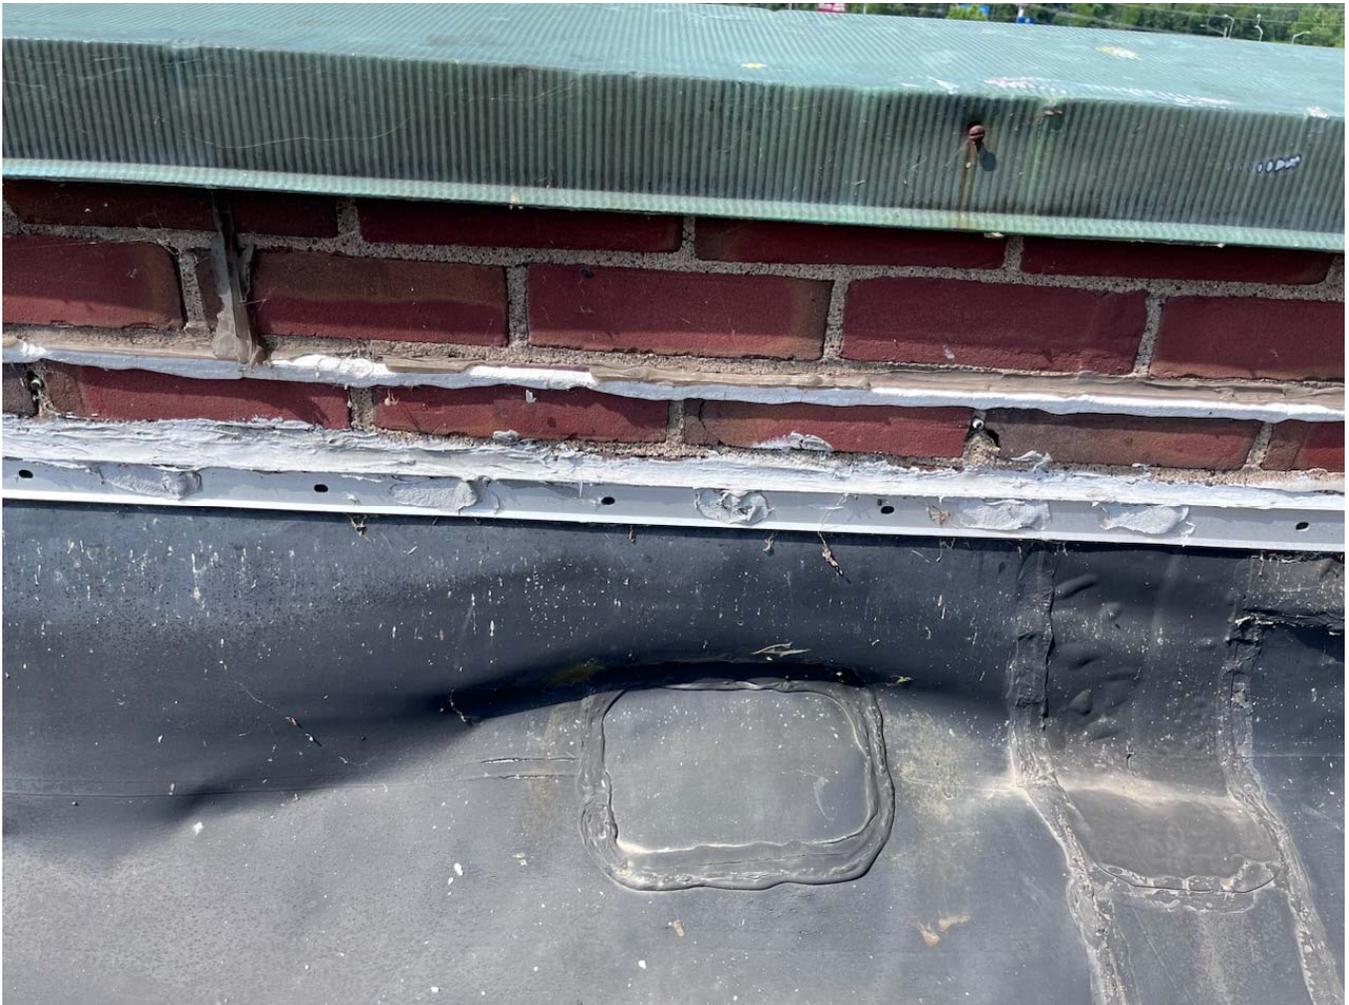
1947 Roof-white caulk around perimeter

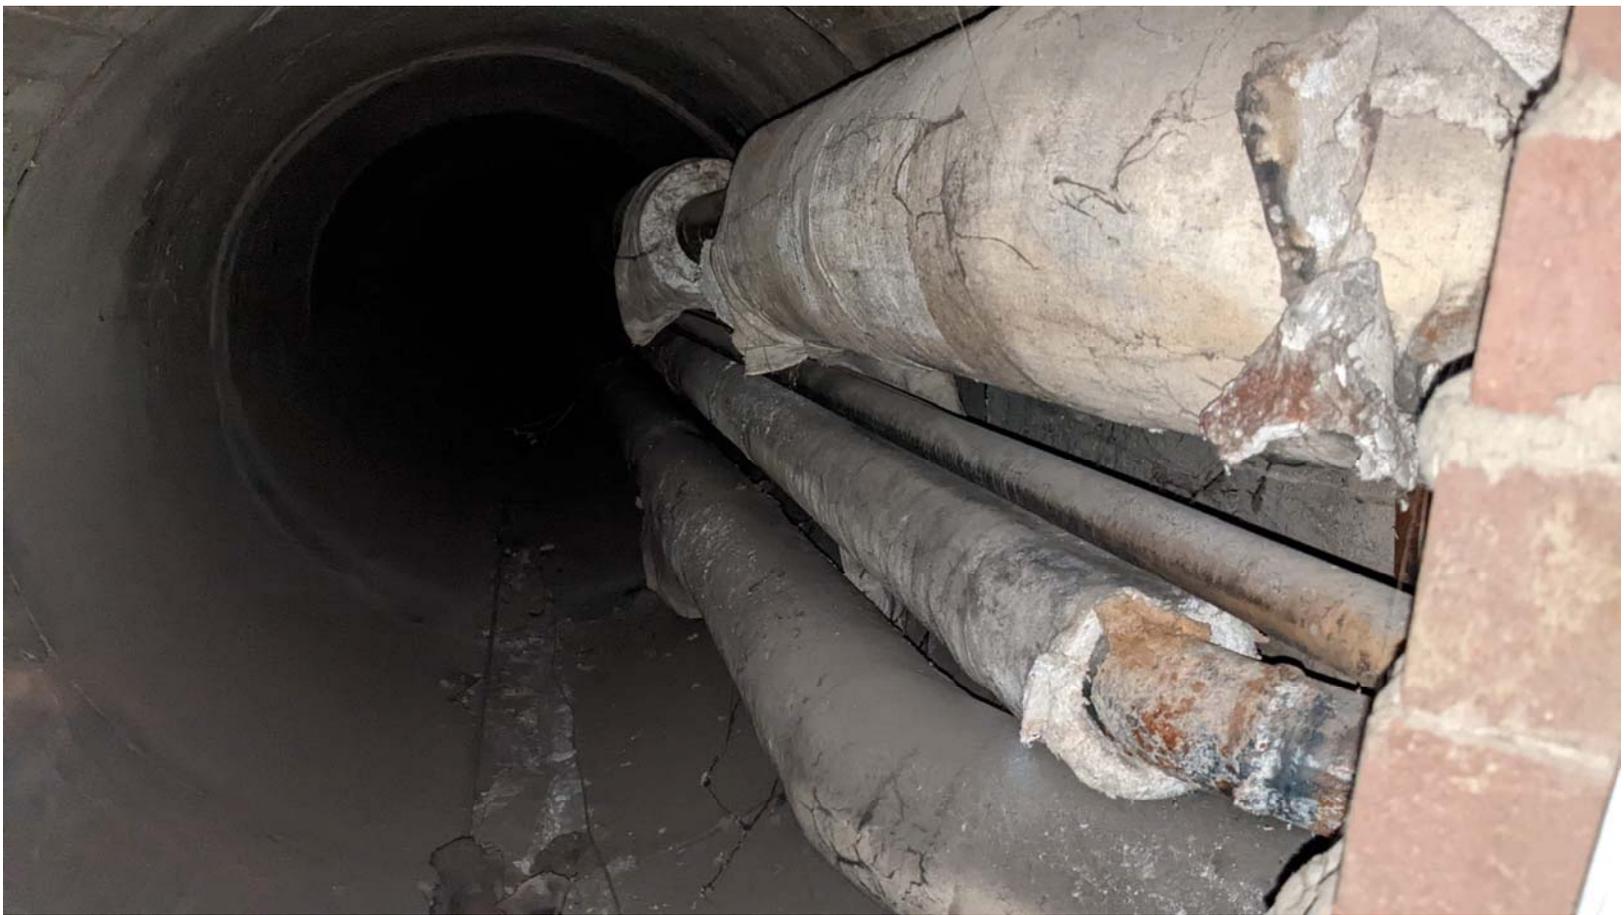
47-83	Pipe Insulation Pipes with ACM insulation connect the boiler out building to the main hospital. There are 3 pipes with Mag insulation that are assumed to run approximately 150' in a tunnel into the 1947 vintage basement.	Tunnels to main building	450 LF	RACM

1947-ACM pipe insulation from boiler building tunnel

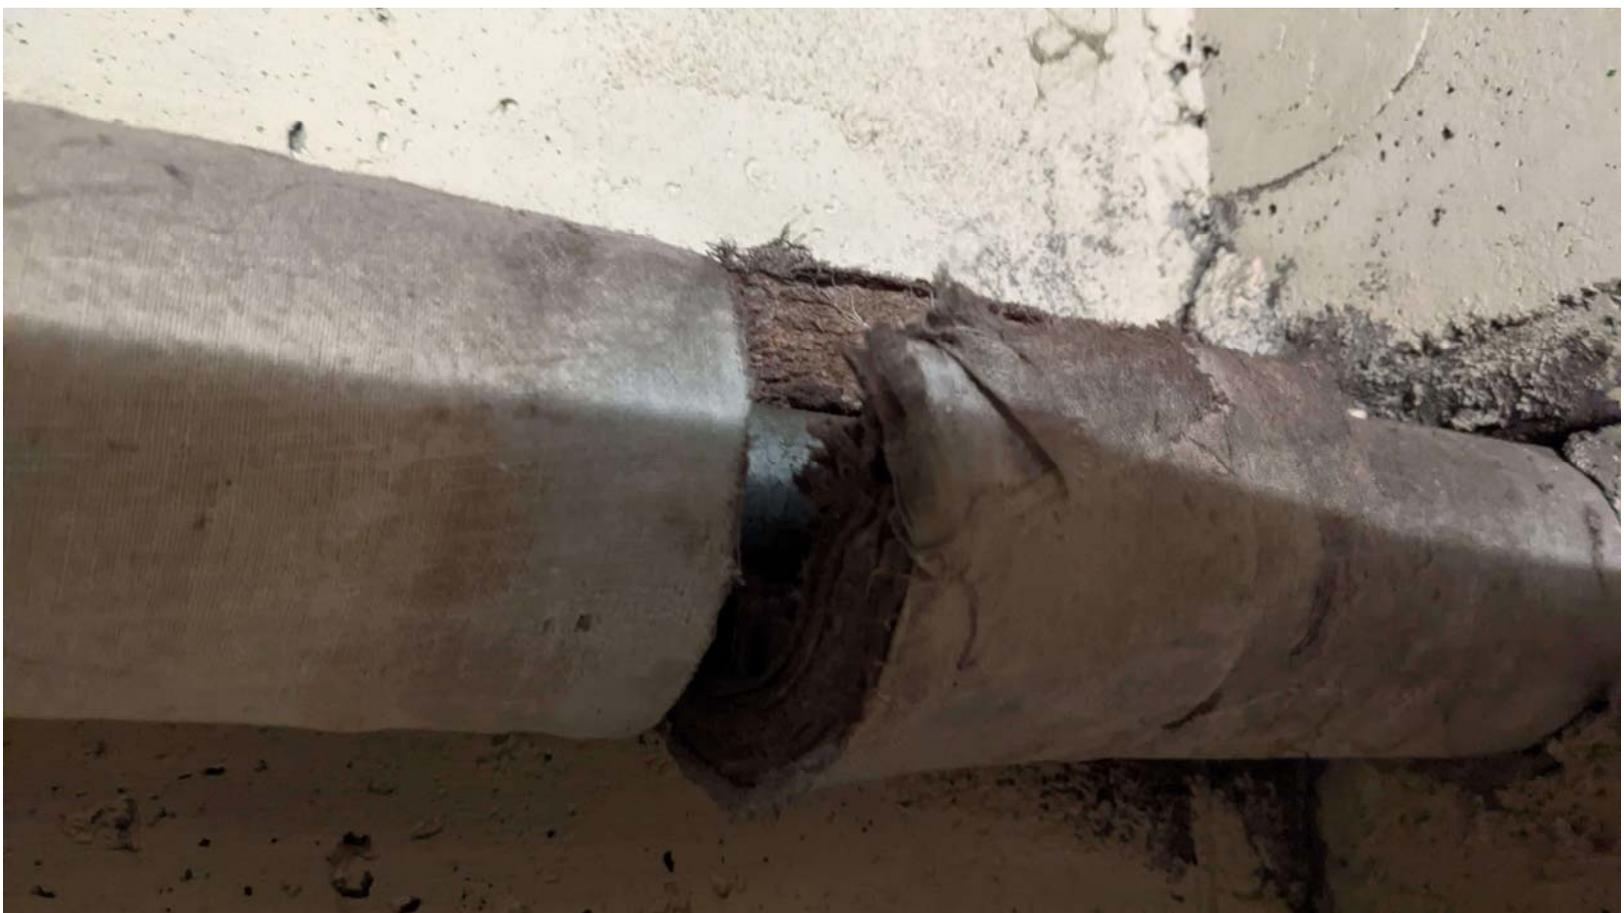
1947-ACM pipe insulation-typical

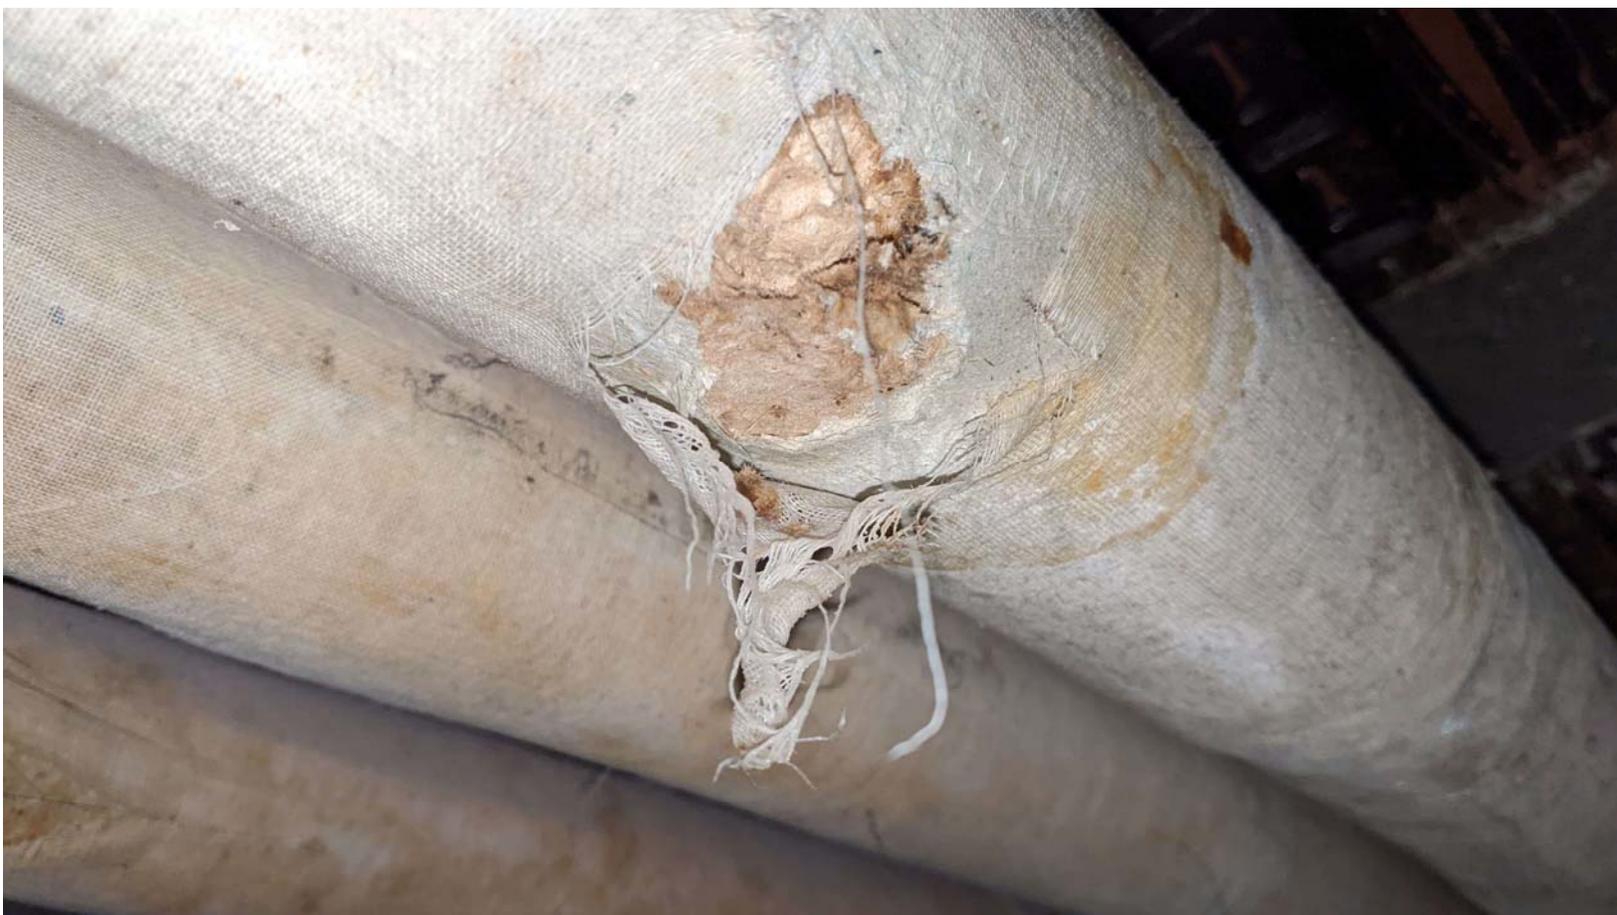
1947-ACM pipe insulation

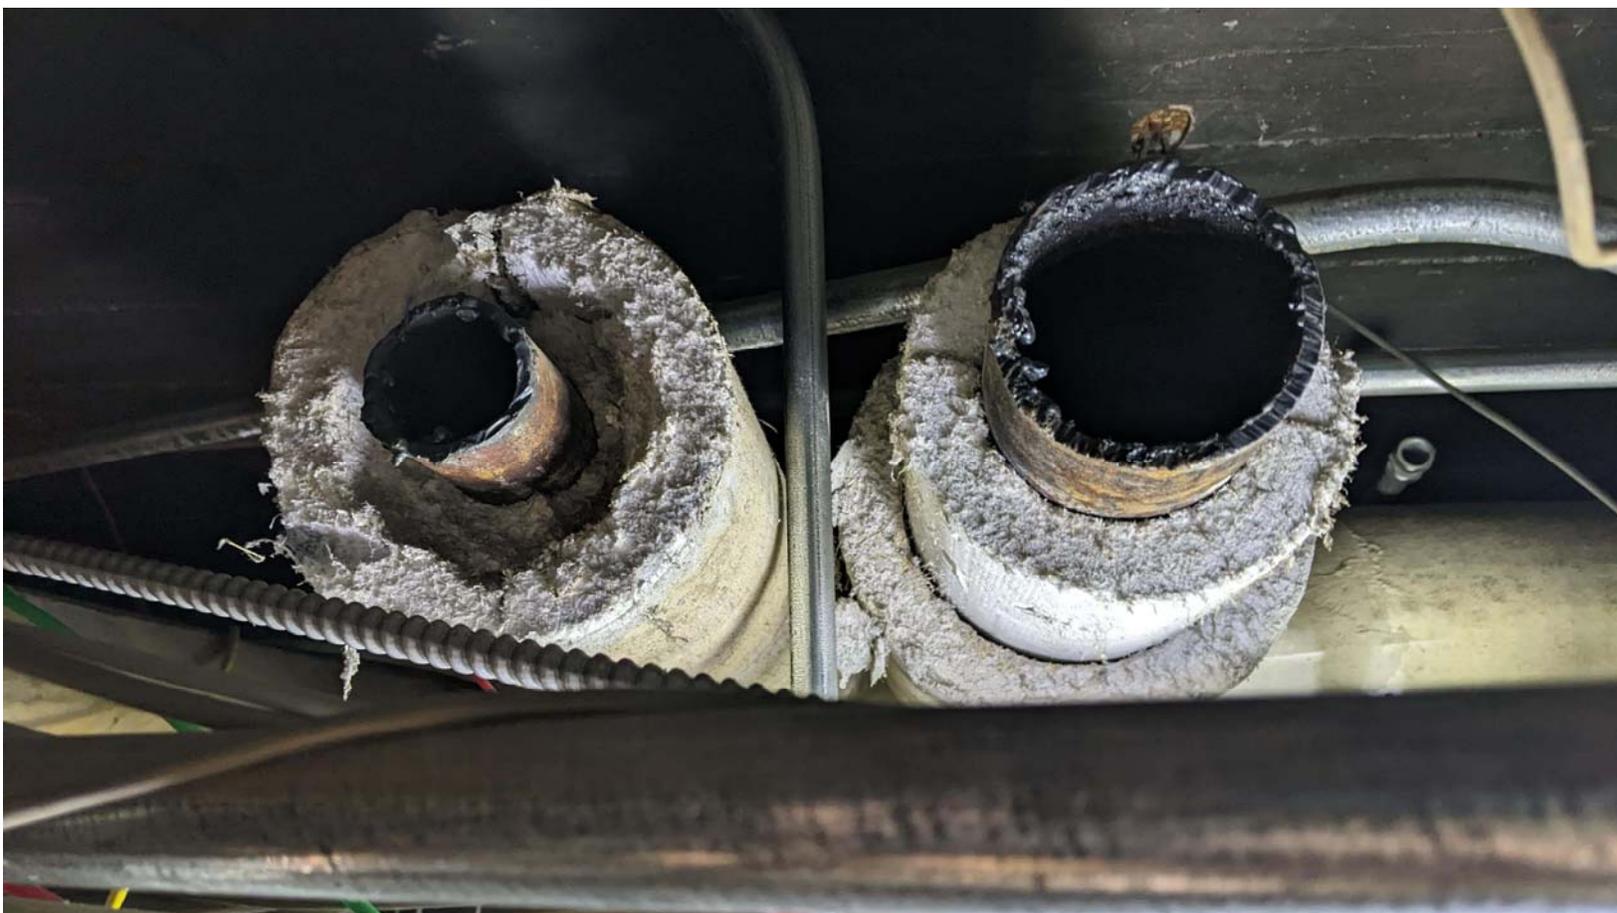
1947-ACM pipe insulation (2)

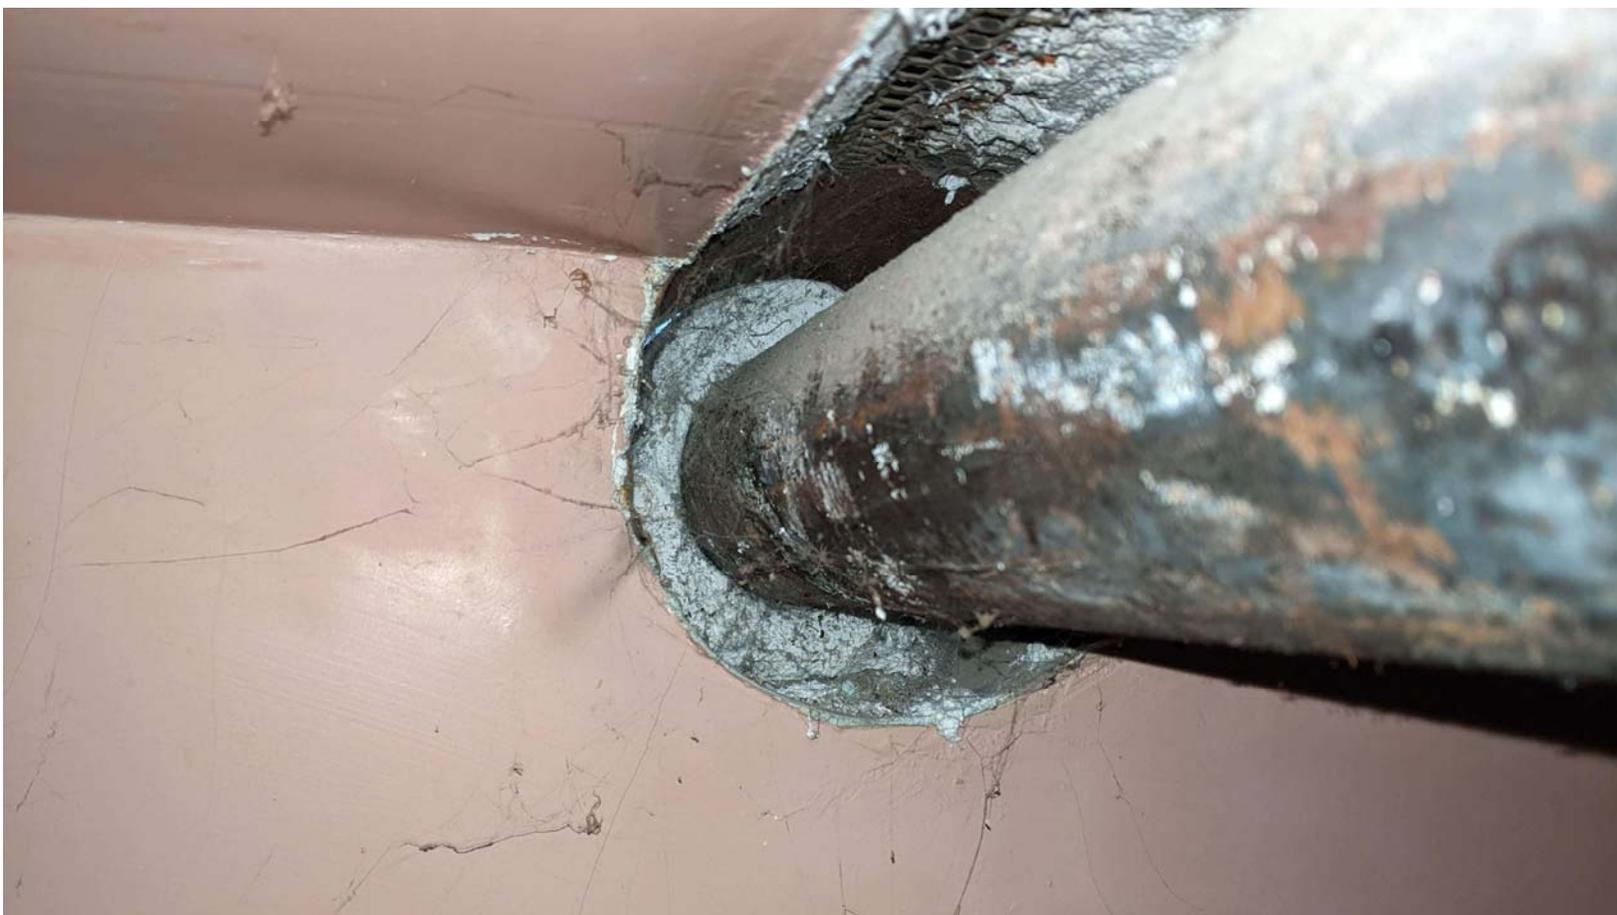
1947-residual ACM pipe insulation left in wall penetrations

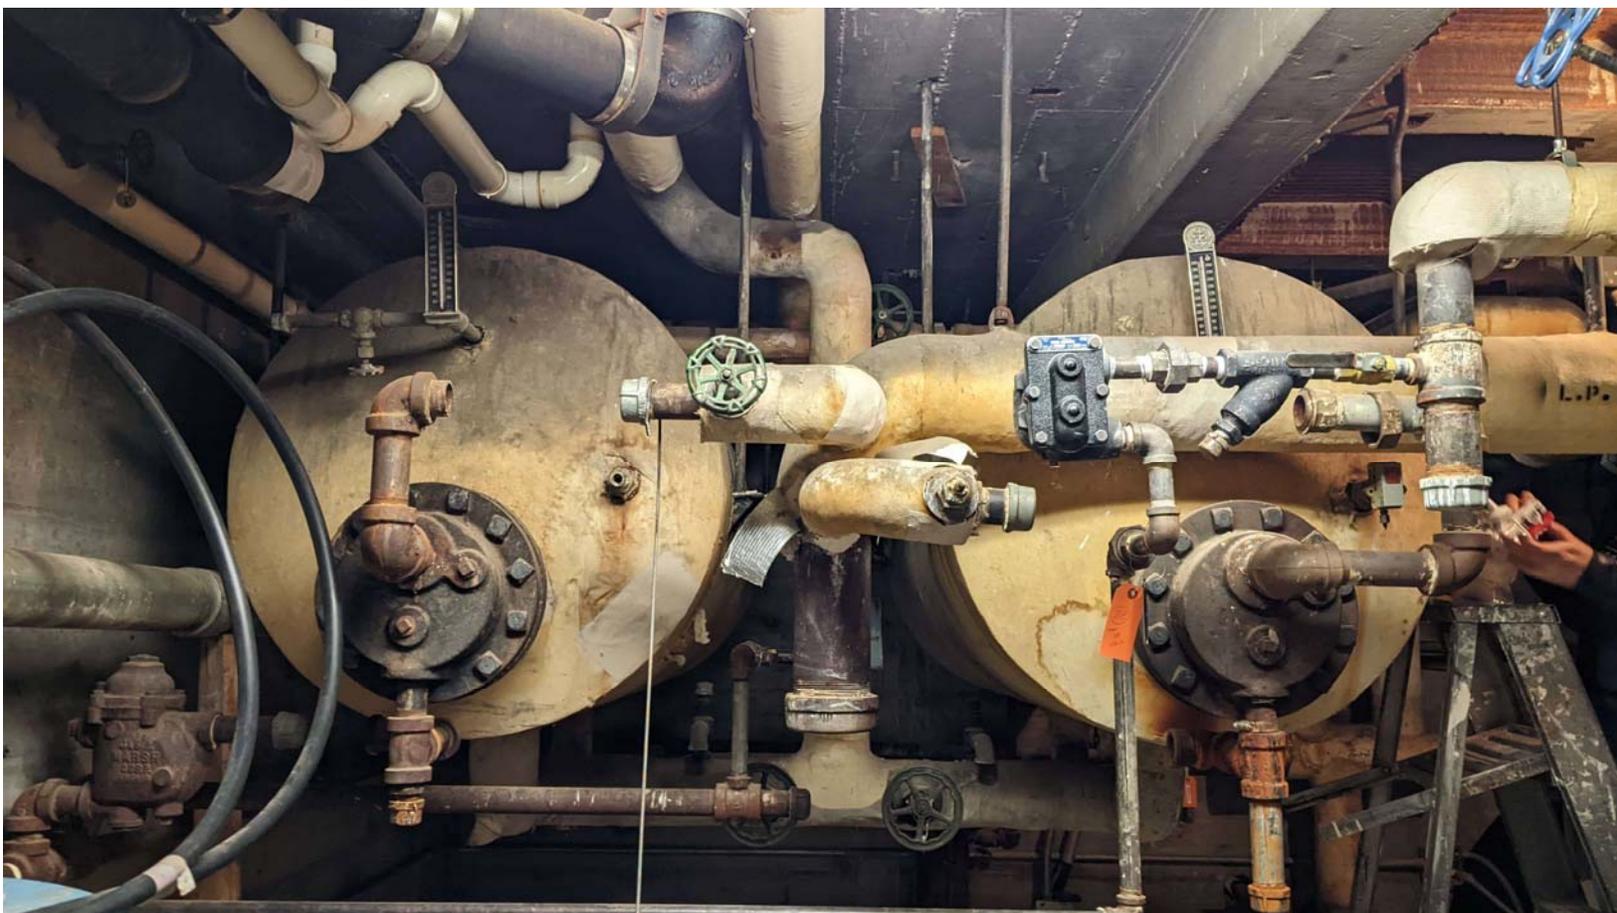
1947-Basement mechanical room- ACM tank insulation and pipe insulation

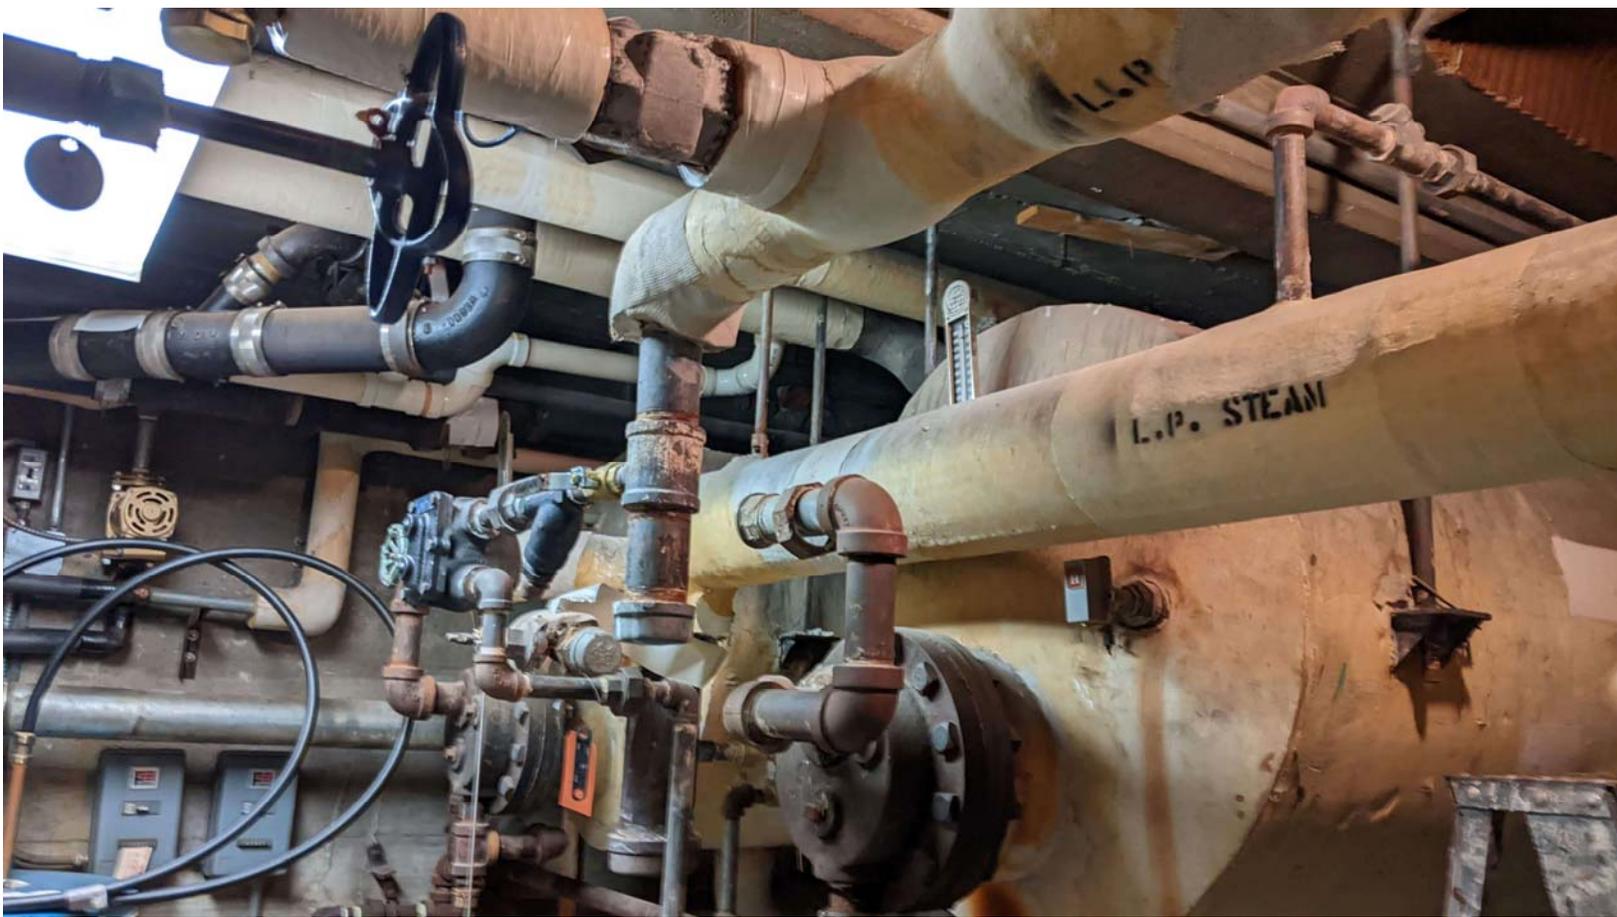
1947-Basement mechanical room- ACM tank insulation and pipe insulation (2)

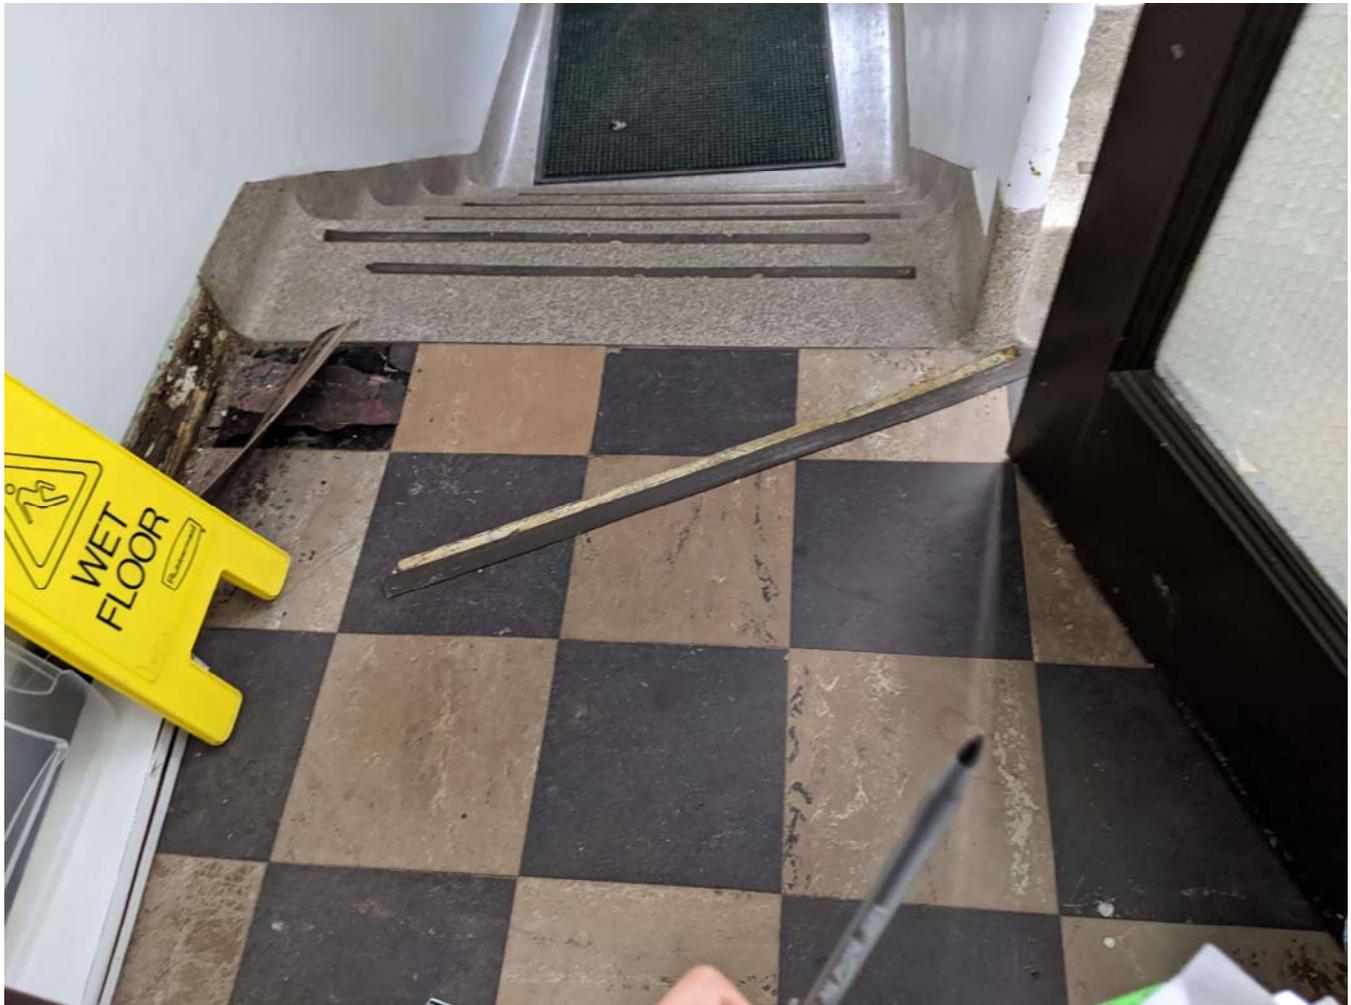
1947-ACM floor tile and mastic-stairs
