Advertisement for Bids – Asbestos Abatement and Building Demolition

RE: Final Report- Pre-Demolition Services
 LEGEND No. 23WI059

This report presents the results of the pre-demolition inspection of the Marshfield Medical Center located at 900 College Avenue W in Ladysmith, WI conducted by LEGEND Technical Services, Inc. (LEGEND) representative Mr. Lucas Sokol, WI Asbestos Inspector #AII-267101 and Katia Castro Lopez, WI Asbestos Inspector #AII-290508 on May 2, 3, 13 and 24; June 7, 29, 2023. LEGEND's services were requested and authorized by Gary Shilts with Rusk County.

900 Colleve Avenue W
Ladysmith, WI 54848
Ground Floor
ACM Diagram

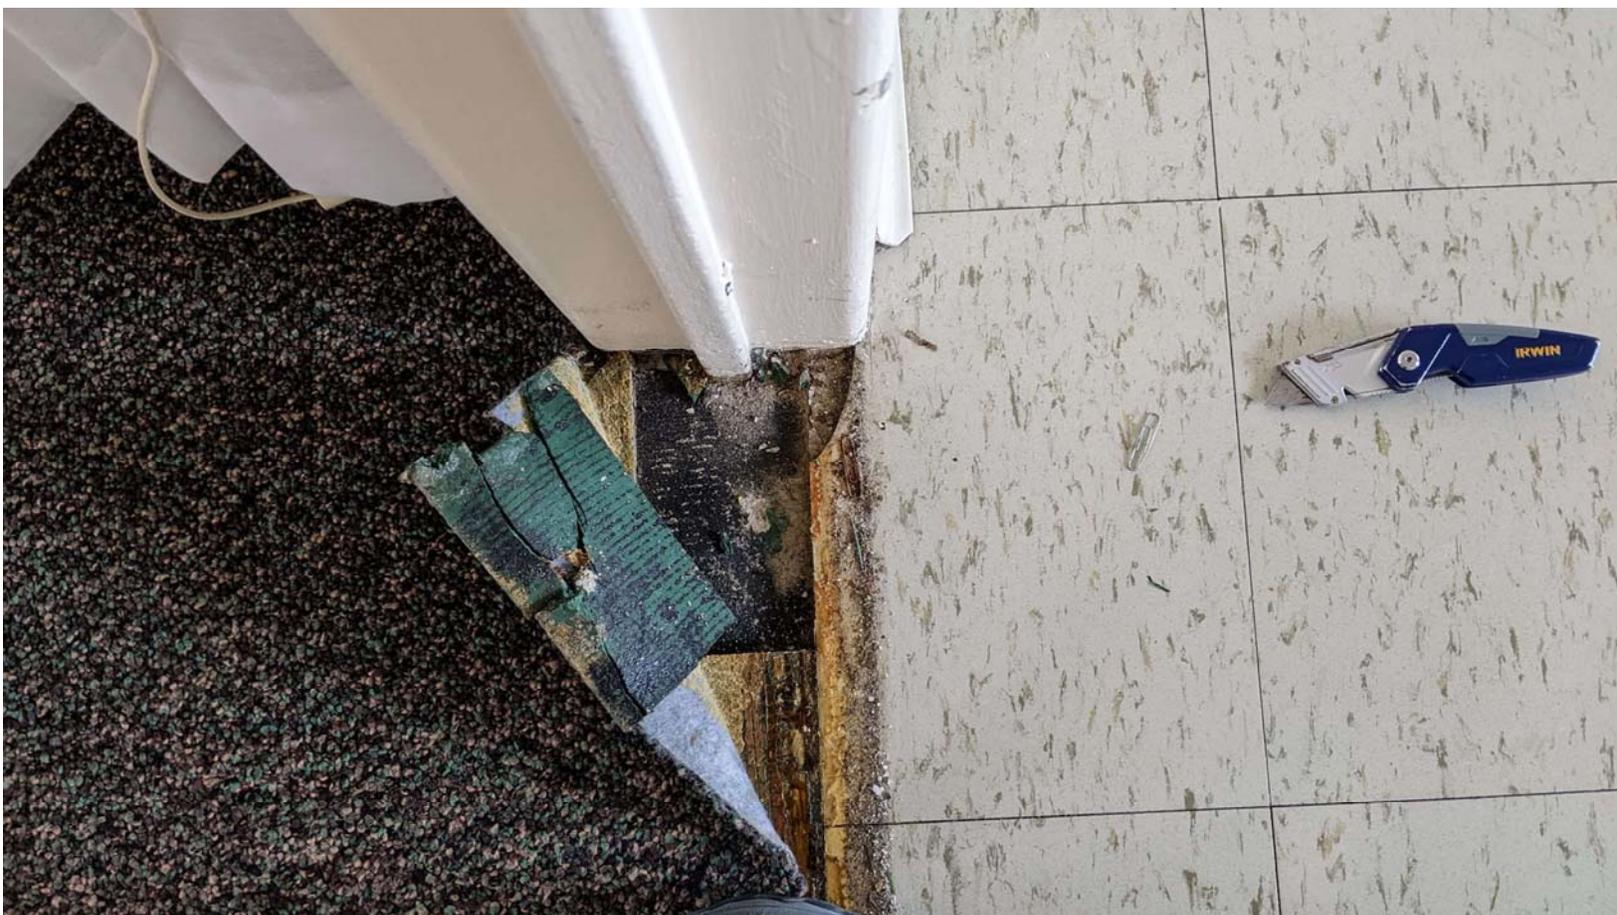
1947-ACM floor tile and mastic-typical throughout

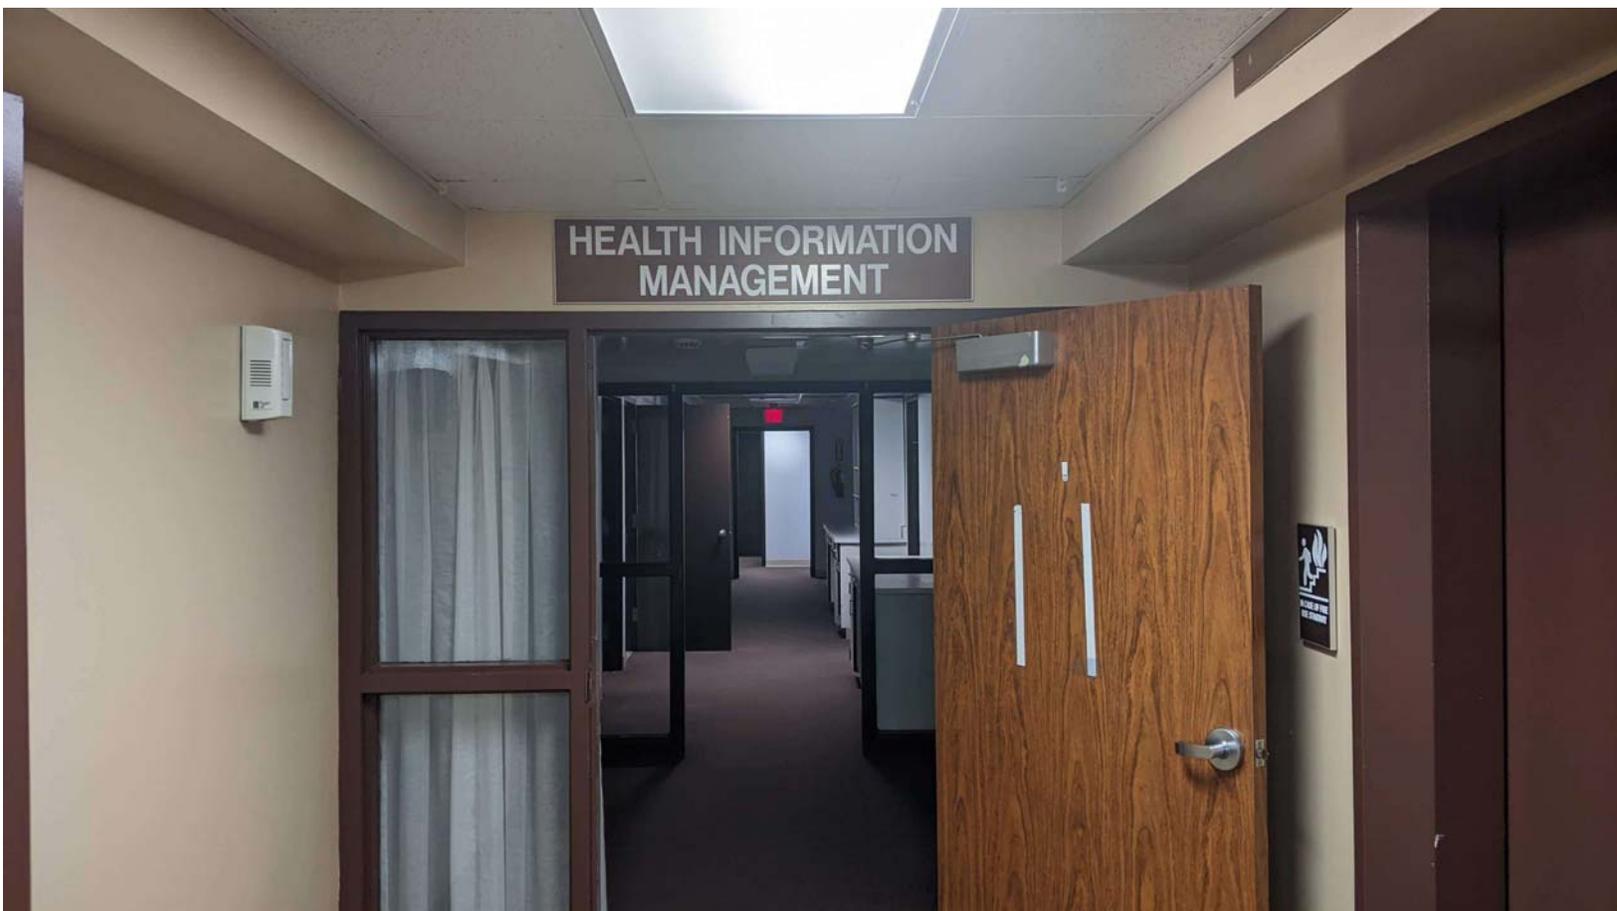
1947-ACM window glaze in hallways

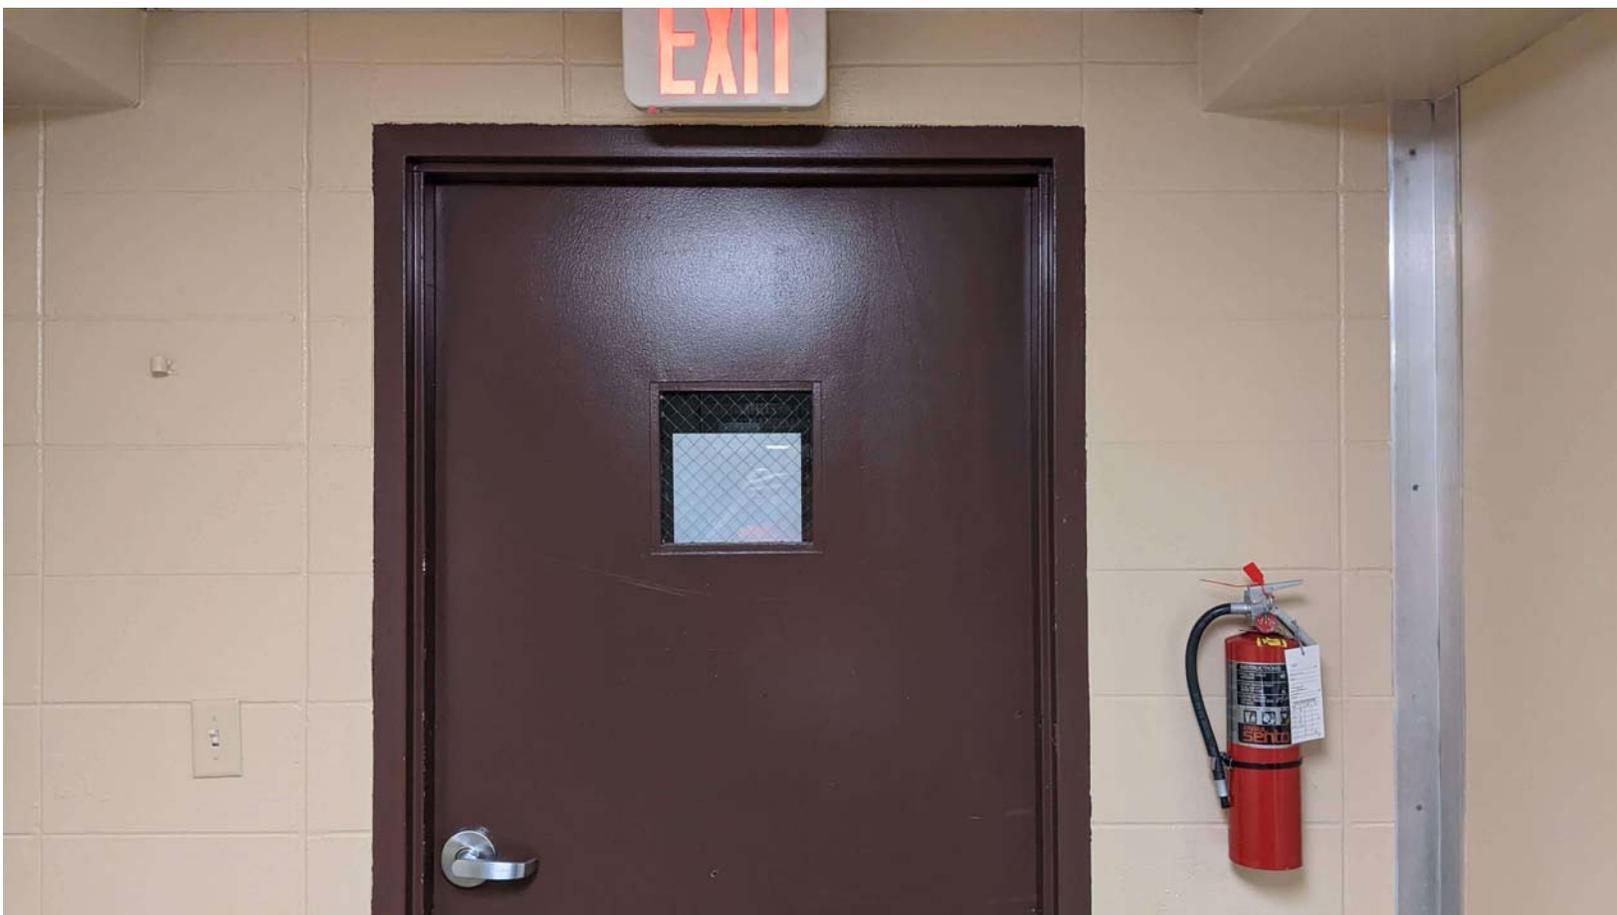
1947-ACM door glaze on fire door-typical

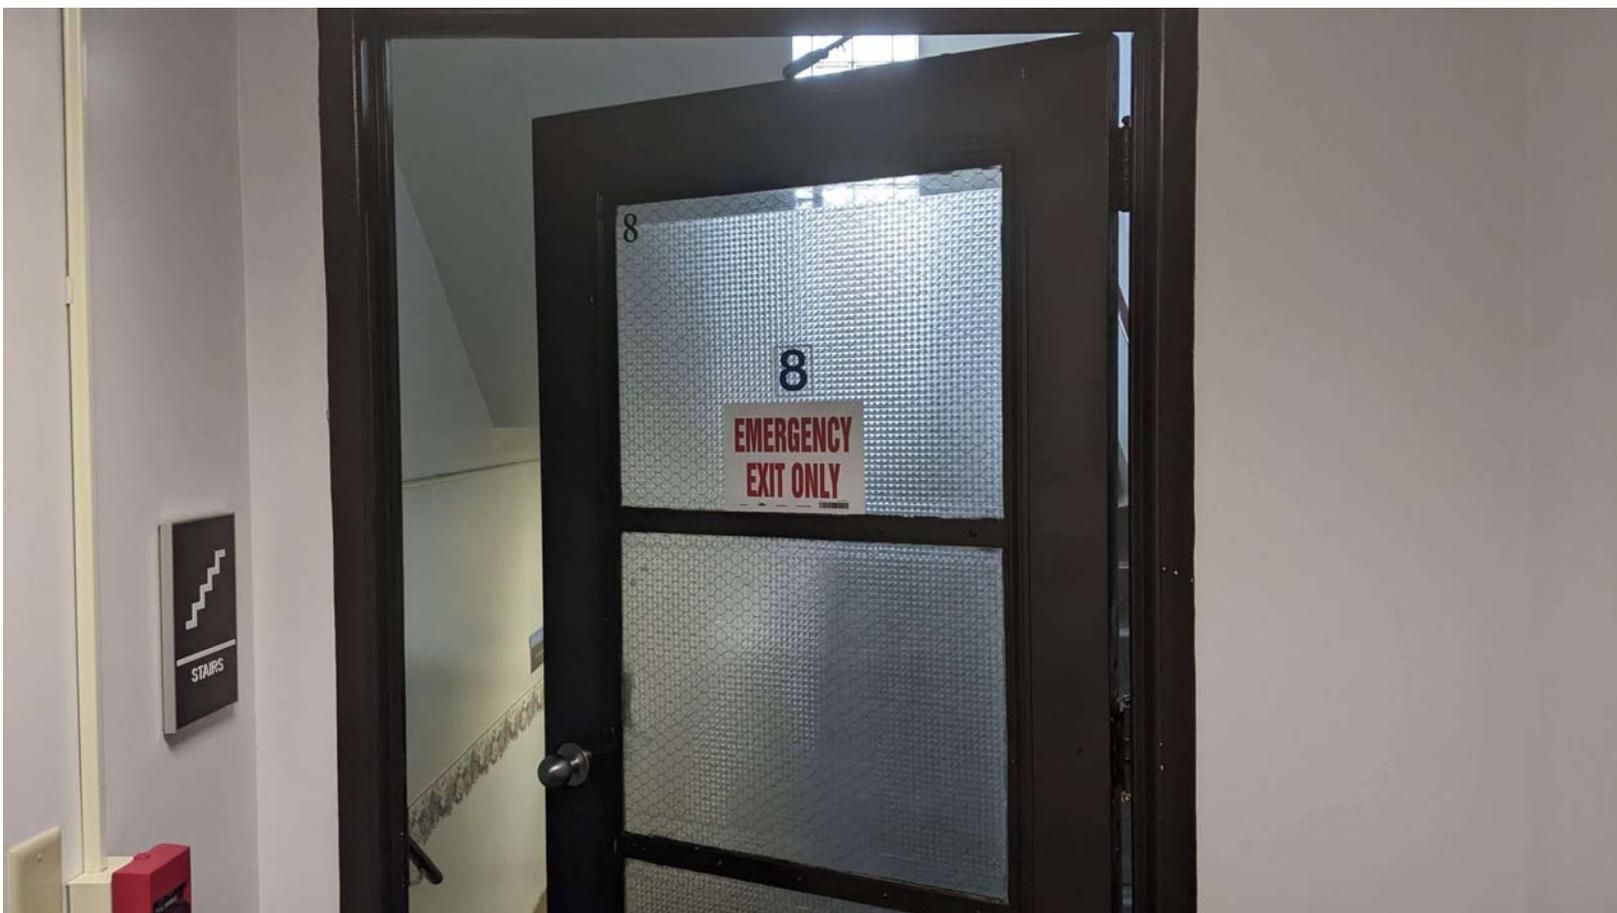
1947-ACM door glaze on stairwell door-typical

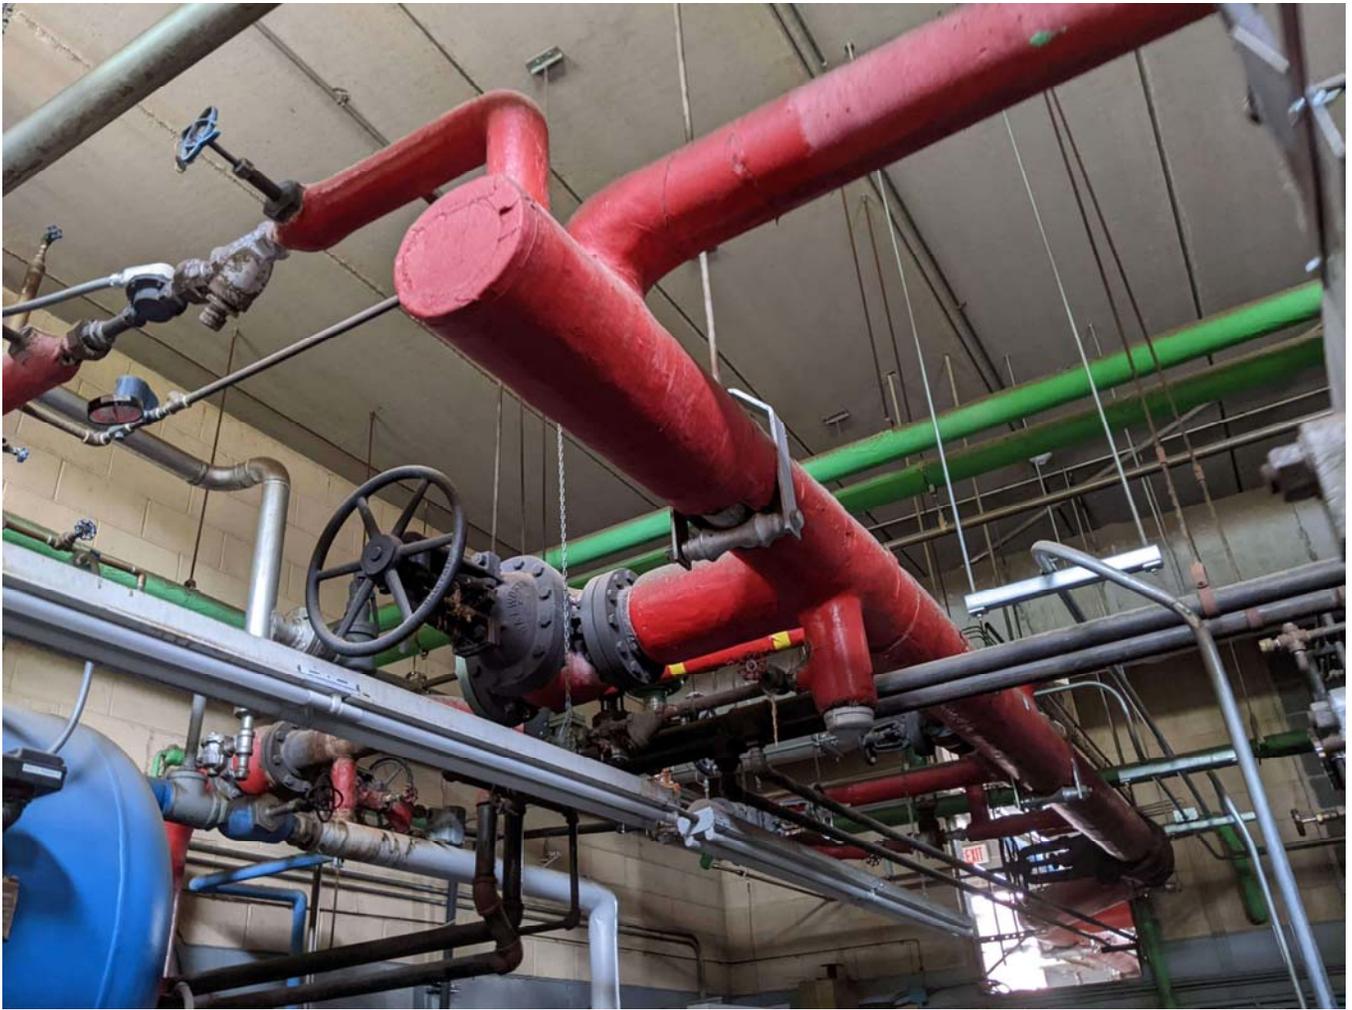
Boiler Building-ACM pipe insulation-typical

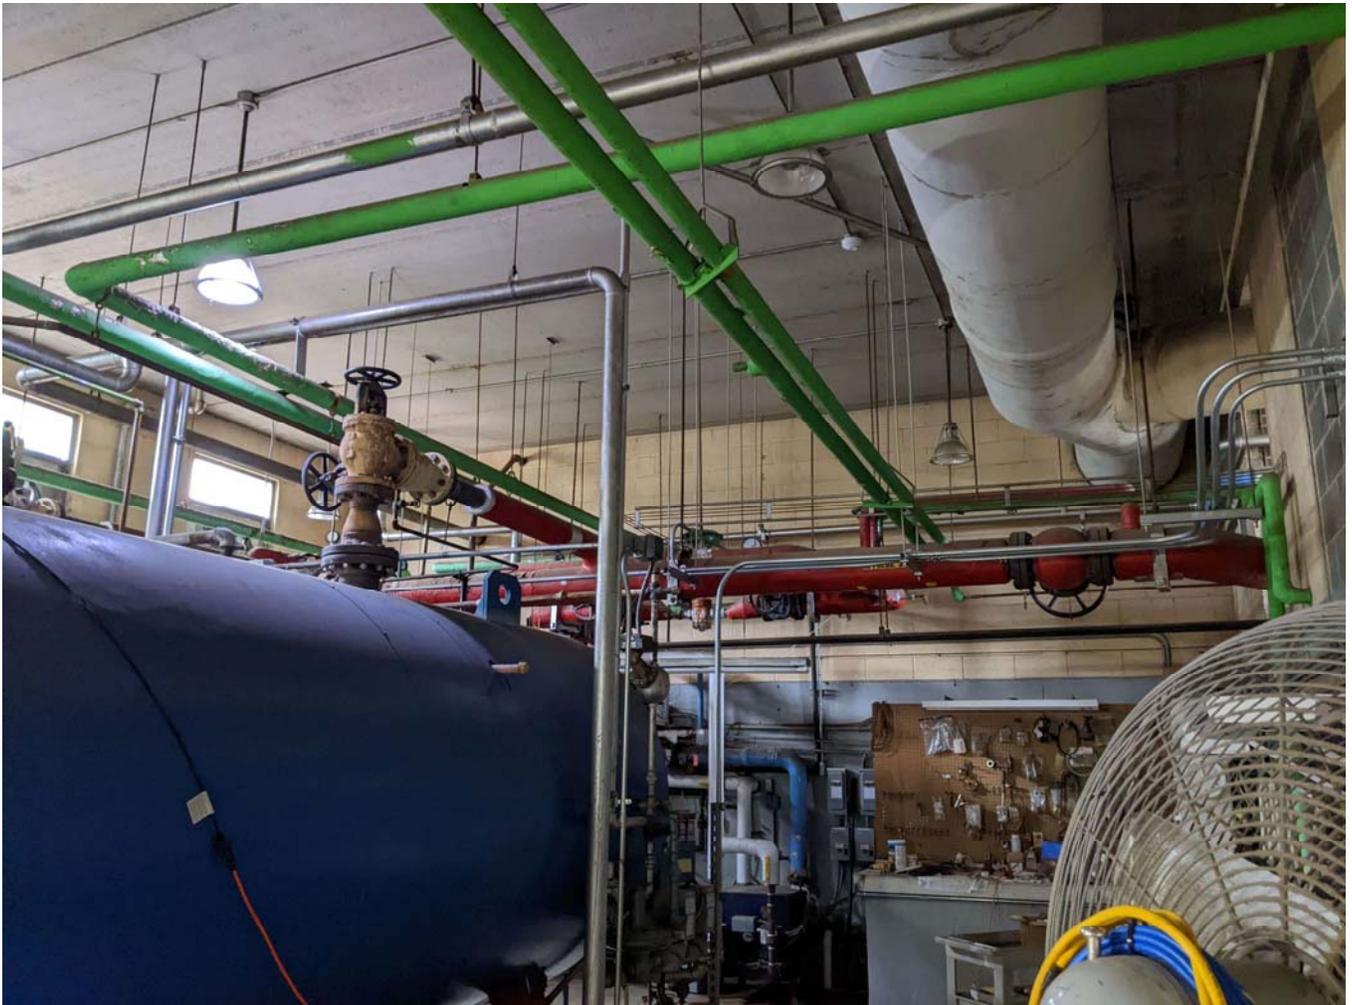
Boiler Building-Boiler breach and pipe insulation-typical

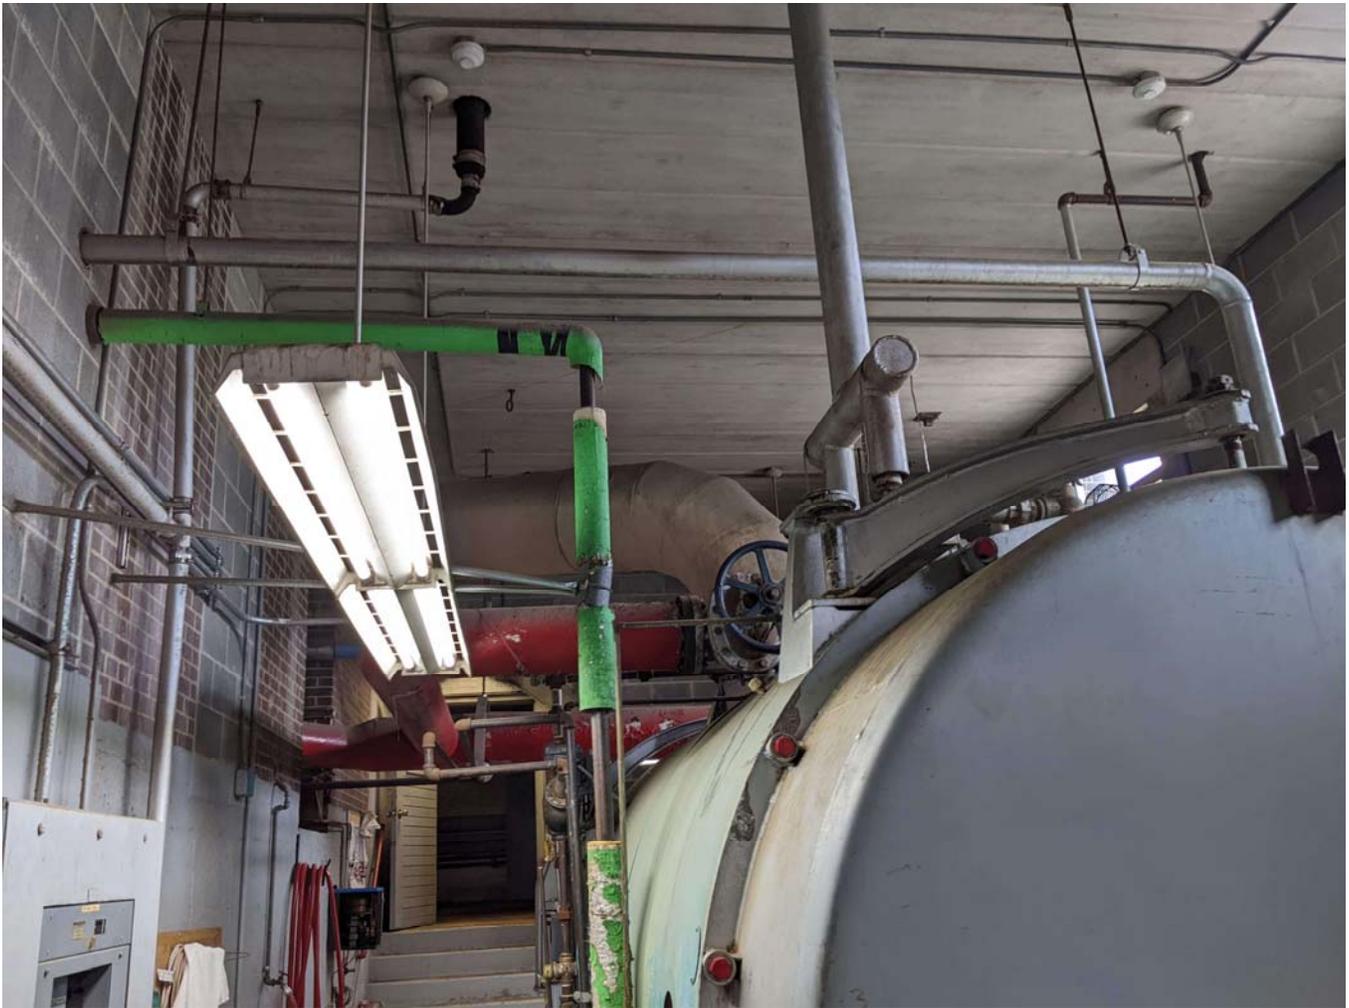
Boiler building-ACM boiler breach

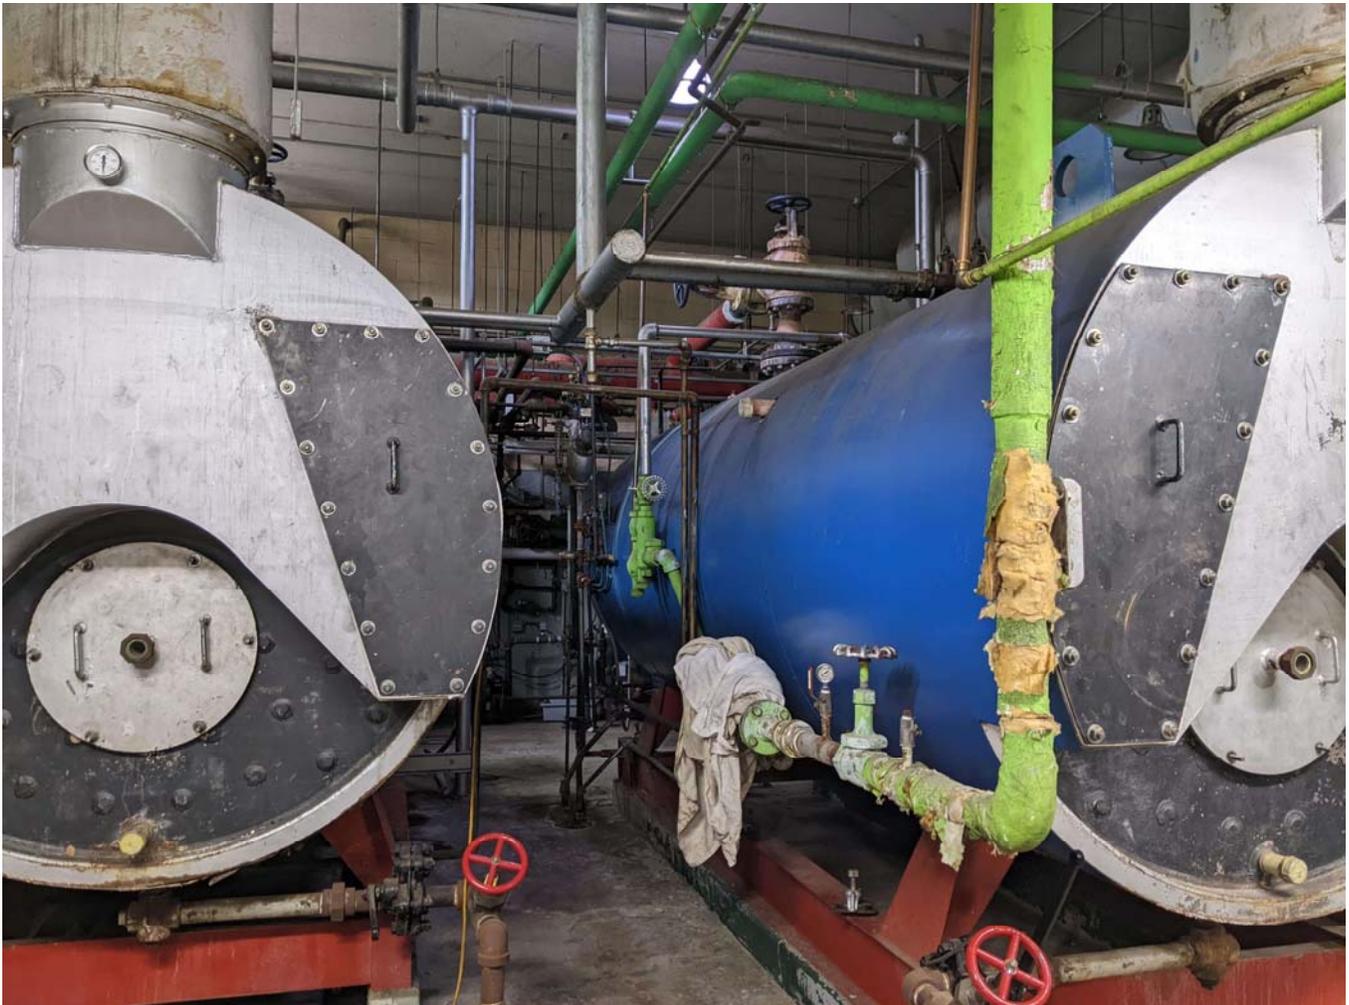
Boiler building-ACM boiler insulation

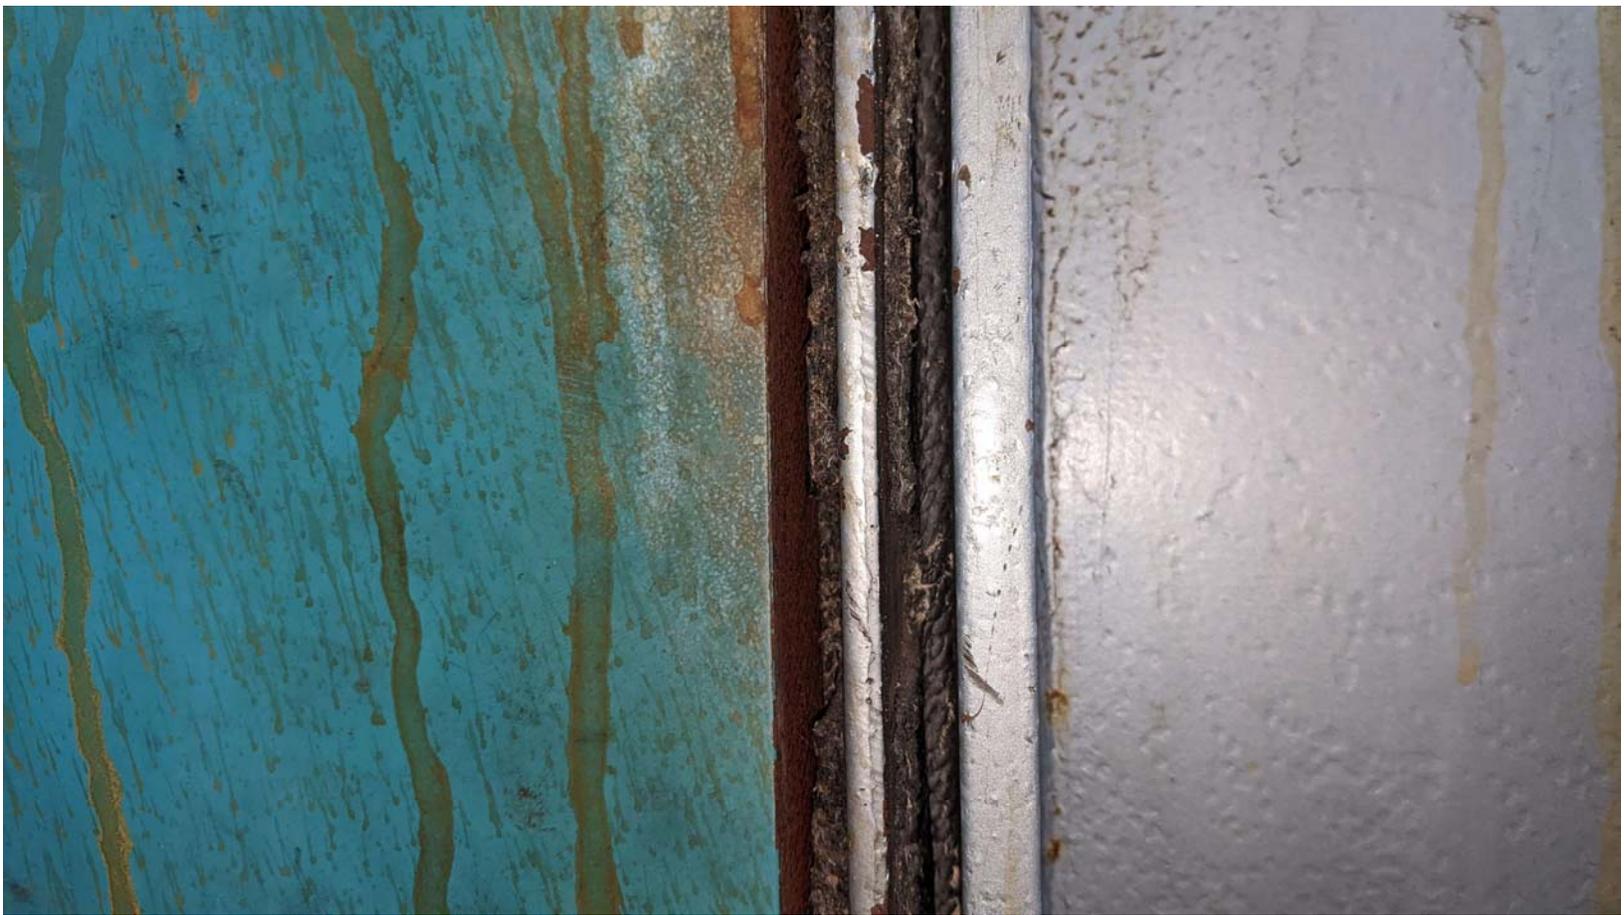
Boiler building-ACM boiler gaskets-typical

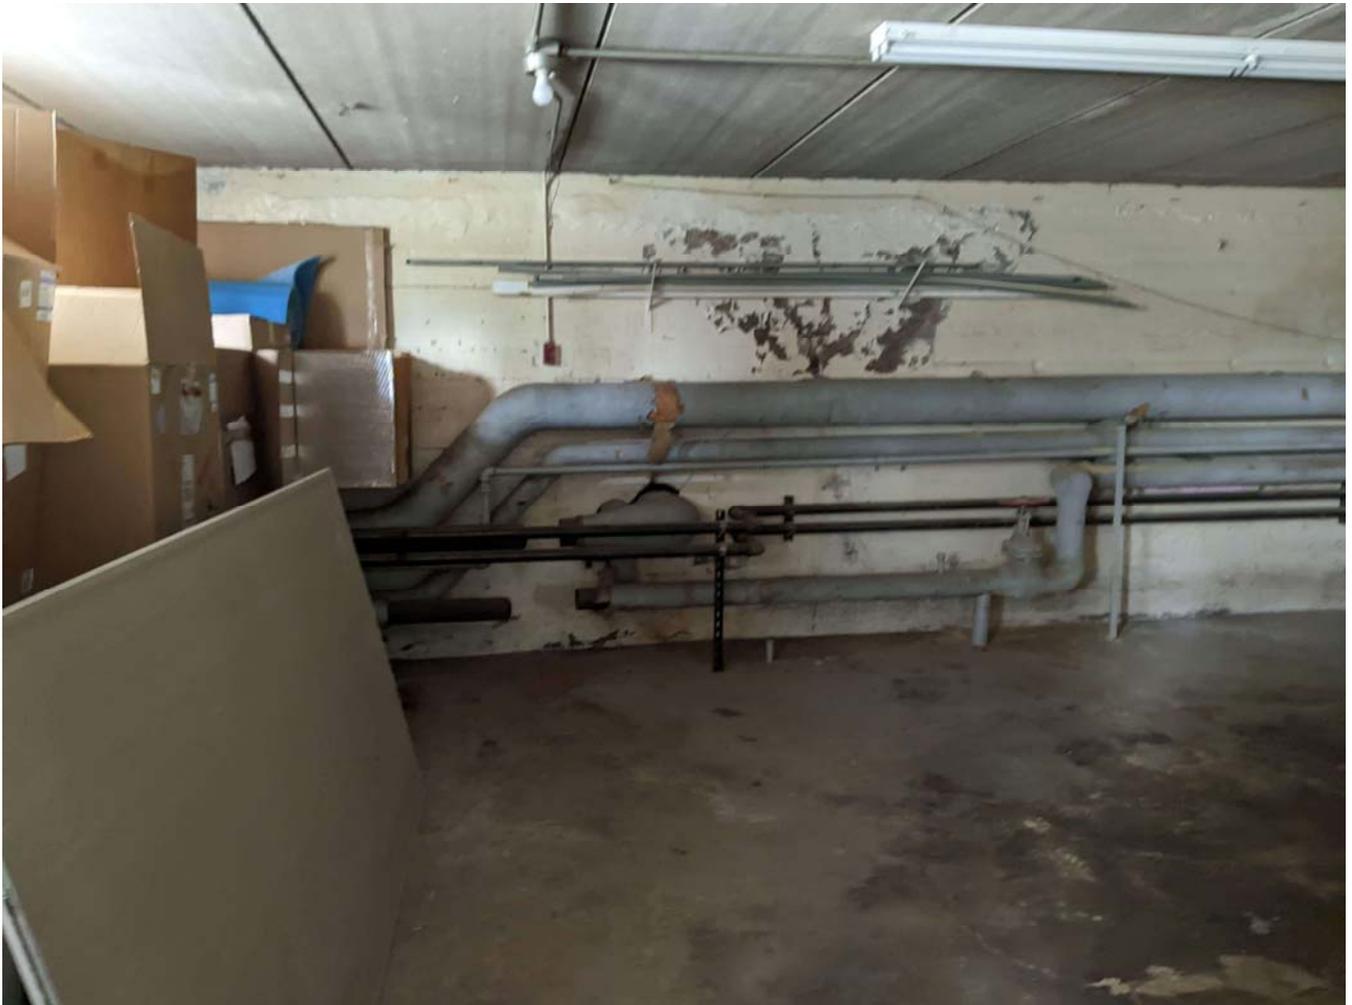
Boiler building-ACM pipe insulation

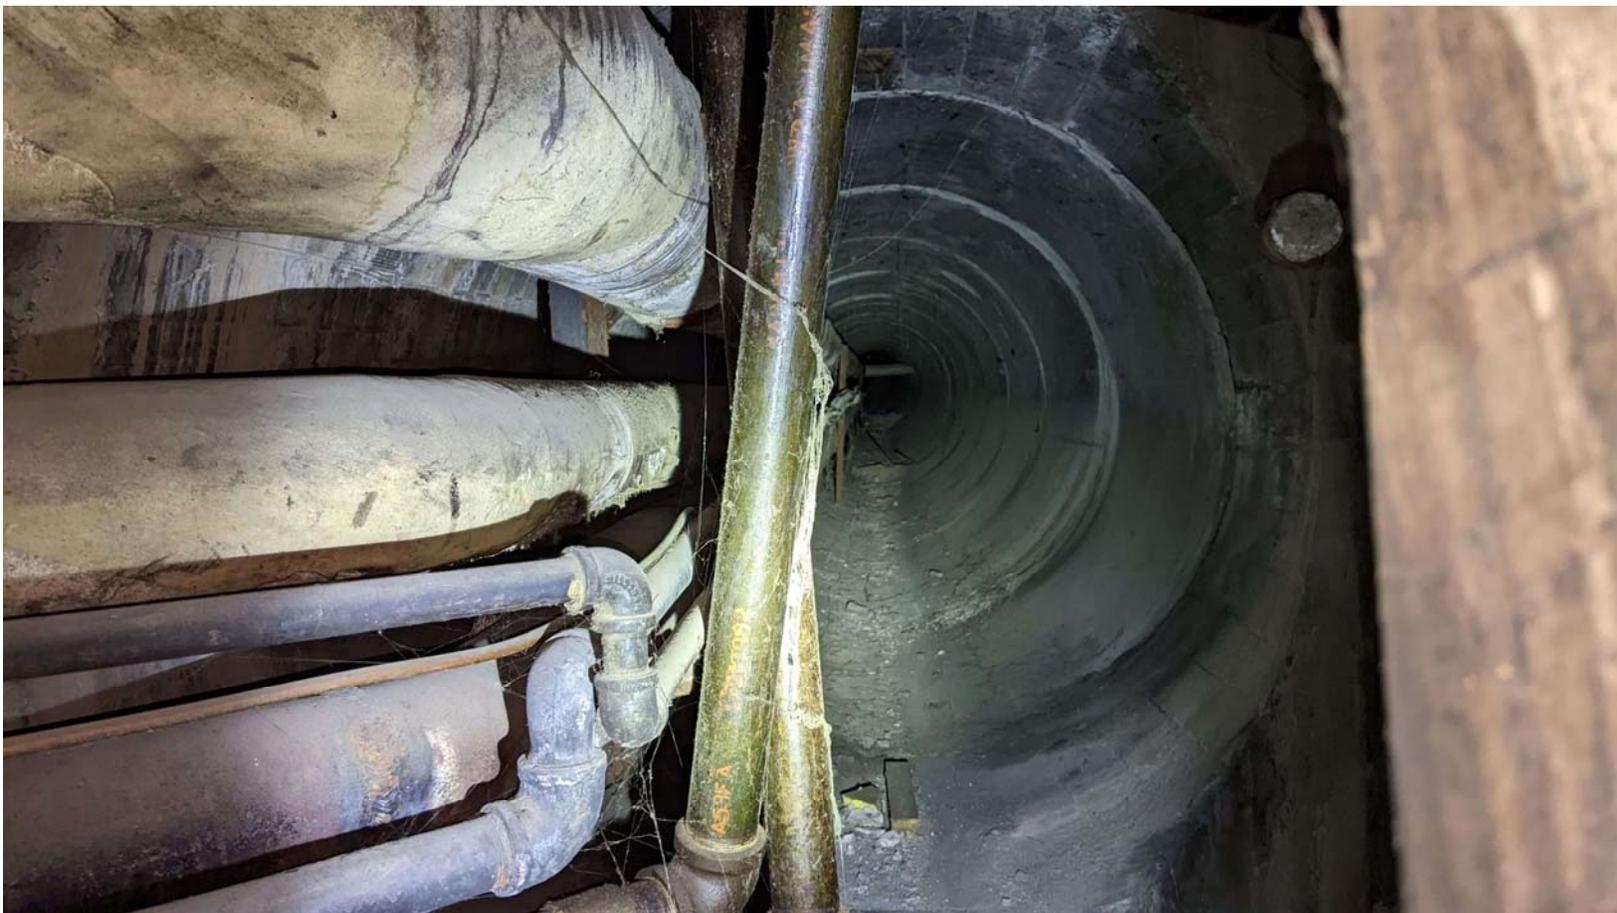
Boiler Building-ACM pipe insulation in tunnel

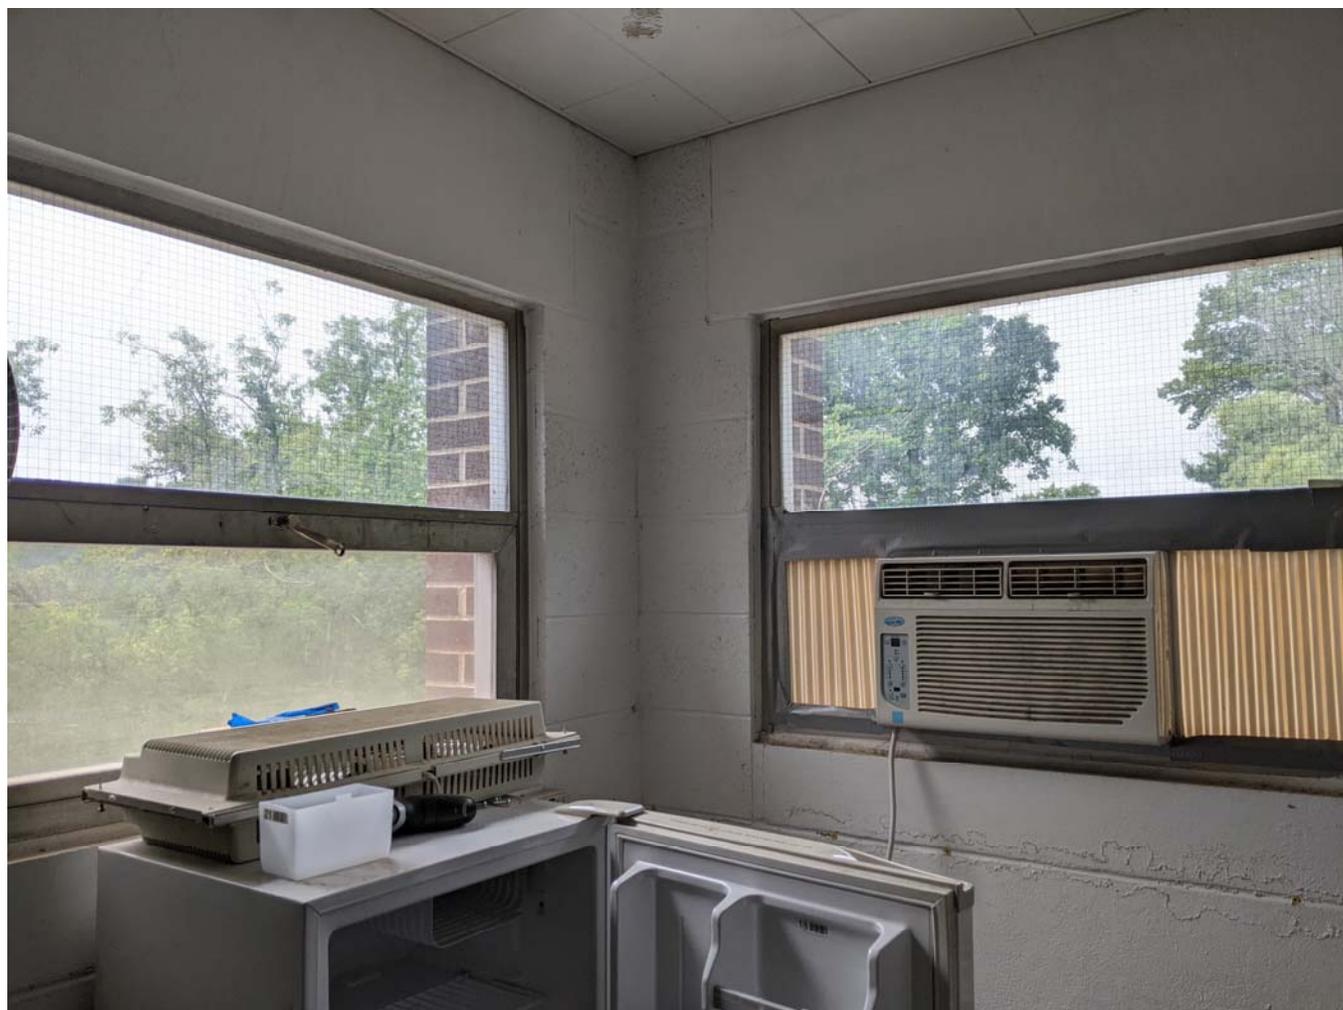
Boiler building-ACM window glaze-typical

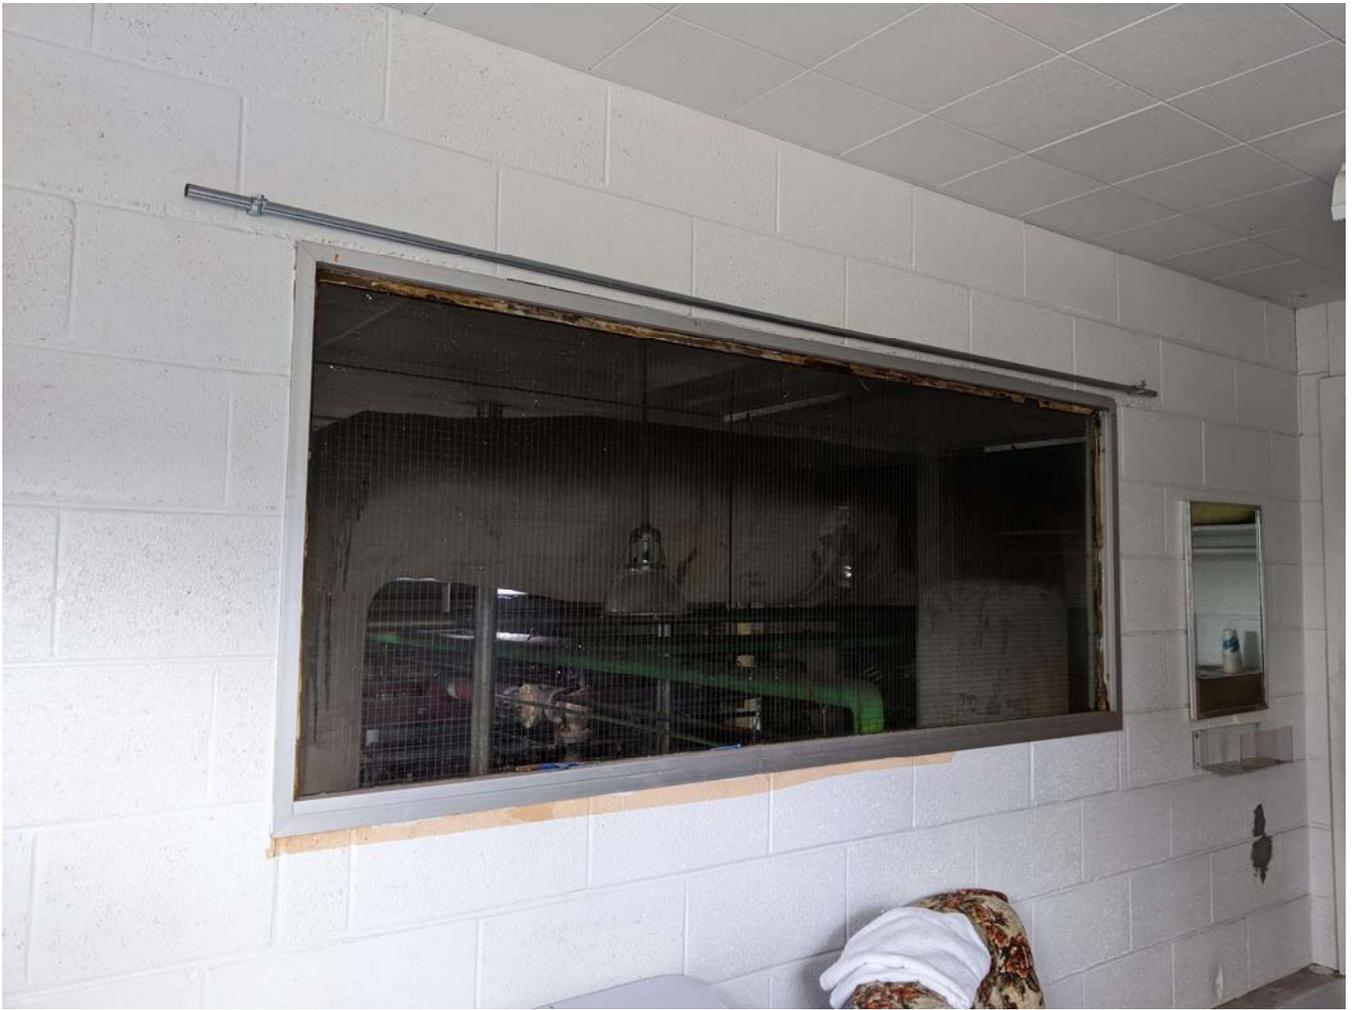
Boiler building-ACM window glaze-typical (2)

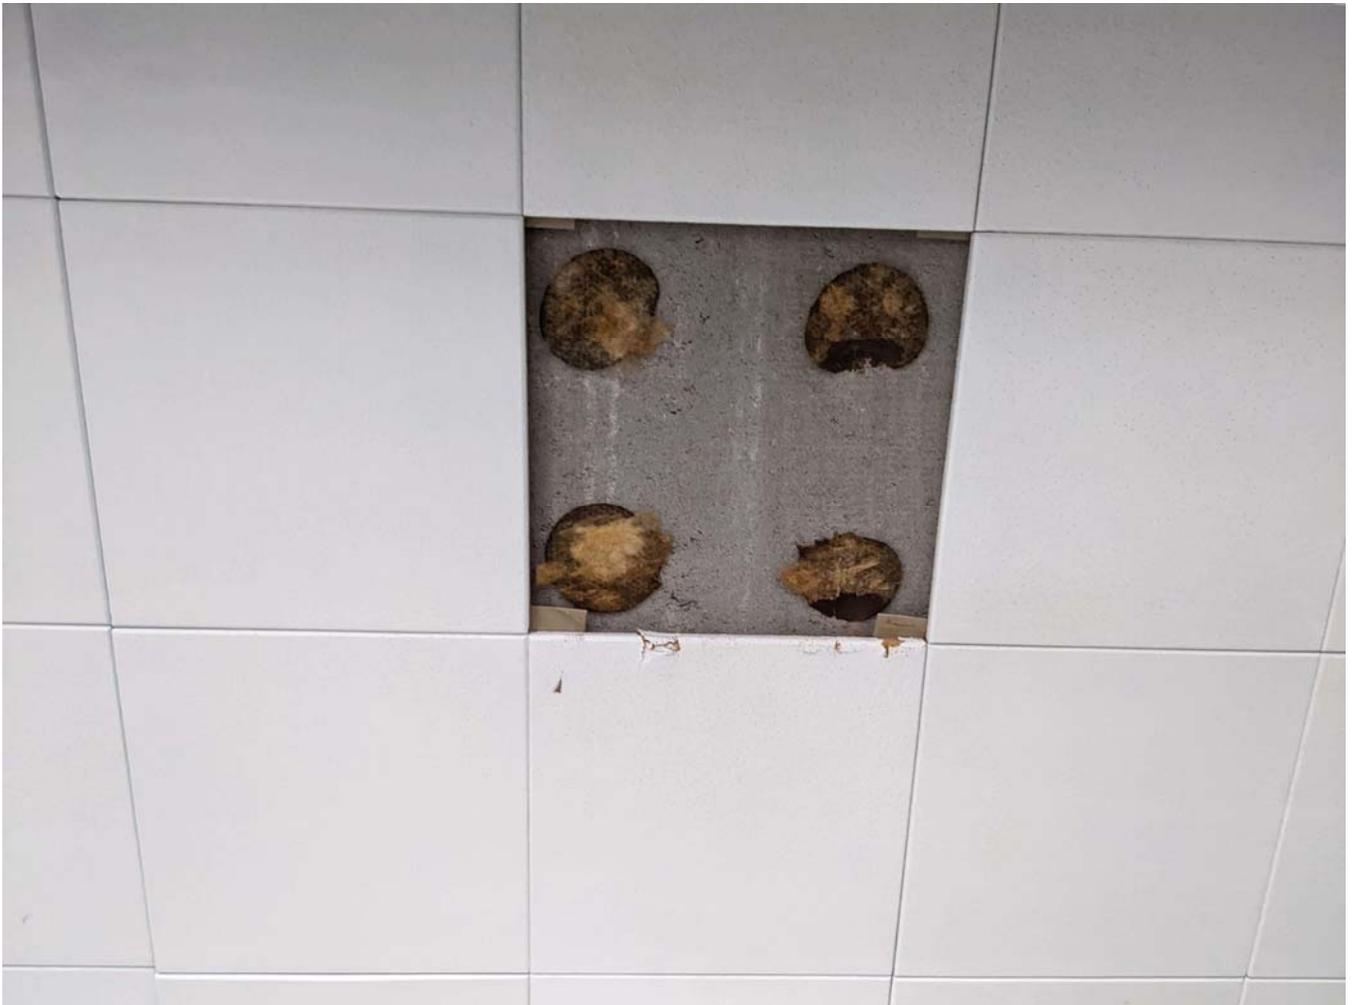
Boiler Building-ACM glue pucks for ceiling tile-upper bedroom
