James Madison Park Shelter

Building Condition Assessment & Study

Date: October 21, 2013

RE: **James Madison Park Shelter
Mechanical/Electrical Evaluation and Condition Report**

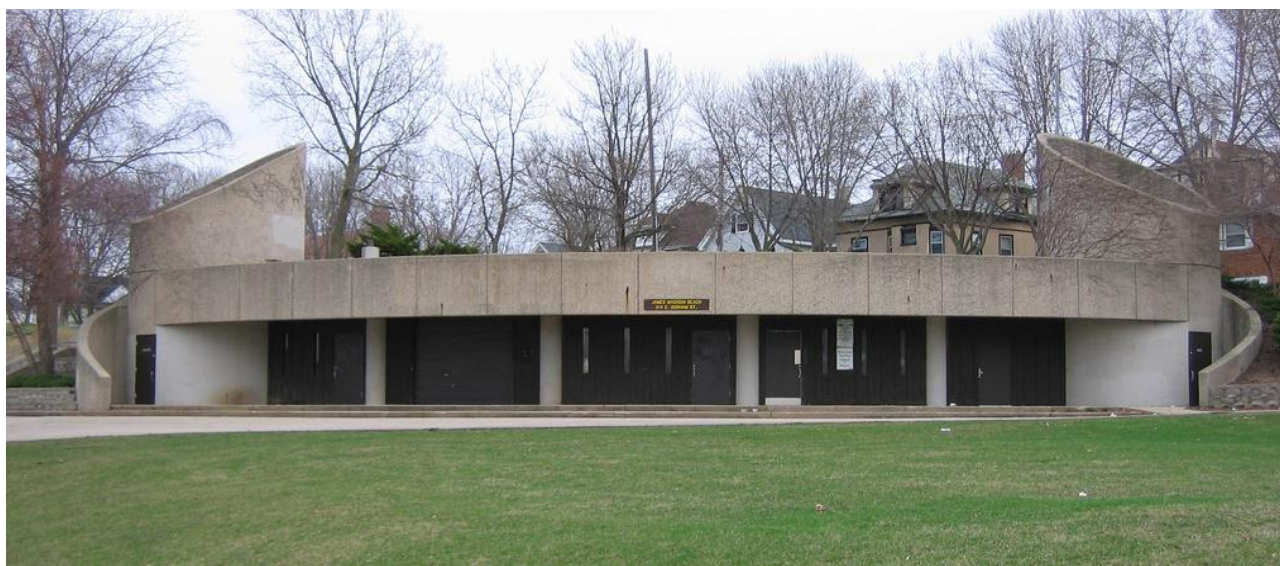
Shelter Front

Lakeside: The park shelter has excellent lake presence and potential views of Lake Mendota; the downside of the shelter orientation is how the building is nestled into the land with limited visibility from the street. This orientation makes it difficult for the community to be aware of this amenity. The concrete patio is limited in depth and abruptly ends at the asphalt service drive.

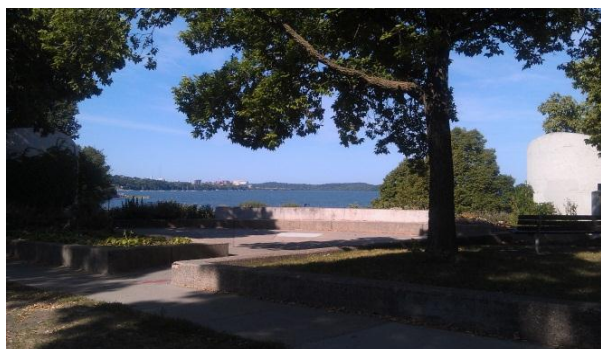
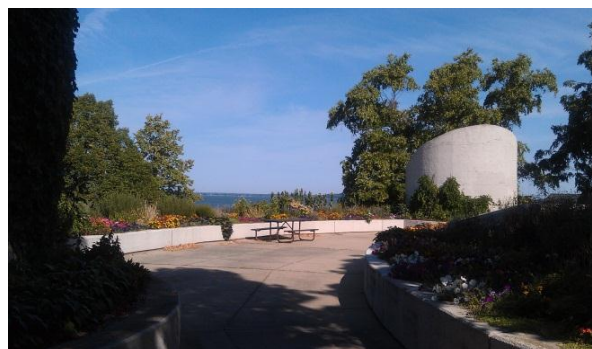
Roof Terrace looking southwest

Roof Terrace looking west toward Lake Mendota

Roof Terrace: The roof area is wonderfully planted with a single picnic table. The roof garden is well integrated into the streetscape; unfortunately it is so well done, it is not apparent that you are on the actual shelter roof.

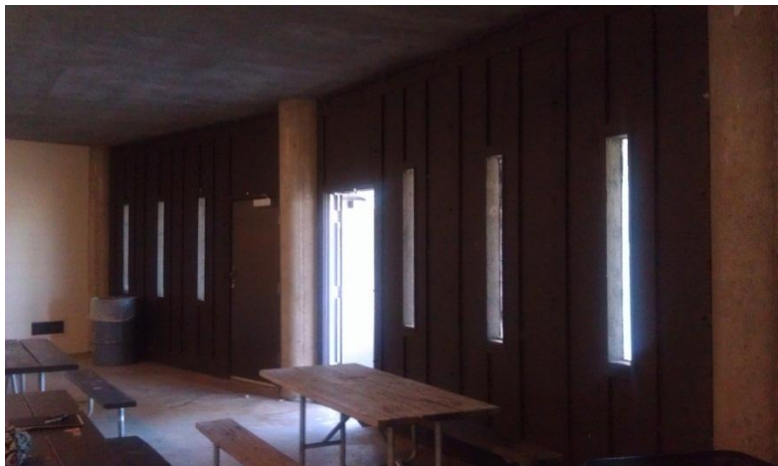
Activity Room: The space is expansive, constructed primarily of exposed architectural concrete, concrete masonry walls and concrete floors. Acoustics are a challenge and lighting glare, performance and efficiency needs improvement. The solid wood entry wall with slot windows eliminates any lake views from this interior gathering area.

Interior of Activity Room looking toward the lake

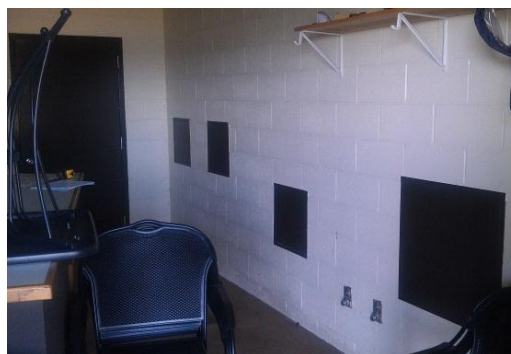
Concessions: This area has two hose bibbs and a coiling door for vendor sales and/or a serving area for shelter patrons. There is a single door to the lake side and no visual connection to the exterior. Currently this space is used for miscellaneous storage and outdoor furniture.

Interior of Concessions room – used as storage

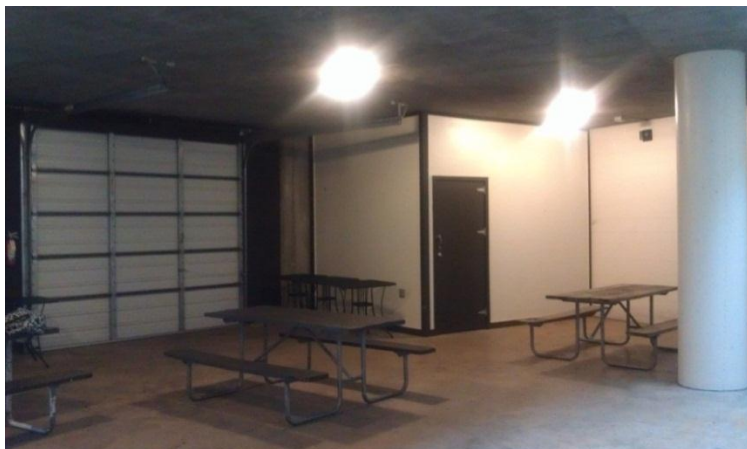
Storage: This small room was constructed with a temporary wood partition for a former vendor. It is currently used for life guard storage.

Activity Room with garage door on lakeside and added storage room

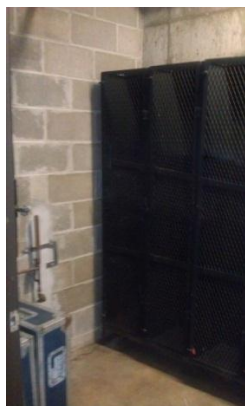
Mechanical: There are two small mechanical rooms that will accommodate basic upgrades. The northeast mechanical room is used for janitor storage and has an abandoned furnace. The southwest mechanical room has lockers for life guards, water line and meter. There is no service sink or janitor sink in the building.

Southwest Mechanical

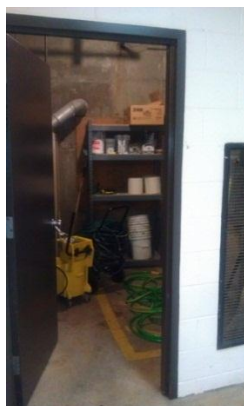
Northeast Mechanical

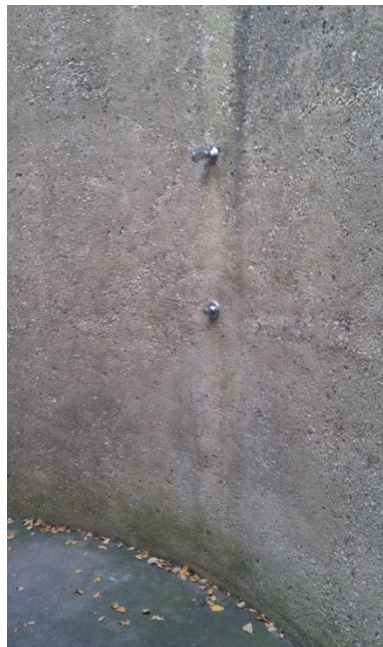
Toilet Rooms: The current toilet rooms and outdoor showers are well-used and provide only cold water. They require maintenance and need ADA Accessibility upgrades.

Outdoor Shower

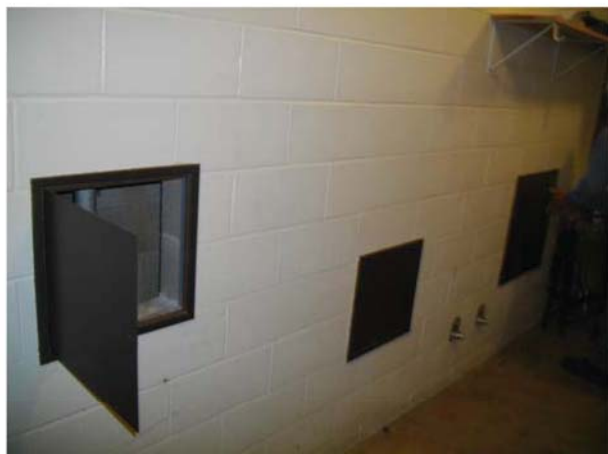
The plumbing fixtures appear to be either original or replaced many years ago. The water closets use concealed flush valves but access to the valves is very limited.

Plumbing Chase Access Panels

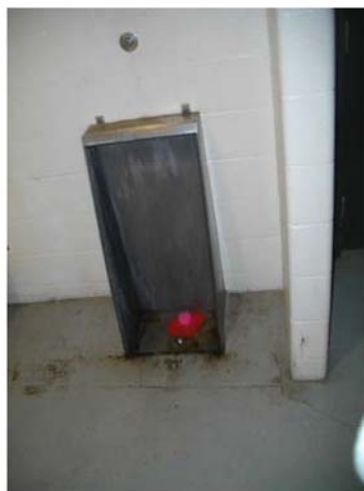
Stainless Steel Floor Mtd Urinal

- Toilet fixtures and flush control will require upgrade to meet ADA accessibility
- Add 18" grab bar at toilets
- Urinal flush control will require upgrade to meet ADA accessibility
- Sinks need off-set drains to meet clearance
- Current paper towel dispensers do not meet ADA clearances or reach requirements

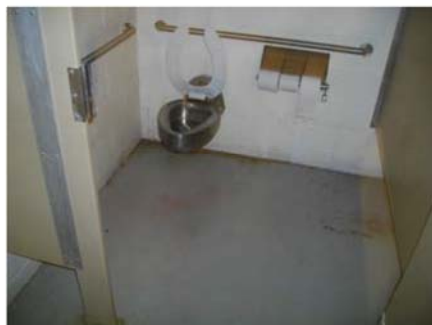
Stainless Steel Wall Mtd Water Closet

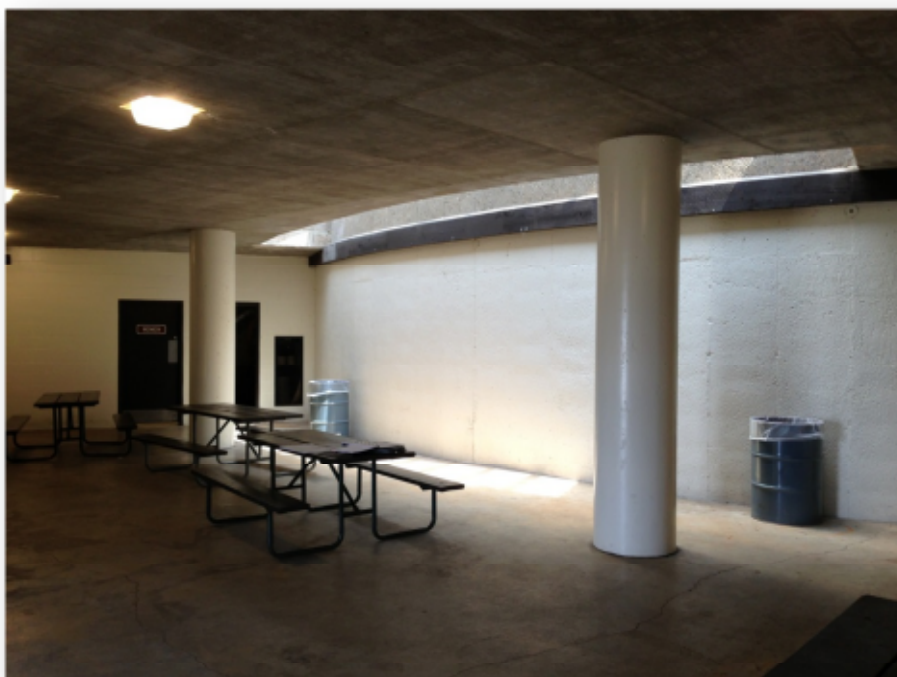
Photo 2 - Lower Level with Skylight

A couple notable structural concerns regarding the existing conditions were made. Concrete is spalling off the bottom of the elevated concrete wall at the front entrance of the building (Photo 4). The open air terrace has a skylight along the back of the building that appears to have an active or recent leak allowing moisture penetration (Photos 2, 3). The planter gardens located on top of the slab appear to have a soil depth of around 2’-0”. The structural drawings show these planters filled with soil to that depth and this load is

In general, the Park Shelter building is in very good condition. **(mp)²** recommends the spalling concrete be addressed to avoid possible injury from falling debris. The moisture penetration at the skylight should be addressed by repairing the leaks. **(mp)²** also would recommend a detailed analysis of the flat mat slab be performed if the proposed renovation were to increase the current slab design loads.
