Advertisement for Bids – Asbestos Abatement and Building Demolition

RE: Final Report- Pre-Demolition Services
 LEGEND No. 23WI059

This report presents the results of the pre-demolition inspection of the Marshfield Medical Center located at 900 College Avenue W in Ladysmith, WI conducted by LEGEND Technical Services, Inc. (LEGEND) representative Mr. Lucas Sokol, WI Asbestos Inspector #AII-267101 and Katia Castro Lopez, WI Asbestos Inspector #AII-290508 on May 2, 3, 13 and 24; June 7, 29, 2023. LEGEND's services were requested and authorized by Gary Shilts with Rusk County.

900 Colleve Avenue W
Ladysmith, WI 54848
Ground Floor
ACM Diagram

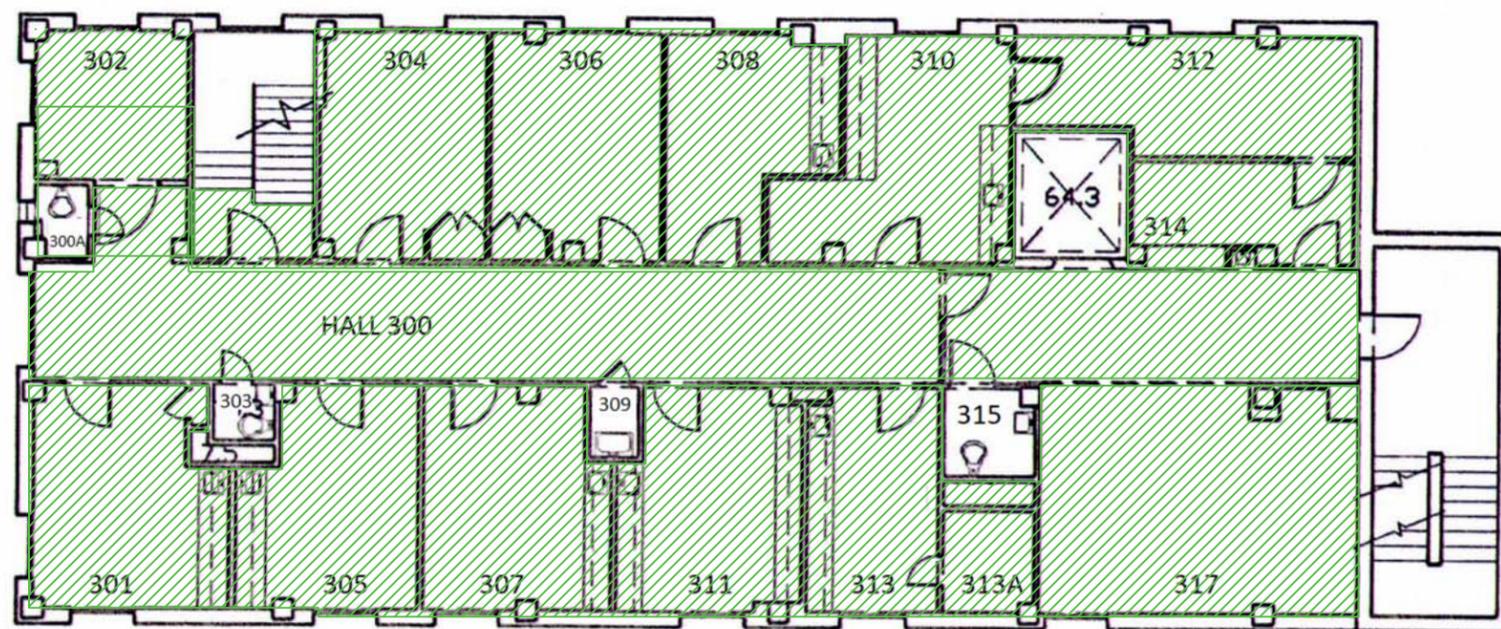
THIRD FLOOR PLAN

- ACM WINDOW CAULK
- ACM FLOOR TILE AND BLACK MASTIC
- ACM DOOR/WINDOW GLAZE
- ACM SINK UNDERCOATING
- ACM PIPE INSULATION

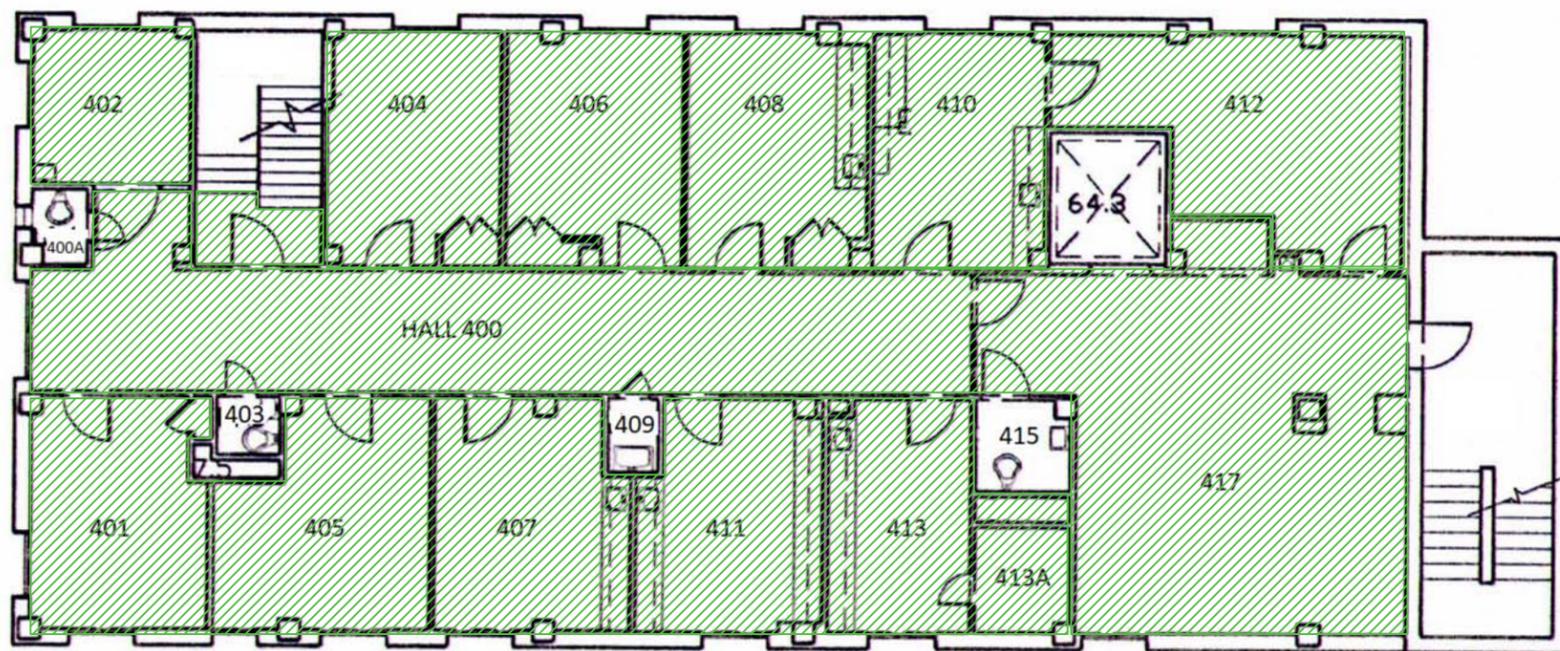
FOURTH FLOOR PLAN

- ACM WINDOW CAULK
- ACM FLOOR TILE AND BLACK MASTIC
- ACM DOOR/WINDOW GLAZE
- ACM SINK UNDERCOATING
- ACM PIPE INSULATION

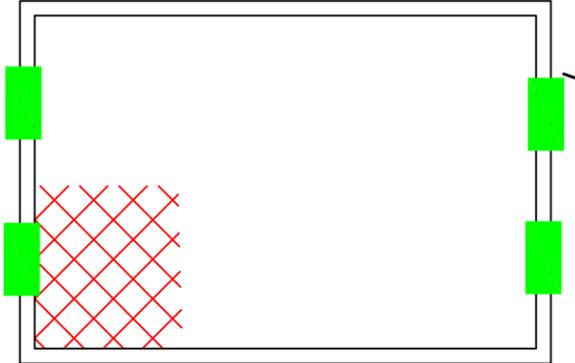
UPPER LEVEL GARAGE

TUNNEL CONTINUES TO 1947 (ACM PIPING THROUGH TUNNEL)

ACM BOILER INSULATION, BREECH, AND PIPE INSULATION THROUGHOUT

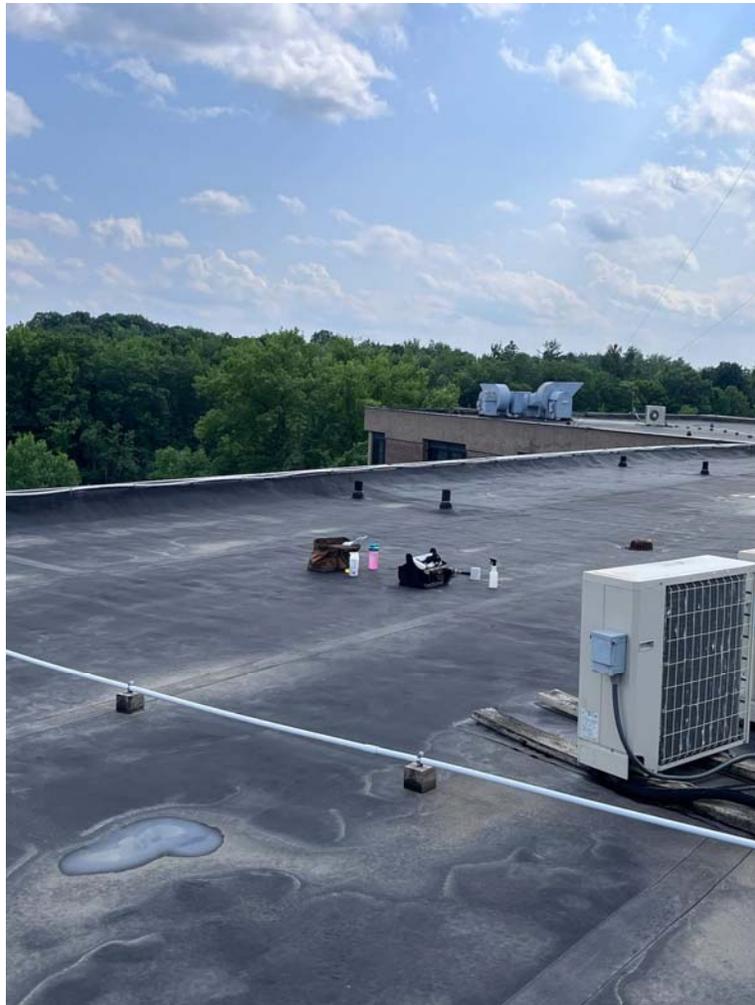
Rooftop-AHU equipment with ACM vibration dampeners
